Job No: 85442.0300 12 May 2022

Palmerston North City Council 32 The Square Palmerston North 4410

Aokautere slope stability: considerations for consenting

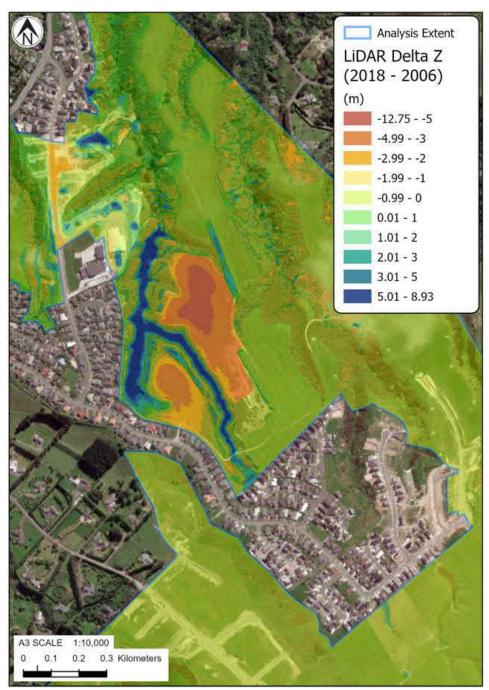
We have carried out an exercise to identify areas likely to contain fill by subtracting the 2006 DEM from the 2018 DEM. Where the resulting values are negative, the land levels have been reduced by the resultant value by excavation and removal of land, and where the resulting values are positive,

the land levels have been raised by that value. The results of this analysis are shown in Figure 3.2. A detailed version of this map is reproduced in Appendix D.

Figure 3.2: Image showing the difference between the 2018 DEM and the 2006 DEM. Positive values indicated land levels that have been raised by filling, negative values indicate land that has been lowered by excavation.

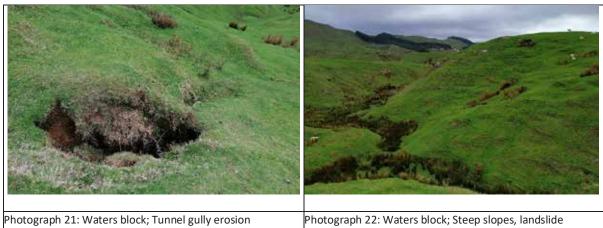
Photograph 22: Waters block; Steep slopes, landslide headscarps and watercourse
