Palmerston North City Council

Notable Tree Survey March and April 2011

Address	Caccia Birch, 130 Te Awe Awe Street	
Tree name	Beech (<i>Nothofagus hybridus</i>) [more likely to be <i>N. solandri</i>]	
Location of the tree on the site	In the rose garden overlooking the lagoon	
Owner's name	Caccia Birch Trust	
Date of STEM Assessment	30 March 2011	Inspected by John Wakeling

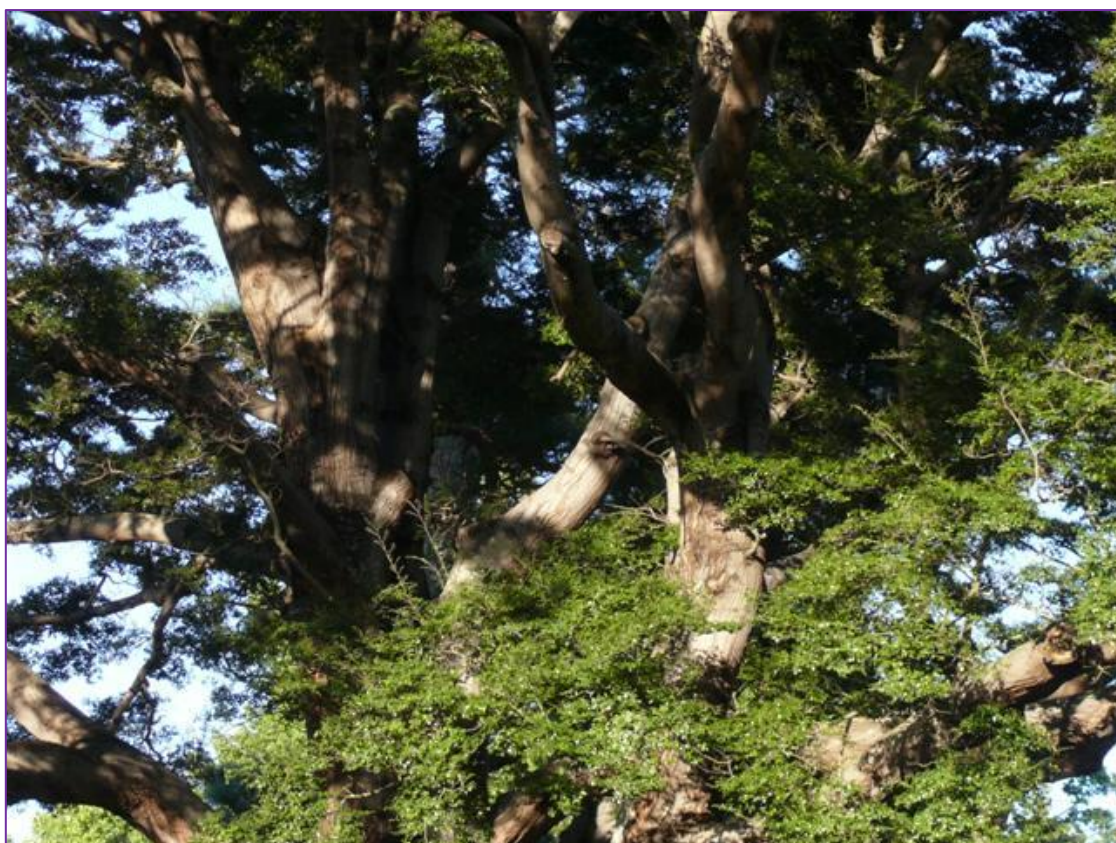
Figure 4, detail of trunk

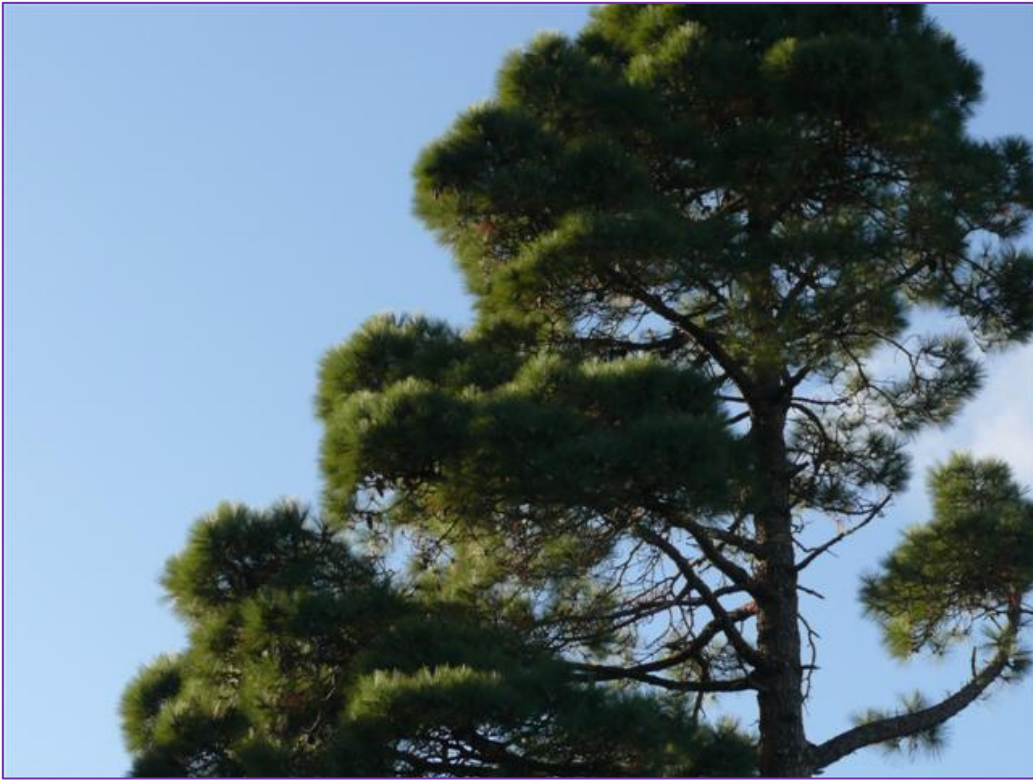
Comments	The tree is healthy and looks set to continue providing an amenity for many more years, the ground and bank beneath the tree should be re-vegetated.

Figure 1, the crown – healthy, well shaped

Category	Priority	Recommended Action	Timing (from April 2011)	Actioned	Completed
Amenity		None at present			
Health					
Safety					
Overhanging b'dry		Underplant the bank with suitable shrubs.

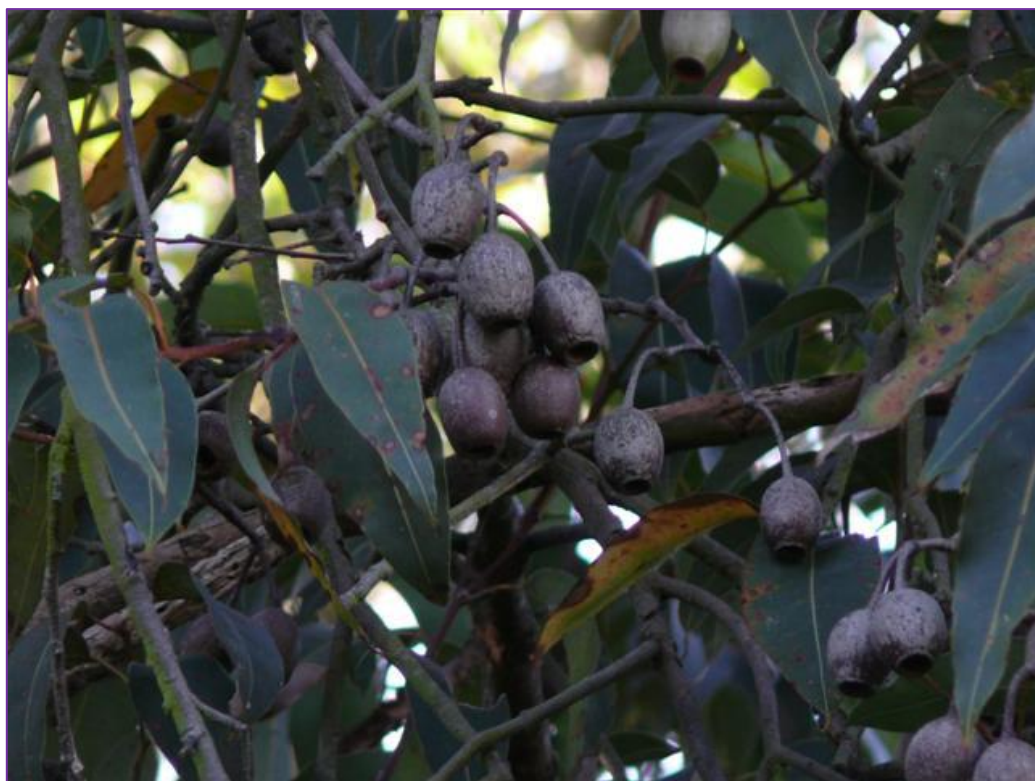
Comments	The species is noted for the brilliance of its mid-summer blossoms (about a month later). The downside is the great weight of the seed pods they produce; these are persistent and can cause breakage of quite large branches.

Figure 4, seed capsules

Category	Priority	Recommended Action	Timing (from April 2011)	Actioned	Completed
Amenity					
Health	routine	Remove end weight caused by seed cases	5 yearly		
Safety					
Overhanging b'dry

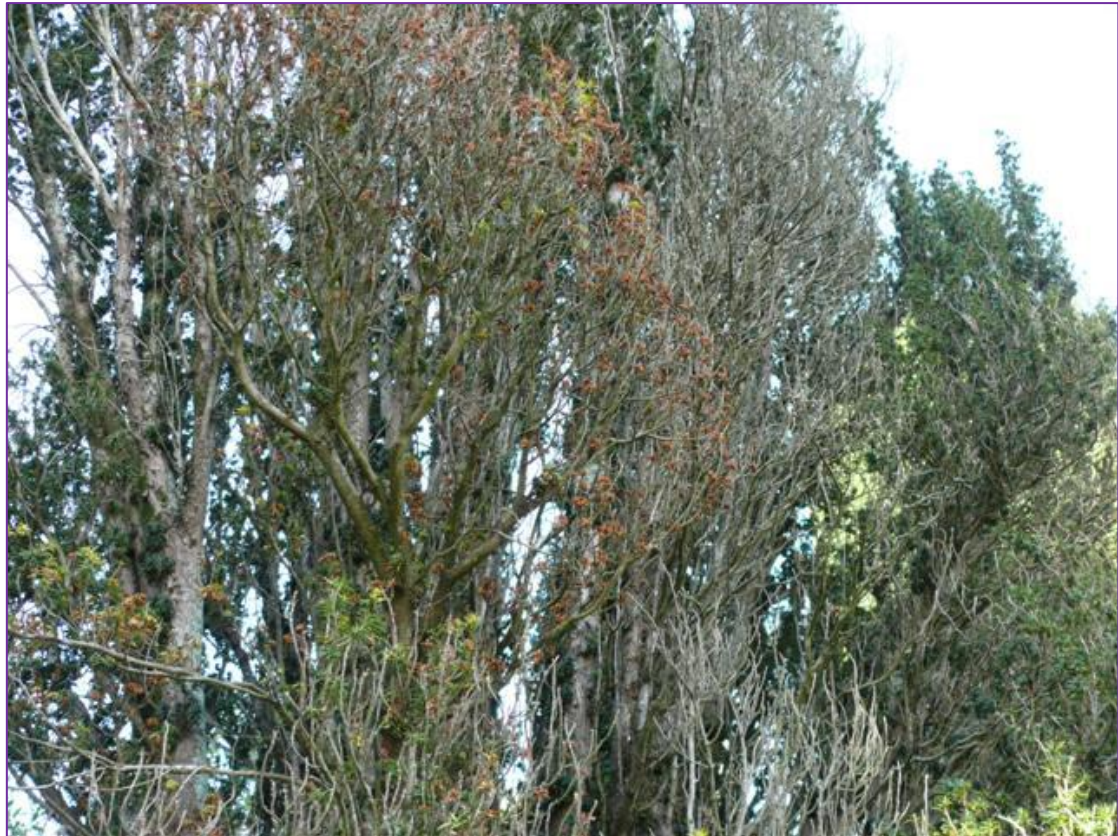
There are two Irish yews standing close together. The tree described above is in good health. Its neighbour, no more than a few metres away appears to be dying – defoliation, shrivelling of the twigs and all happening within a period of three growth seasons. If the tree is left in this state, the dieback will continue and death of the whole tree will result.

Figure 2, the crown of the dying tree

I have seen a similar occurrence in the UK, where, as a last resort, the owners cut the tree hard back to a naked stump of about 1.5m high. Residual reserves managed to start off a flush of new growth, which continued to grow well. I recommend this course of action for this tree. We have little to lose, if, after a year's waiting, nothing has happened, the stump can be removed.

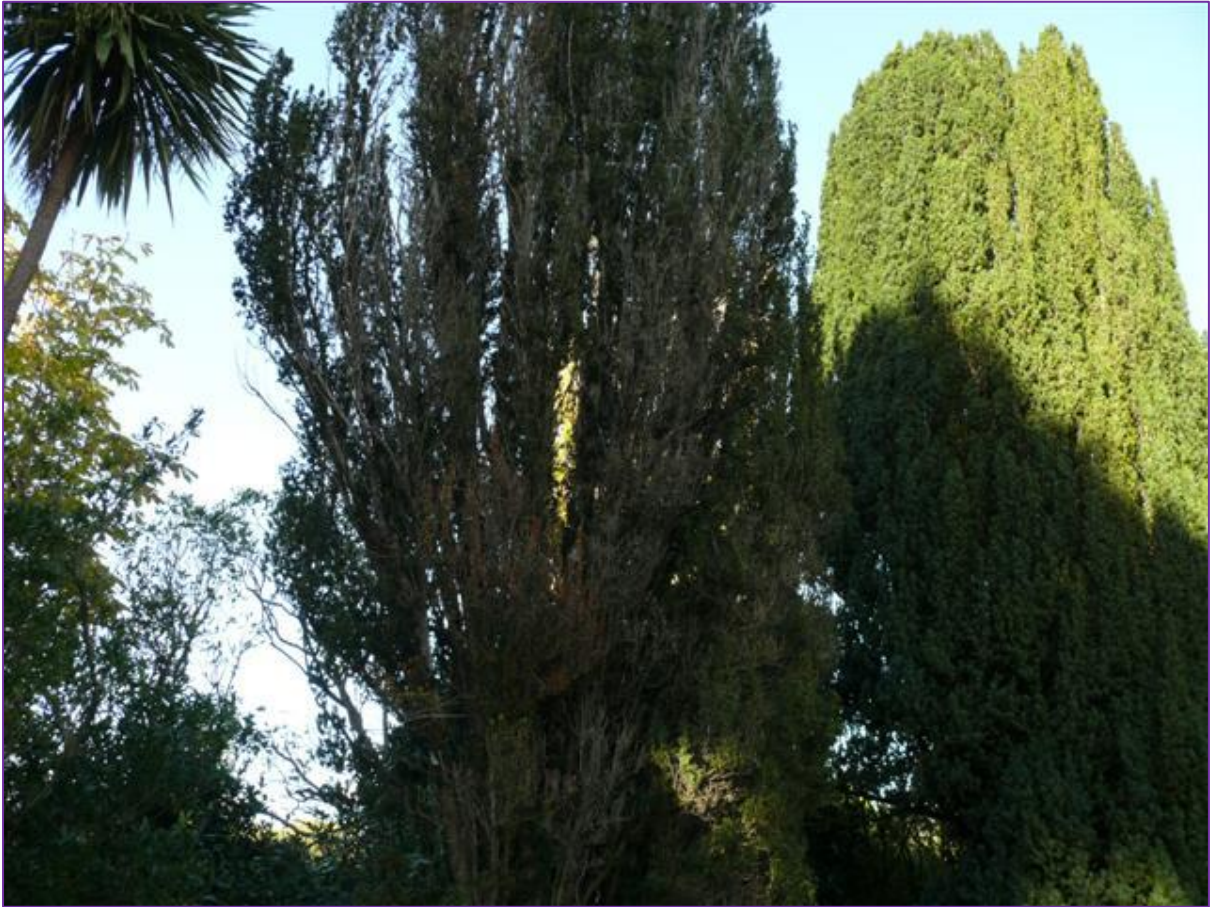
Figure 3, the two trees

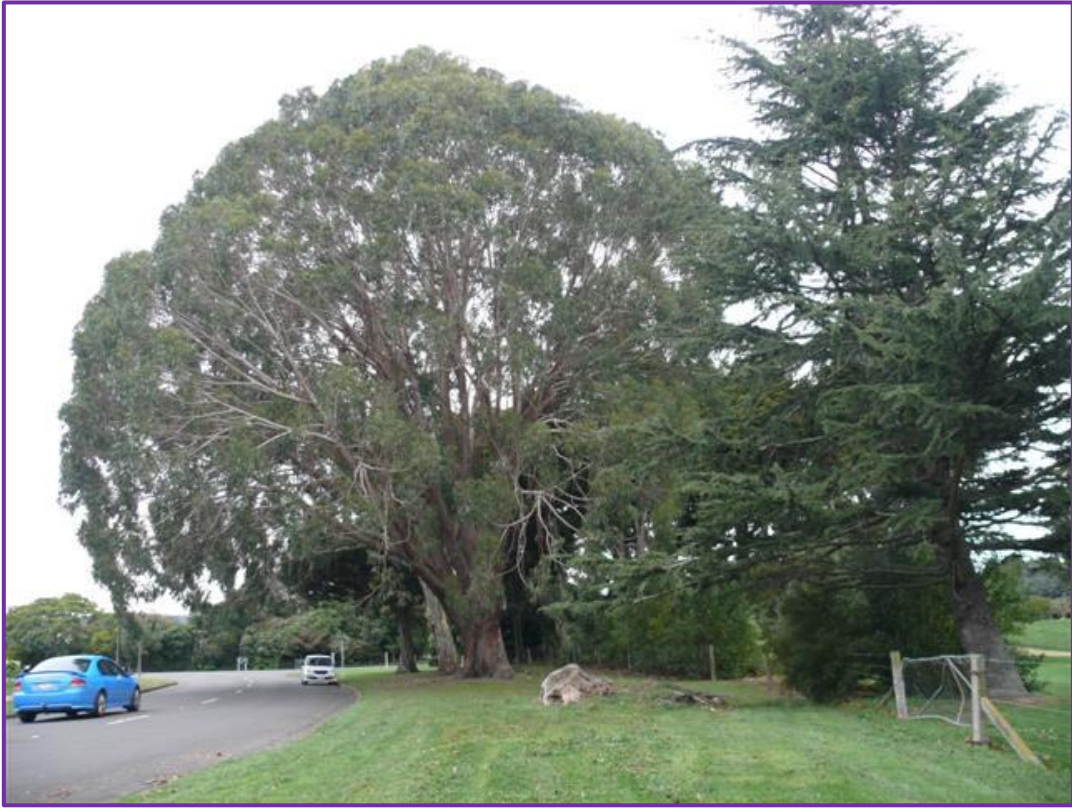
Comments	<p>There used to be a group of three trees; one fell over and the remaining trees are becoming something of a nuisance – one tree is suppressing the growth of two totara trees and the other is starting to shed branches.</p> <p>It is timely to consider removal of both trees and to plan for some replacement trees.</p>

Figure 1, larger of the two gum trees, with stump in foreground

Category	Priority	Recommended Action	Timing (from April 2011)	Actioned	Completed
Amenity					
Health					
Safety		Remove the trees.			
Overhanging b'dry

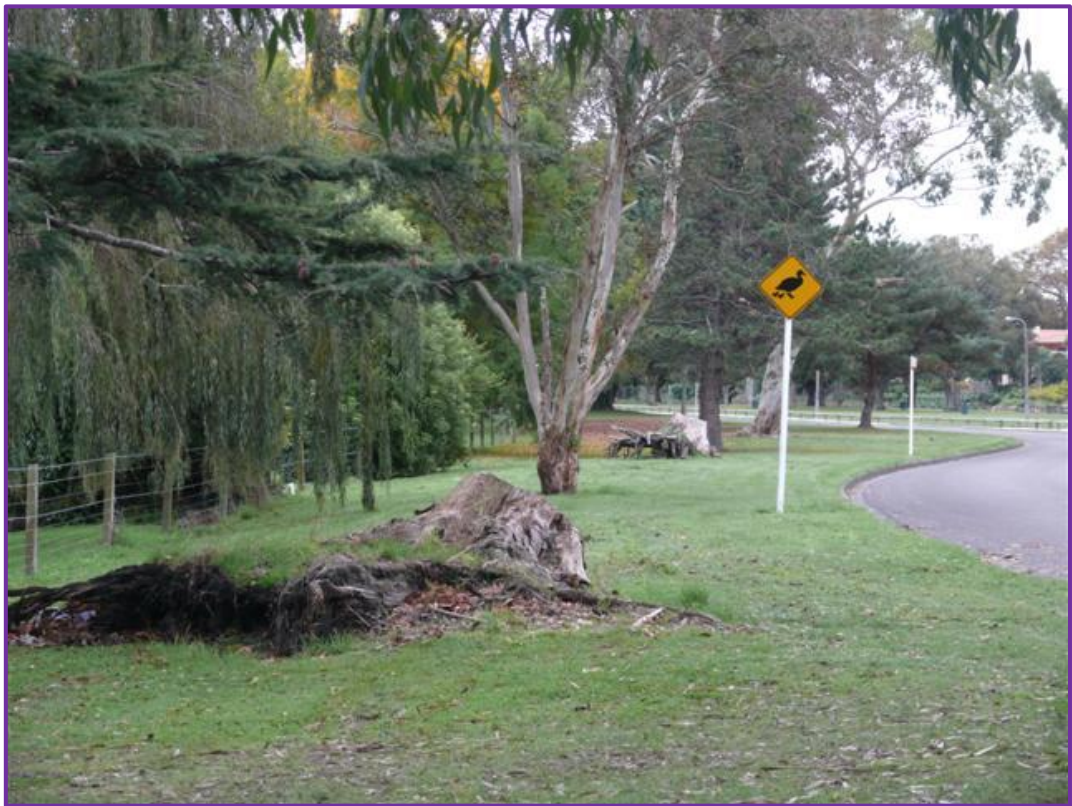
Changes noticed in last five years	Die-back/health – developments nearby – excavations nearby. One tree has fallen down.
---	---

Figure 2, stump of fallen tree.

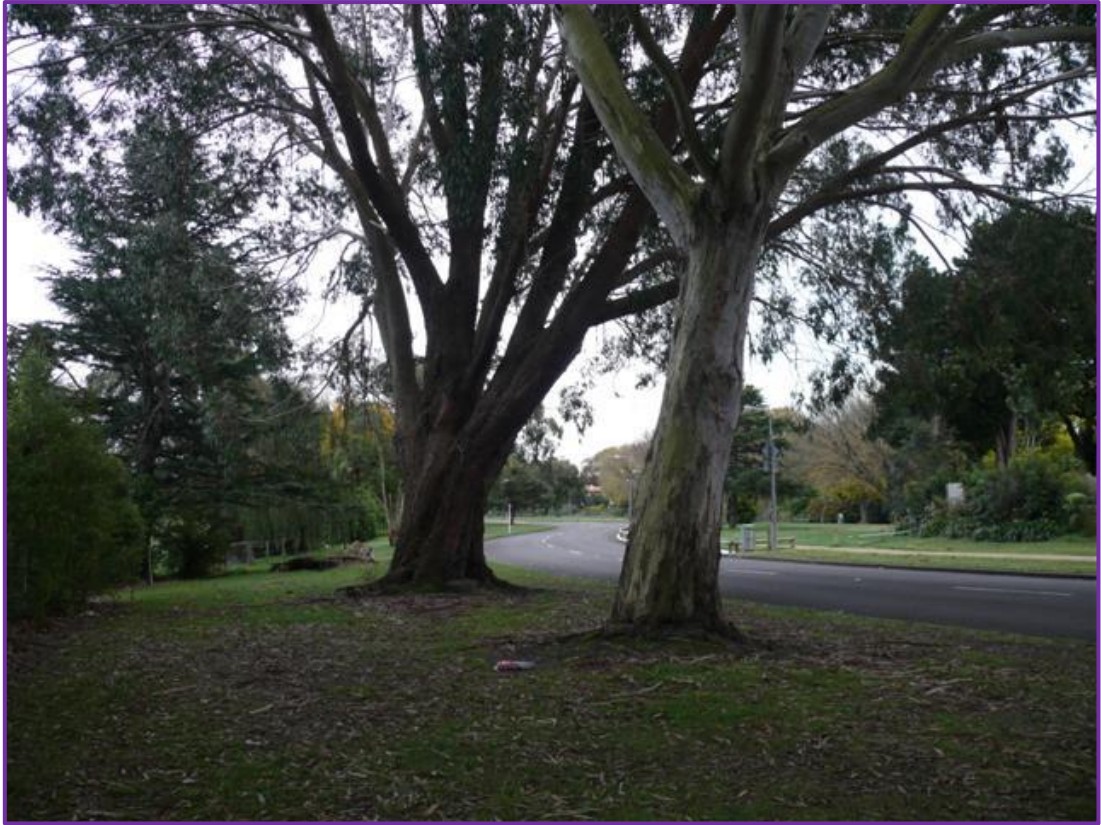
Figure 3, The two gums

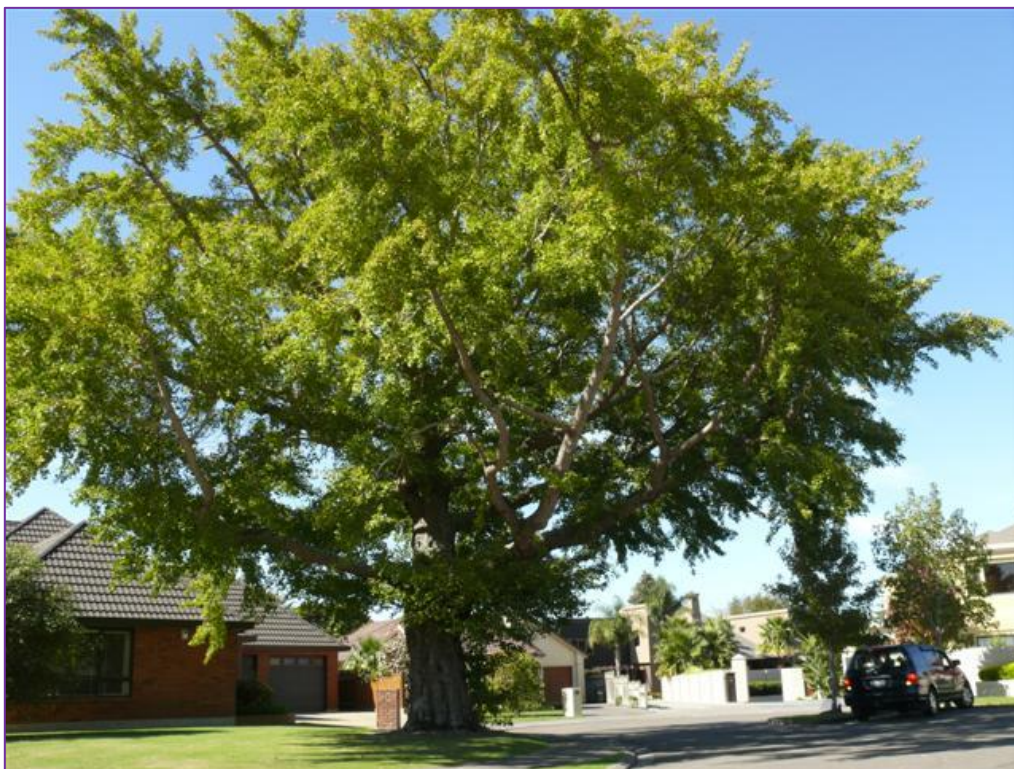
Figure 1. healthy crown, minor wind shaping

Category	Priority	Recommended Action	Timing (from April 2011)	Actioned	Completed
Amenity	routine	Shorten lower limbs, raise crown as needed	Every 5 years		
Health	-				
Safety	-				
Overhanging b'dry	As requested	Reduce width of limbs	As above

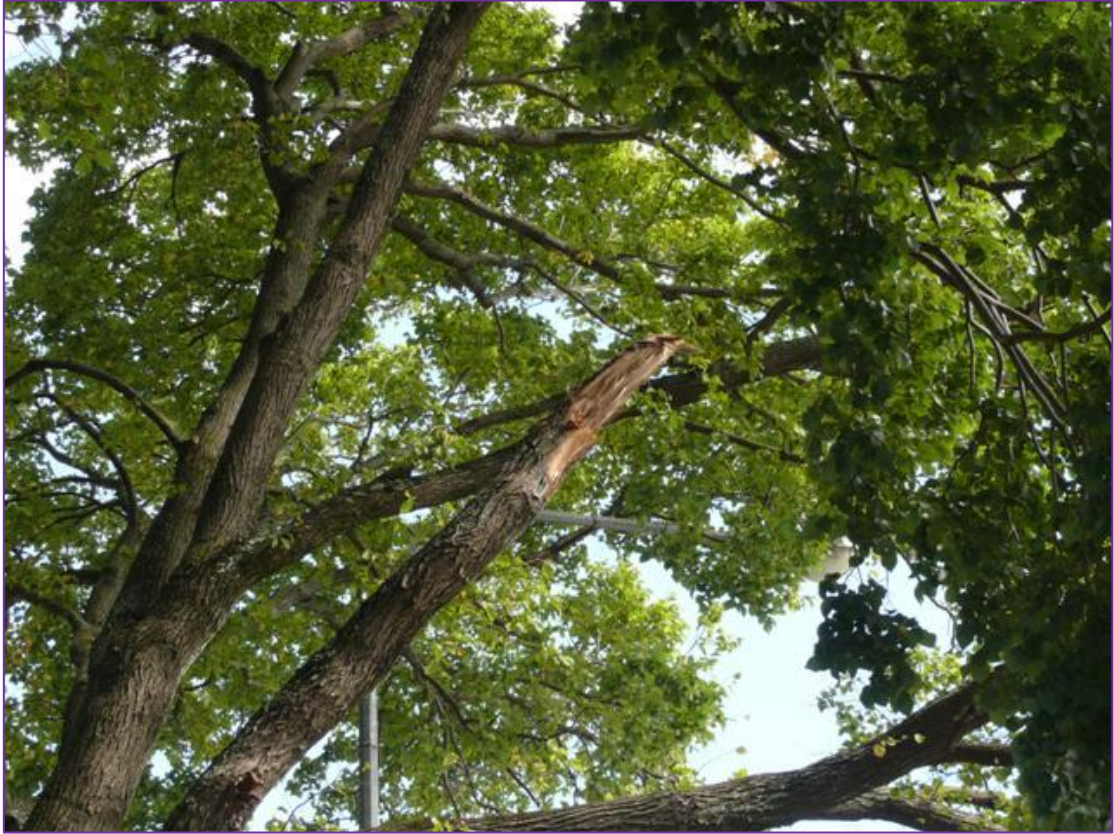
Figure 2, broken limb – this will increase in proportion to the trees' size and age, crown reduction can help reduce frequency.
