# Palmerston North City Council

## Notable Tree Survey March and April 2011

<b>Address</b>	3 Stanley Street	
<b>Tree name</b>	Black beech ( <i>Nothofagus solandri</i> )	
<b>Location of the tree on the site</b>	Front garden	
<b>Owner's name</b>		
<b>Date of Inspection</b>	30 March	<b>Inspected by</b> John Wakeling

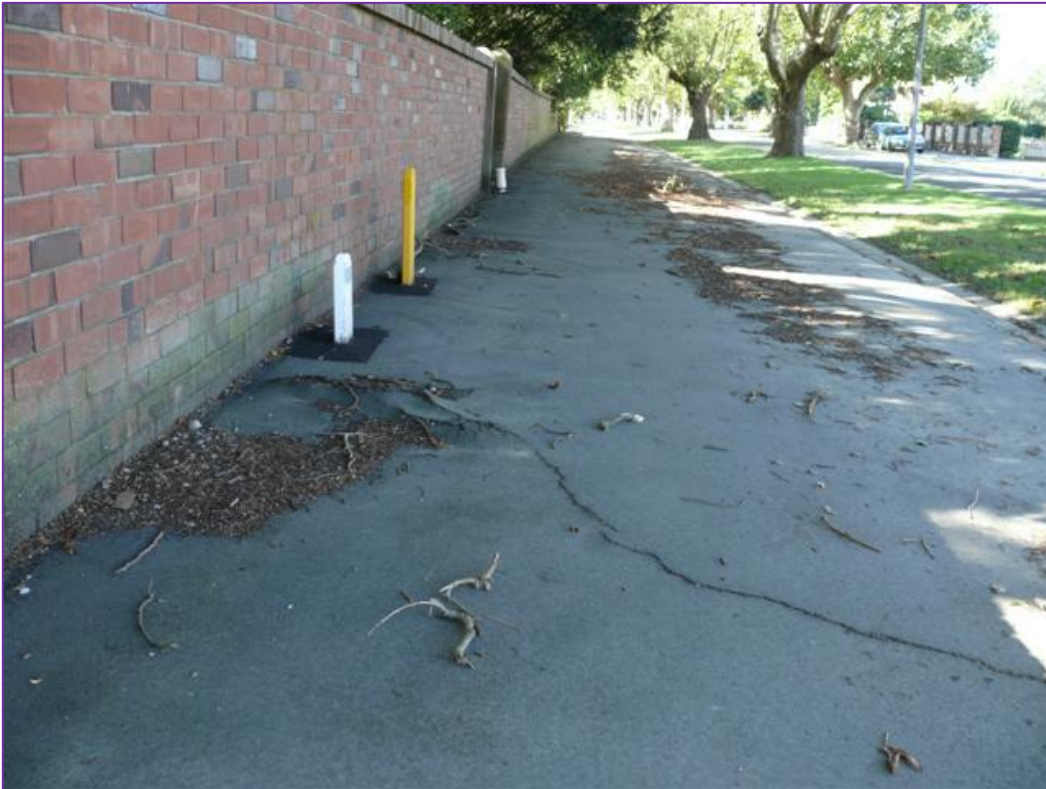
Category	Priority	Recommended Action	Timing (from April 2011)	Actioned	Completed
<b>Amenity</b>	routine	Deadwood removal	Now - 5 years -		
<b>Health</b>		Check for bracket fungi			
<b>Safety</b>	-	The root system is having an adverse effect on the footpath. The council might have to lay an extra coat of asphalt in the affected area.			
<b>Overhanging b'dry</b>

Figure 1 damage to footpath

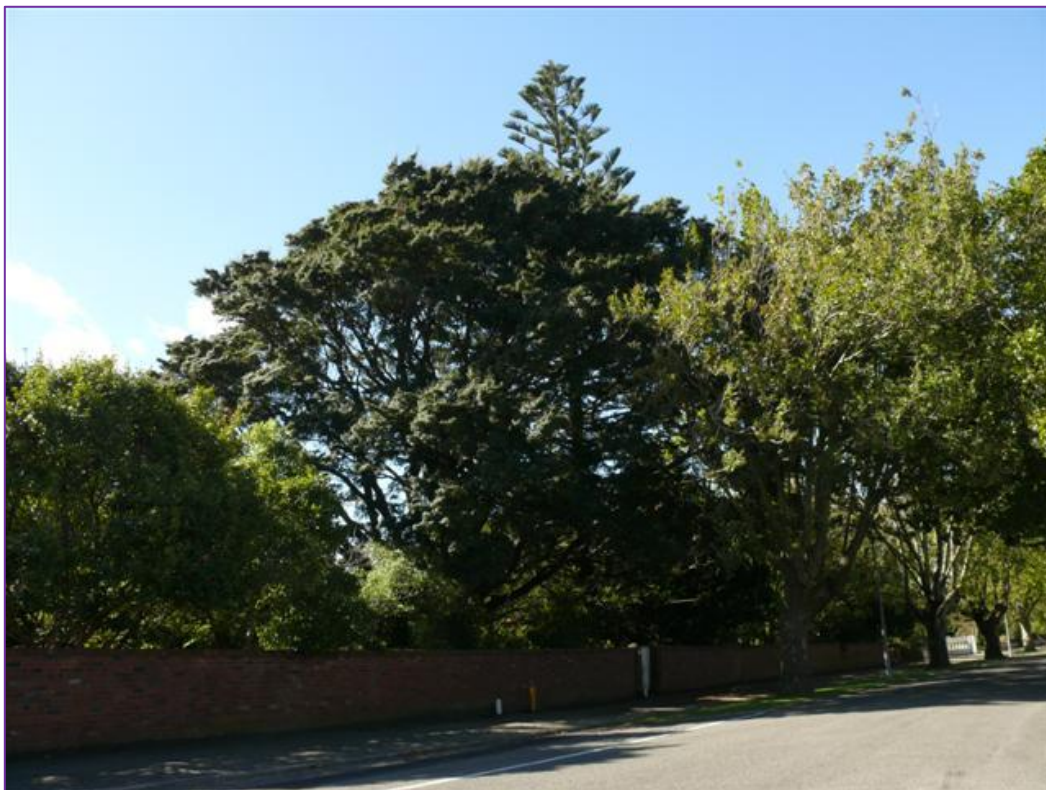
<b>Root Zone</b>	Garden	Natural	Lawn/paddock	U/g services apparent?	Hard surface, if so, explain
<b>Comments</b>	A very pleasant specimen, ideally suited to the scale of the property and blends in well with the street scene.

Figure 2. The tree in its setting
