# Palmerston North City Council

## Notable Tree Survey March and April 2011

Address	9 Featherston Street	
Tree name	Norfolk Island Pine ( <i>Araucaria heterophylla</i> )	
Location of the tree on the site	Front garden	
Owner's name		
Date of STEM Assessment	28 June 2014	Inspected by John Wakeling

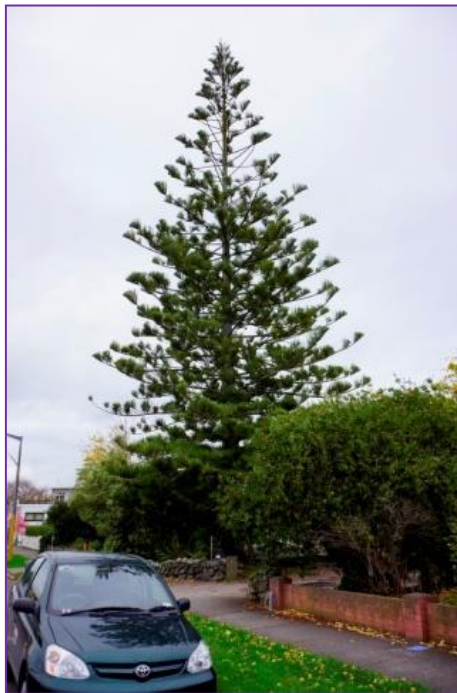
Figure 1, the silhouette of the tree. Note the conical apex

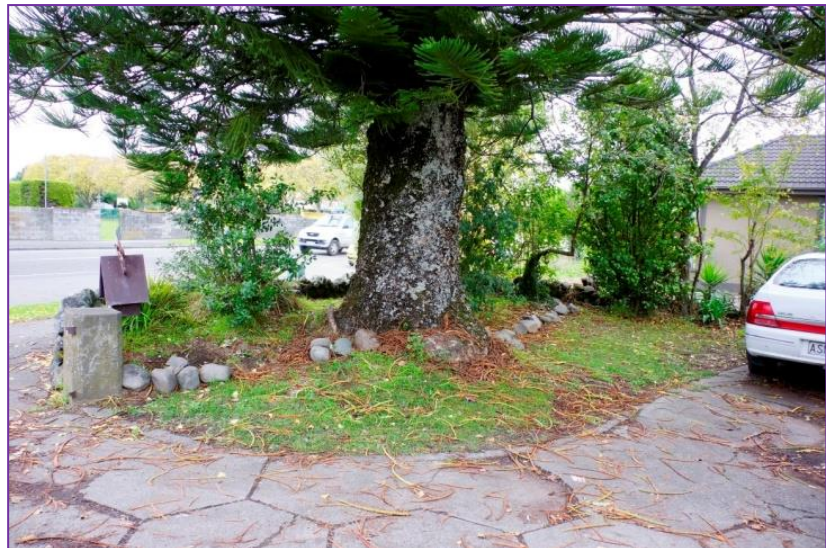
Figure 2, front yard where the tree takes up a lot of the garden
