Palmerston North City Council

Notable Tree Survey March and April 2011

Address	21 Margaret Street	
Tree name	Two giant redwood or mammoth trees (<i>Sequoiadendron giganteum</i>)	
Location of the tree on the site	Rear garden, down a bank	
Owner's name		
Date of STEM Assessment	10 May 2011	Inspected by John Wakeling

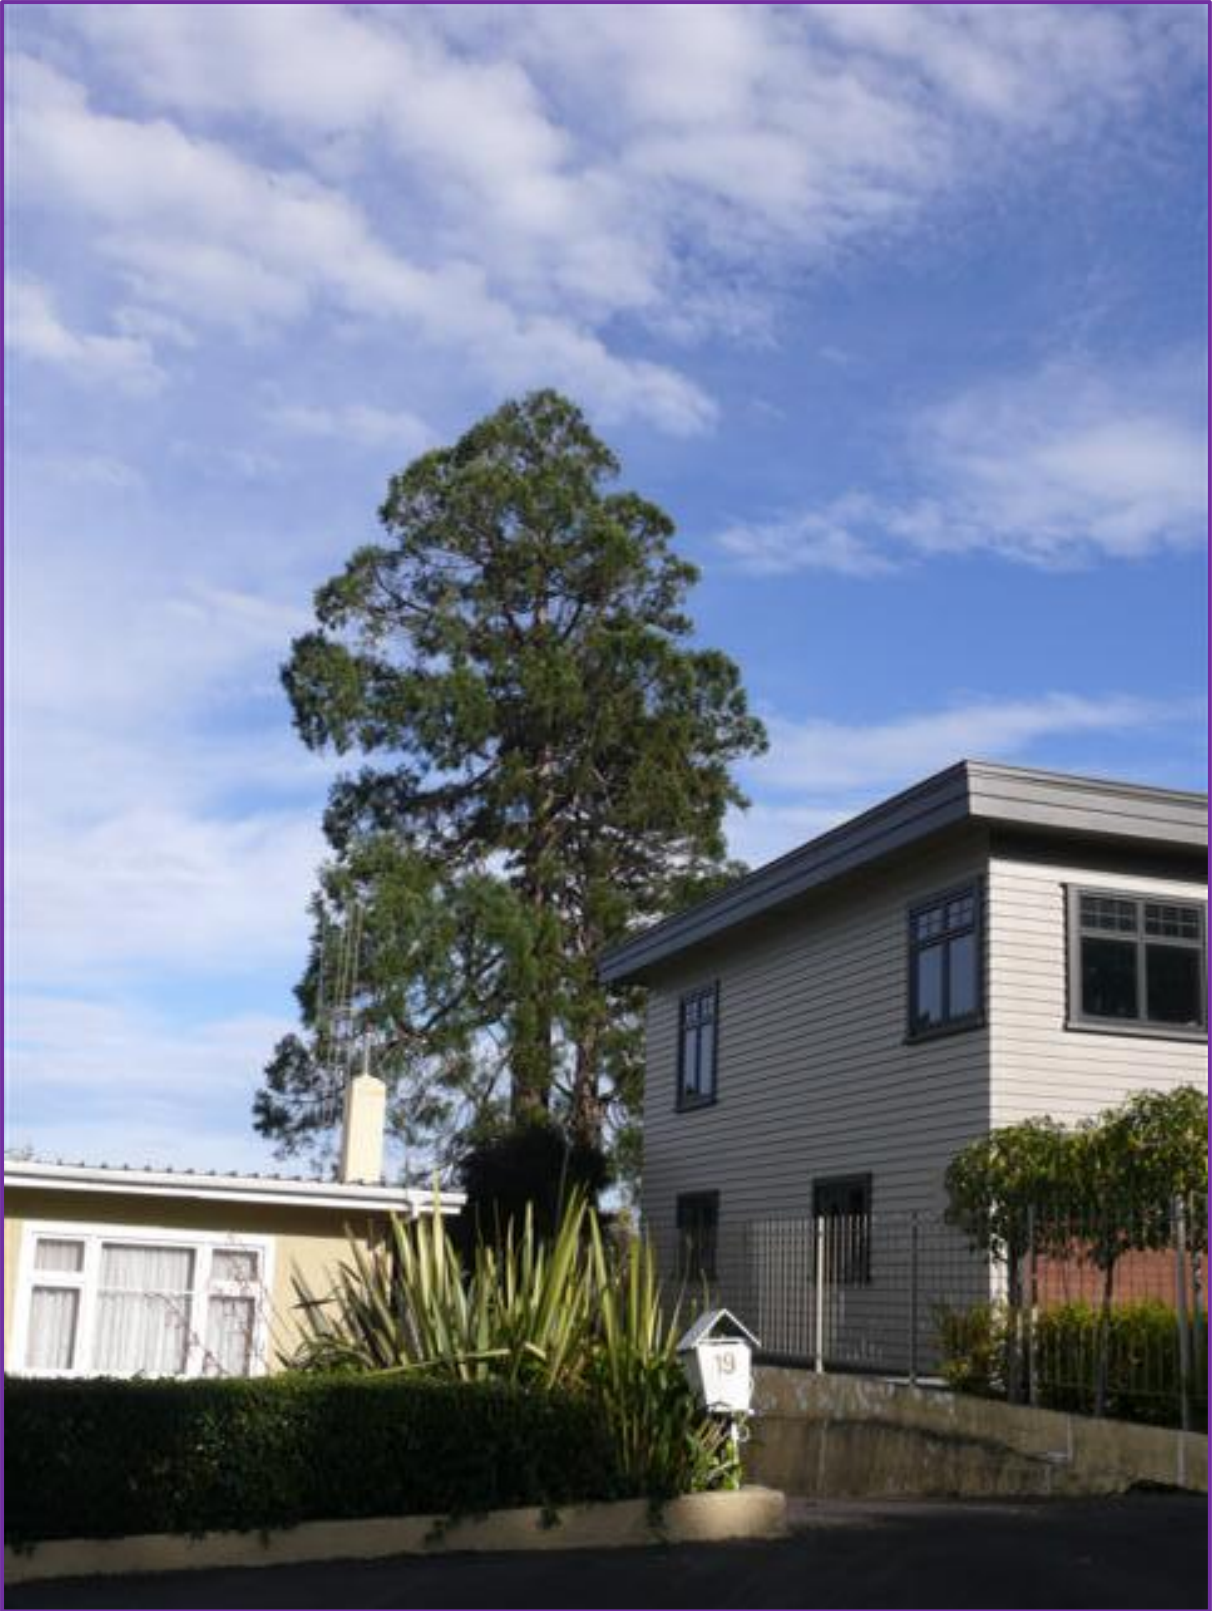
Figure 1 the two trees

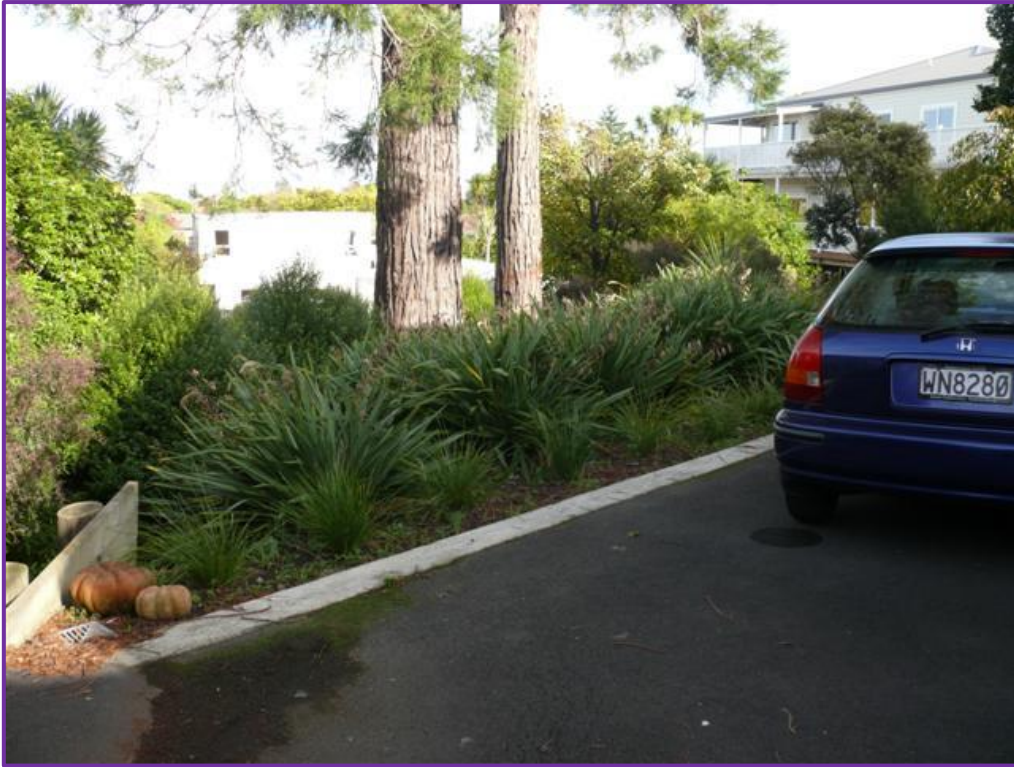
Figure 2, the new garden

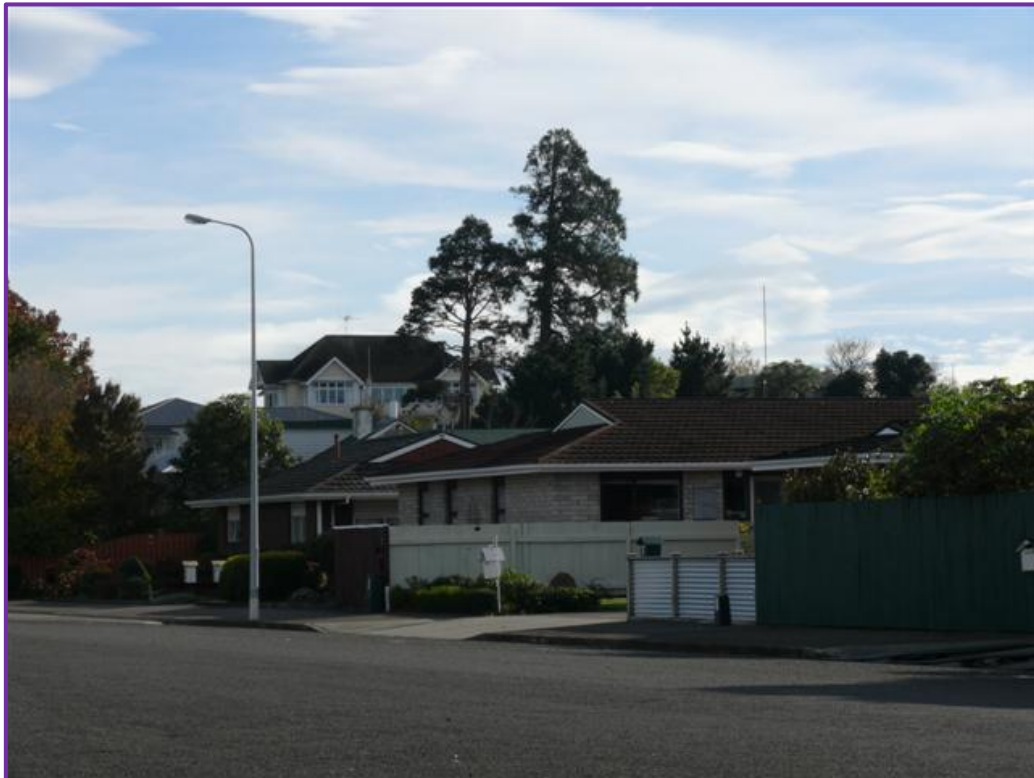
Figure 3 From the Napier Highway

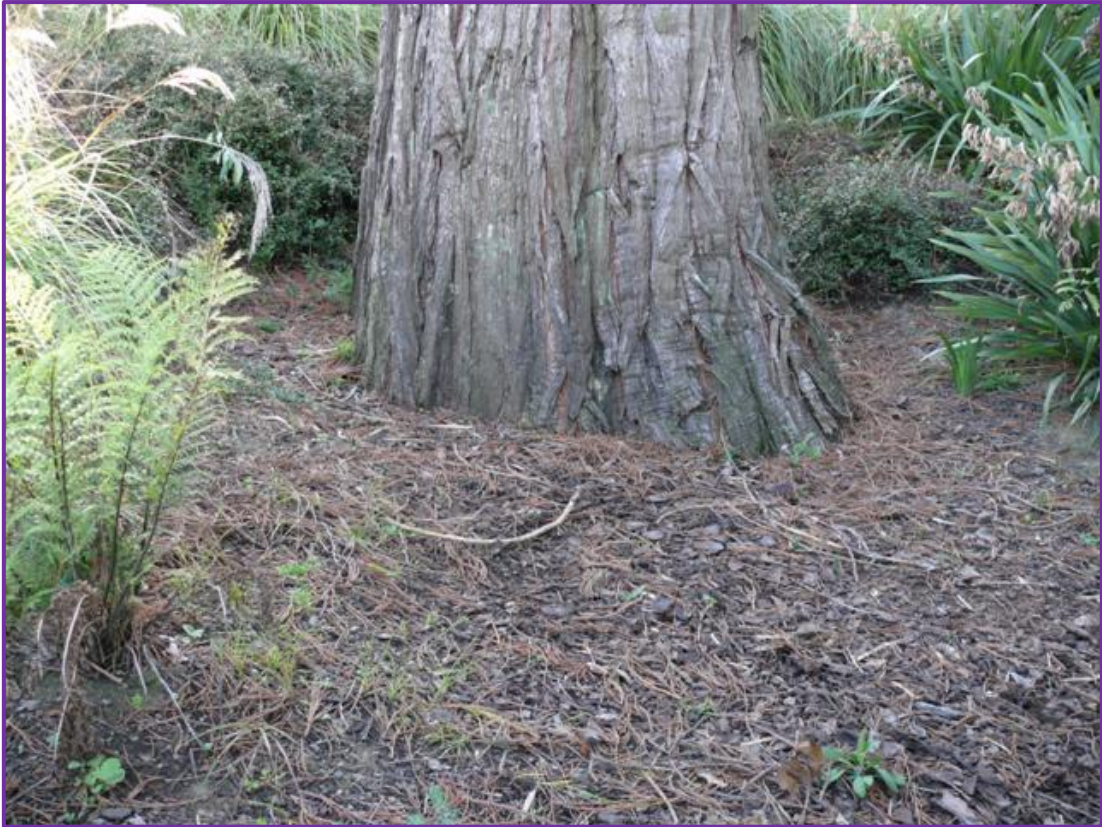
Trunk character	Sound, with good taper. Ground around the base of the trees shows no signs of heaving nor depressions. The new garden was built to keep the new topsoil away from the base of the trees.				
Root Zone	Garden	Native species	Lawn/paddock	U/g services apparent?	Hard surface, if so, explain
Comments	<p>I met Mr. and Mrs Staddon on site and had a discussion with them about the health and stability of the trees. I explained that I considered the lean on the one tree is not a slowly increasing phenomenon, but is the result of the competition from the third tree (that was felled) The Staddons explained their concerns, especially about the noise of the wind in the crowns during stormy weather.</p> <p>Both trees appear to be in good health, with no indications of soil weakness, or fungal disease.</p>

Figure 4, Ground conditions are good

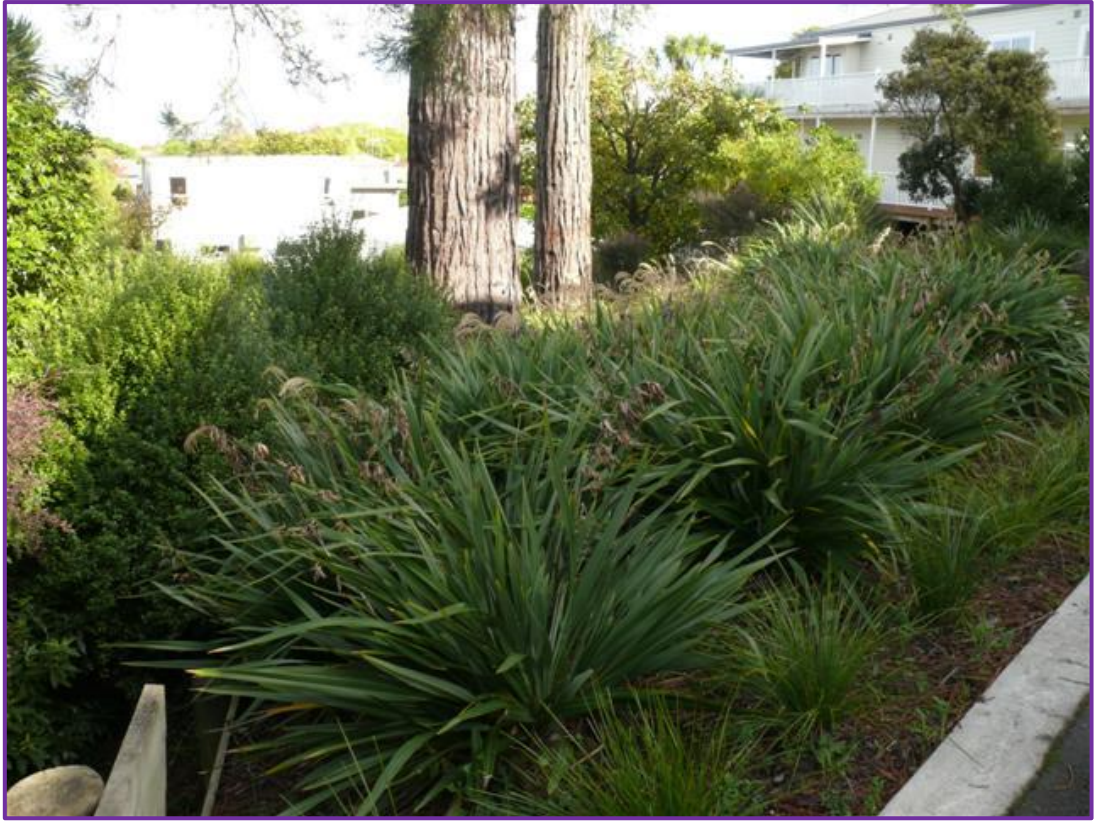
Figure 6, the different sizes of the trunks
