Palmerston North City Council

Notable Tree Survey March and April 2011

Address	30 Moerangi Street	
Tree name	Coastal redwood (<i>Sequoia sempervirens</i>)	
Location of the tree on the site	Front yard, near gateway	
Owner's name		
Date of Inspection	31 March 2011	Inspected by John Wakeling

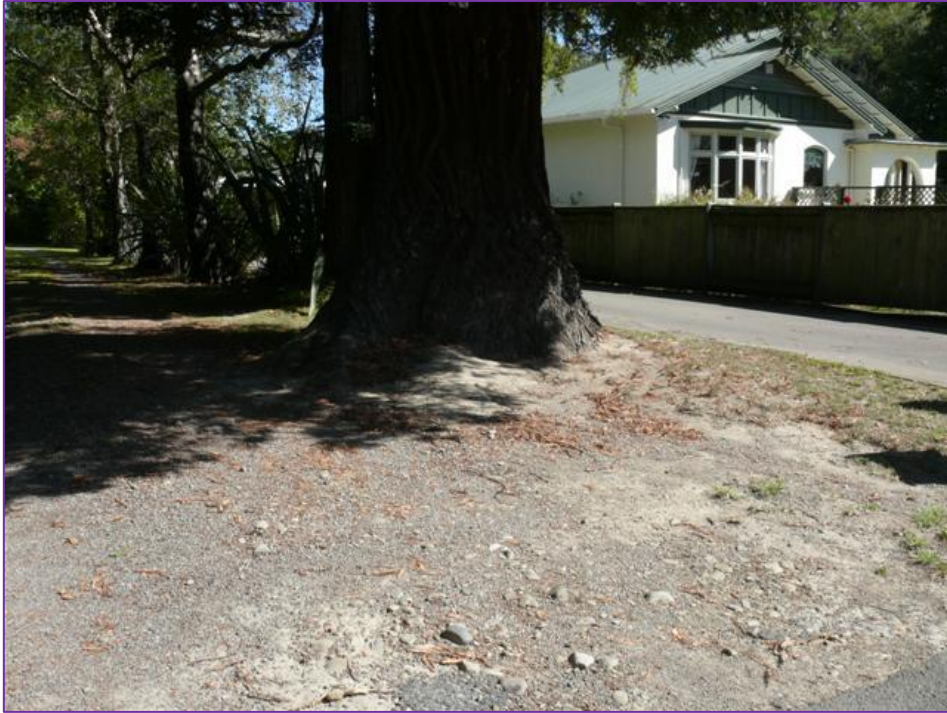
Requested for/by	Routine	Storm Damage	Owner	Developer	DP Review
Pruning History	Occasional crown lifting				
Built Environment	Small tight dev'pment	Standard suburban	Large house and grounds	Other (describe)	
Garden environment	Solo tree	Few trees	Many trees	exotic/native	
Local Environment	Few trees	Some trees	Well treed neighbourhood		
Age Class	young	Semi mature	Mature	Post mature	
Special value	Horticultural	Landscape	Specimen	Historical	Botanical
Structural Character	Single leader	Double leader	Multi-stemmed	Included bark unions	Typical Atypical
Form	Refer to STEM scoresheet				
Crown Shape	Typical	Atypical	Wide/spreading/low crown	Influenced by wind - top battered	Affected by other trees
Foliage Health	Good	Poor, if so, explain			
Limb Structure	Typical or sound	Atypical, if so, explain			
Trunk character	Very well shaped with elegant curve from buttresses towards the trunk				
Root Zone	Garden	Natural	Lawn/paddock	U/g services apparent?	Hard surface, driveway over the roots.

Comments	The driveway and tree have been living in some sort of harmony for about 80 years, so unless there is some major redevelopment, I think the tree has adapted well to the situation.

Figure 2. Base of tree, showing the limited grow space available for the root system.
