Palmerston North City Council

Notable Tree Survey March and April 2011

Address	34 Slack Street	
Tree name	Northern Rata (Metrosideros robusta)	
Location of the tree on the site	Street frontage	
Owner's name		
Date of STEM Assessment	29 March 2011	Inspected by John Wakeling

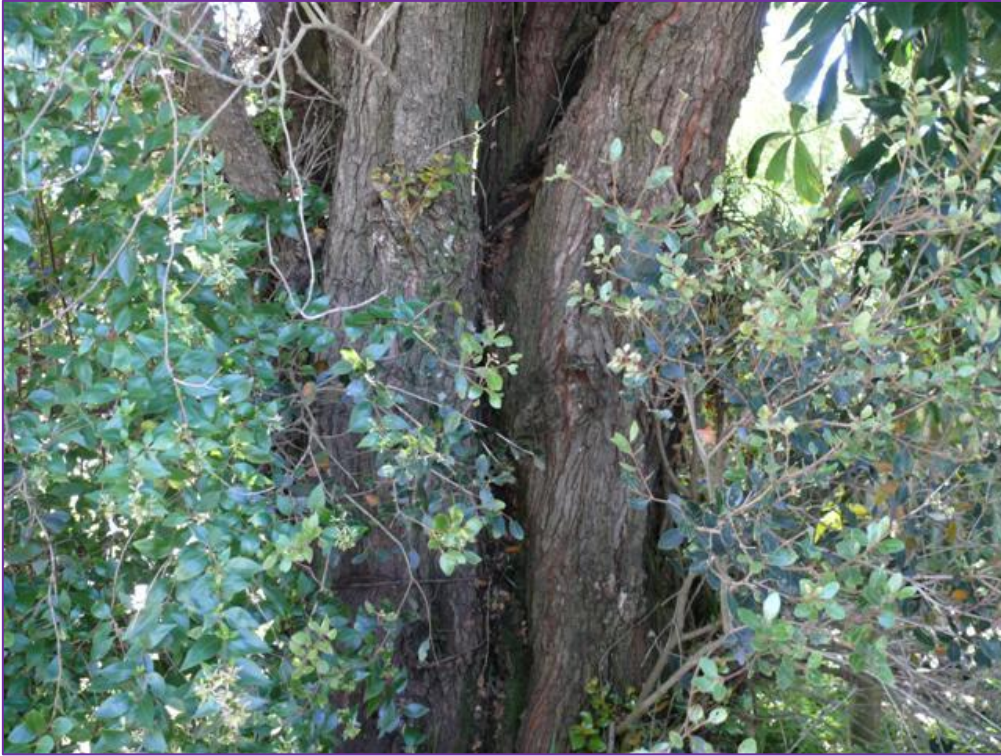
Figure 1, typical fluted and multi stem trunk

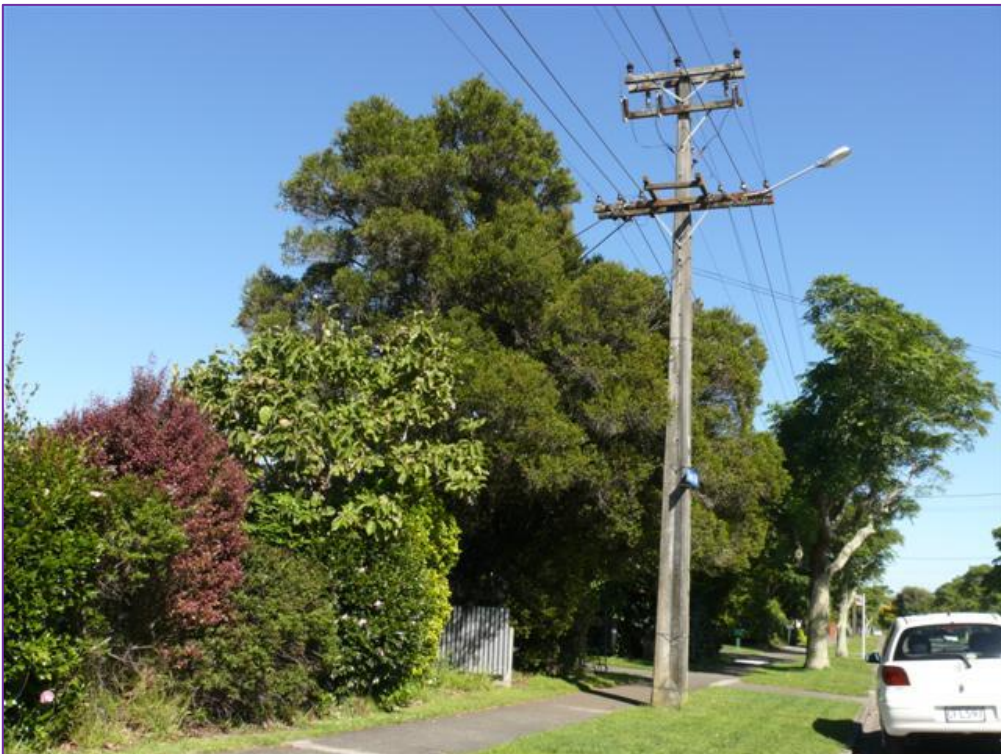
Requested for/by	Routine	Storm Damage	Owner	Developer	DP Review	
Pruning History	Recently pruned to give power line clearance					
Built Environment	Small tight dev'pment	Standard suburban	Large house and grounds	Other (describe)		
Garden environment	Solo tree	Few trees	Many trees	Mainly exotic/native		
Local Environment	Few trees	Some trees (mostly young)		Well treed neighbourhood		
Age Class	young	Semi mature	Early Mature	Post mature		
Special value	Horticultural	Landscape	Specimen	Historical	Botanical	
Structural Character	Single leader	Double leader	Multi-stemmed	Included bark unions	Typical	Atypical
Form	Refer to STEM score sheet					
Crown Shape	Typical	Atypical	Wide/spreading/low crown	Influenced by wind	Affected by power pruning	by line
Foliage Health	Good	Poor, if so, explain				
Limb Structure	Typical or sound	Atypical, if so, explain				
Trunk character	Typically multi stemmed					
Root Zone	Garden	Natural	Lawn/paddock	U/g services apparent?	Hard surface, if so, explain

Figure 2. the influence of power lines on the tree

Category	Priority	Recommended Action	Timing (from April 2011)	Actioned	Completed
Amenity	routine	deadwood	5 yearly, from now		
Health					
Safety	routine	Prune away from o/h lines	As required		
Overhanging b'dry

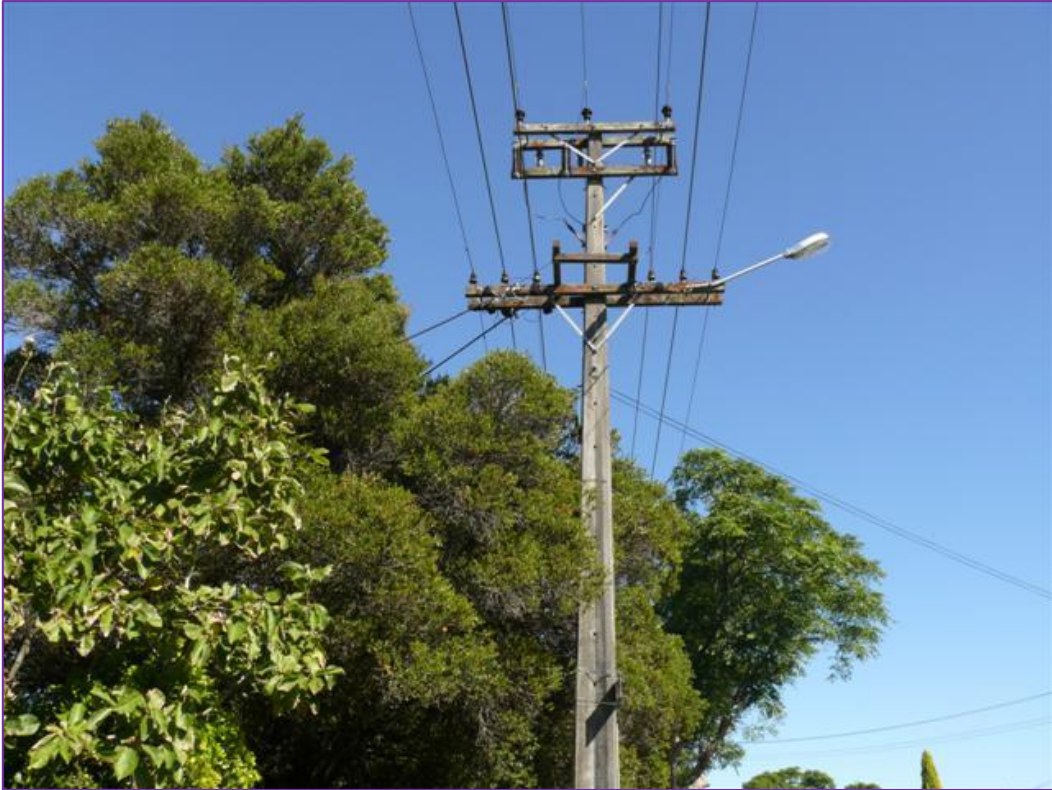
Figure 3, detail of pruning needed

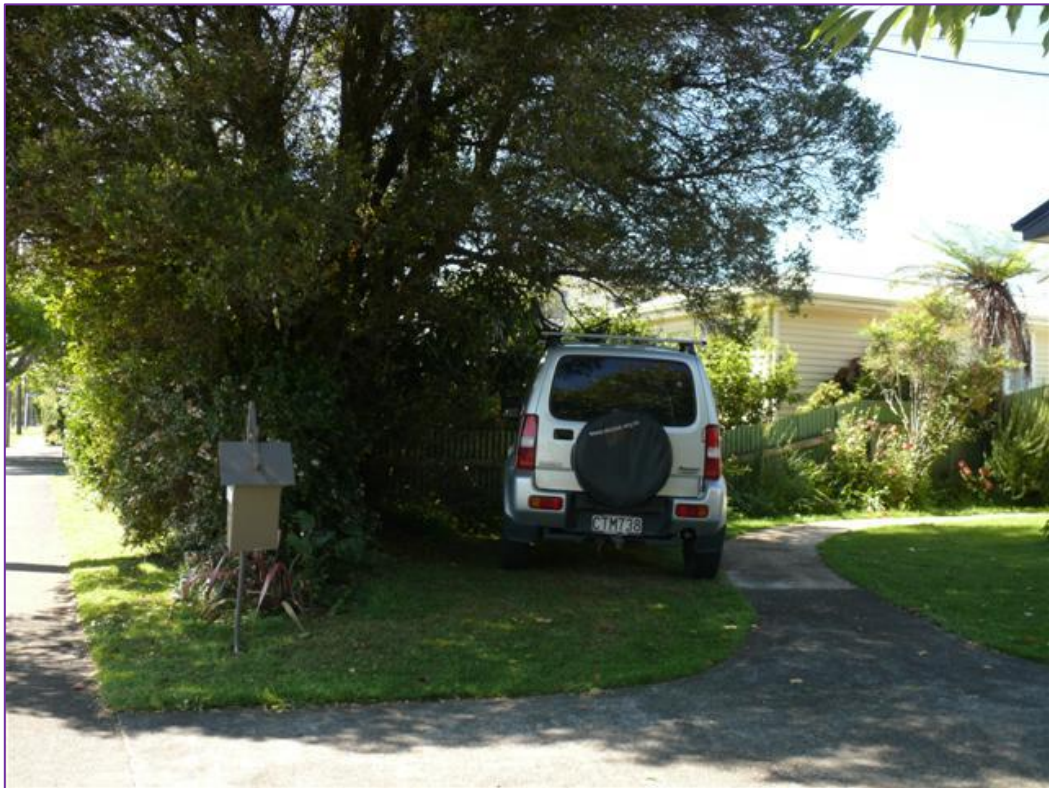
Figure 4, the trunk and base.
