Palmerston North City Council

Notable Tree Survey March and April 2011

Address	61 Lombard Street	
Tree name	Pohutukawa (<i>Metrosideros excelsior</i>)	
Location of the tree on the site	Side boundary, backing onto rear boundary of neighbouring site	
Owner's name		
Date of Inspection	29 March 2011	Inspected by John Wakeling

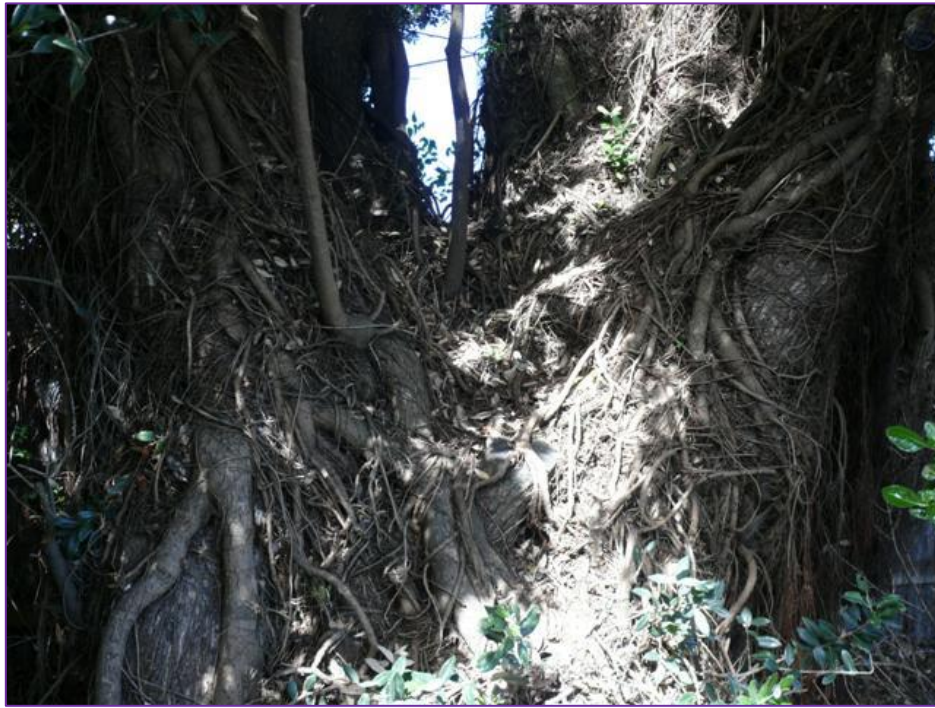
Requested for/by	Routine	Storm Damage	Owner	Developer	DP Review	
Pruning History	Some crown lifting over the yard of Lambert's Business Systems – well executed.					
Built Environment	Small tight dev'pment	Standard suburban	Large house and grounds	Other (describe)		
Garden environment	Solo tree	Few trees	Many trees	Mainly exotic/native		
Local Environment	Few trees	Some trees	Well treed neighbourhood			
Age Class	young	Semi mature	Mature	Post mature		
Special value	Horticultural	Landscape	Specimen	Historical	Botanical	
Structural Character	Single leader	Double leader	Multi-stemmed	Included bark unions	Typical	Atypical
Form	Refer to STEM scoresheet					
Crown Shape	Typical	Atypical	Wide spreading low crown	Influenced by wind	Affected by other trees	
Foliage Health	Good	Poor, if so, explain				
Limb Structure	Typical or sound	Atypical, if so, explain				
Trunk character	The tree is one of those pohutukawa with very many aerial roots that develop along the stems. Many of these have grown and coalesced into thick rope-like roots that entwine the stems and trunk

Figure 1. the dense mat of intertwined aerial roots covering the main stems.

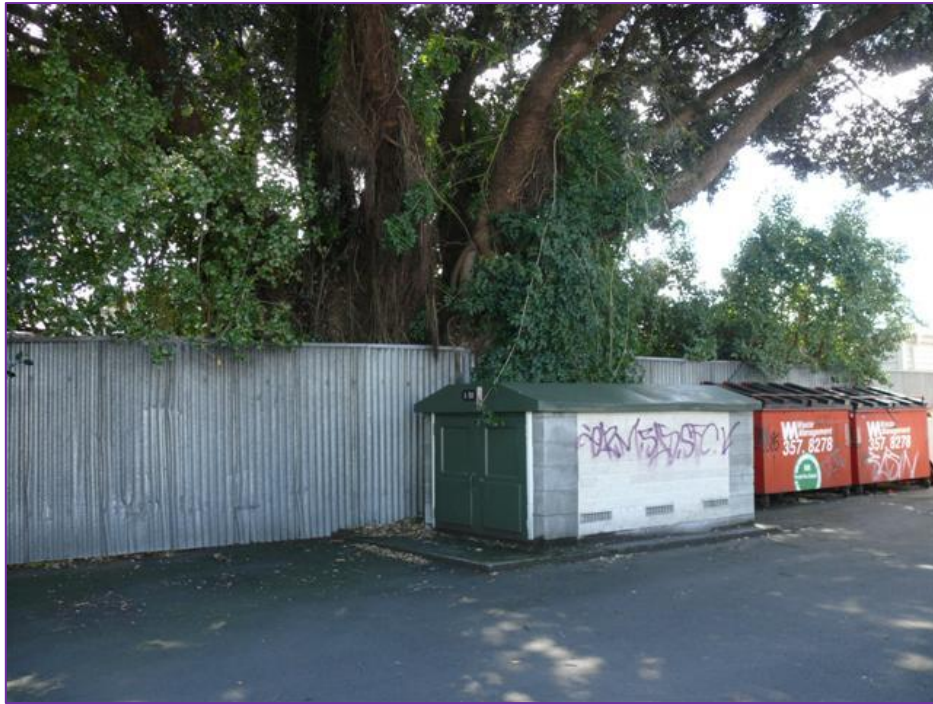
Figure 2. the electrical substation, and the dumpsters. Note: the fence has been damaged by cars, but is otherwise upright and stable

Category	Priority	Recommended Action	Timing (from April 2011)	Actioned	Completed
Amenity	Routine	The tree appears to be growing in harmony with the house on the site. The concrete path to the back door has been badly cracked – could be due to age and/or root growth pressures.	Any work on the foot path should be carried out with due care and will require a consent.		
Health	-				
Safety	Electricity	The electrical sub-station is founded on a reinforced base and it is unlikely that root growth will have and adverse effect on it.			
Overhanging b'dry	Routine	Maintain the crown at a height suitable for vehicles using the Business Systems car park – delivery vehicles and dumpster trucks	Every 5 years. The recent work should be adequate for another 4 years.

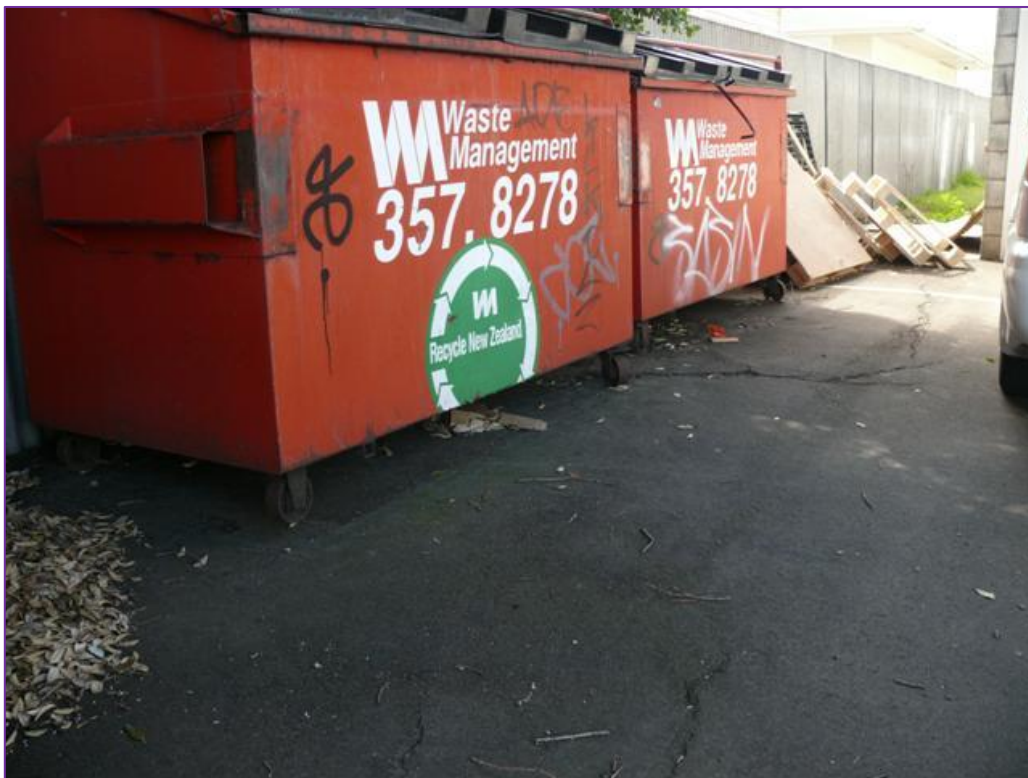
Figure 3. cracks appearing in the car park surface.

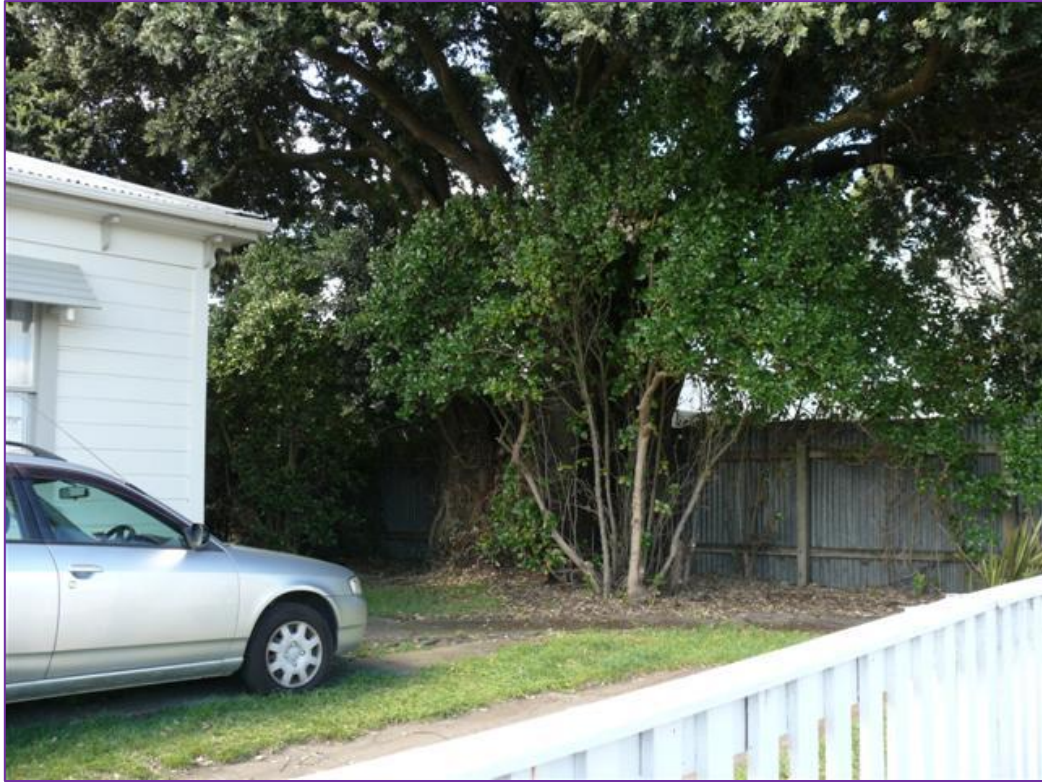
Figure 4. the tree in its setting
