Palmerston North City Council

Notable Tree Survey March and April 2011

Address	80 Albert Street	
Tree name	Rata (<i>Metrosideros robusta</i>)	
Location of the tree on the site	At the entrance/ start of a RoW to a rear site subdivision	
Owner's name		
Date of STEM Assessment	29 March 2011	Inspected by John Wakeling

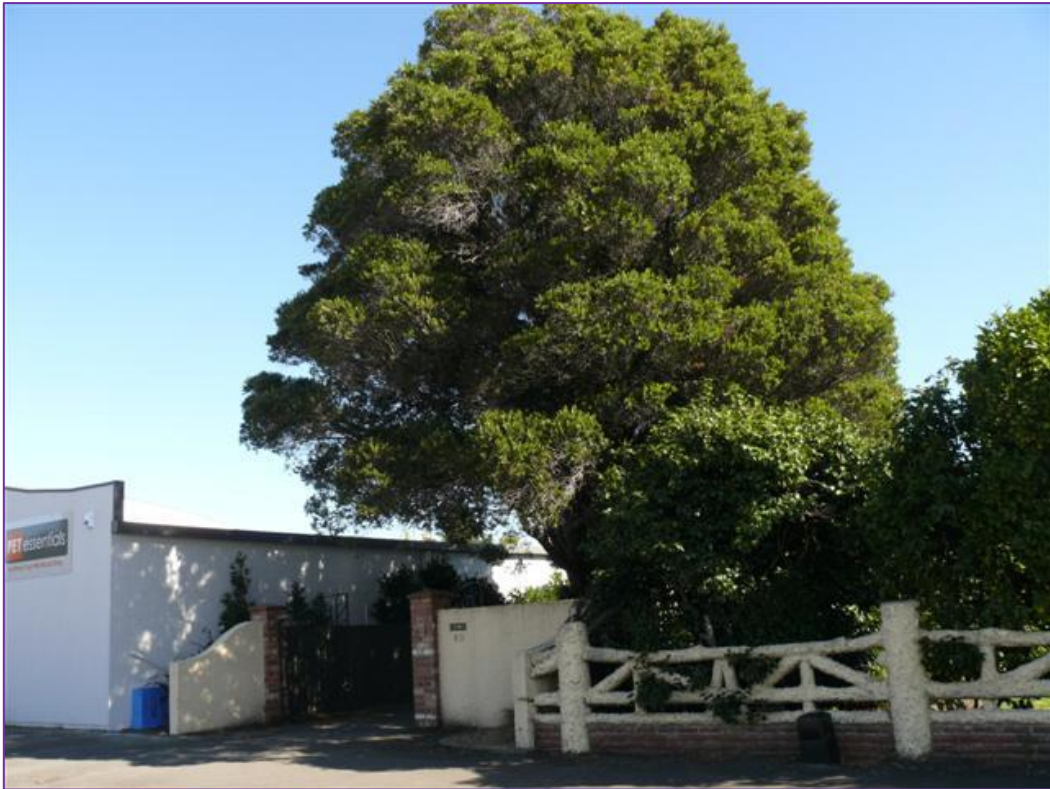
Comments	The tree has survived the installation of the new driveway very well and seems to be thriving.

Figure 4 the tree at the entrance to the drive and the properties

Category	Priority	Recommended Action	Timing (from April 2011)	Actioned	Completed
Amenity	routine	Lift crown over driveway to allow eg fire engines, removal vehicles	From now on		
Health	-				
Safety	-				
Overhanging b'dry	-

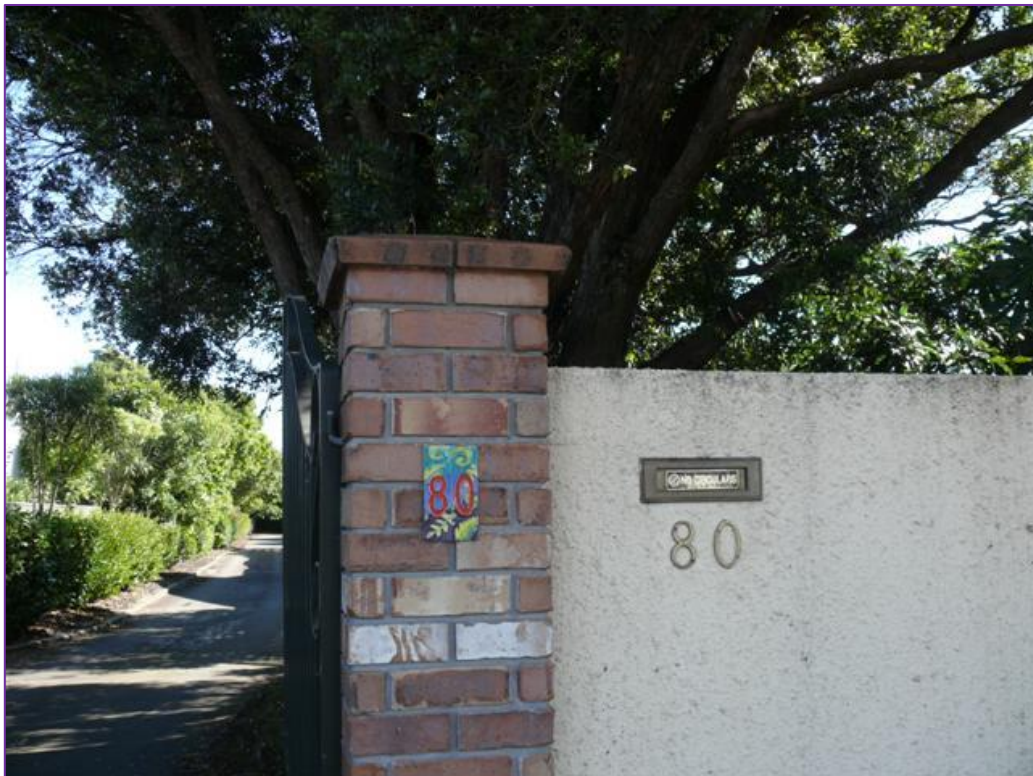
Figure 5. It is likely the gatepost and wall will need repairs every 10 years or so

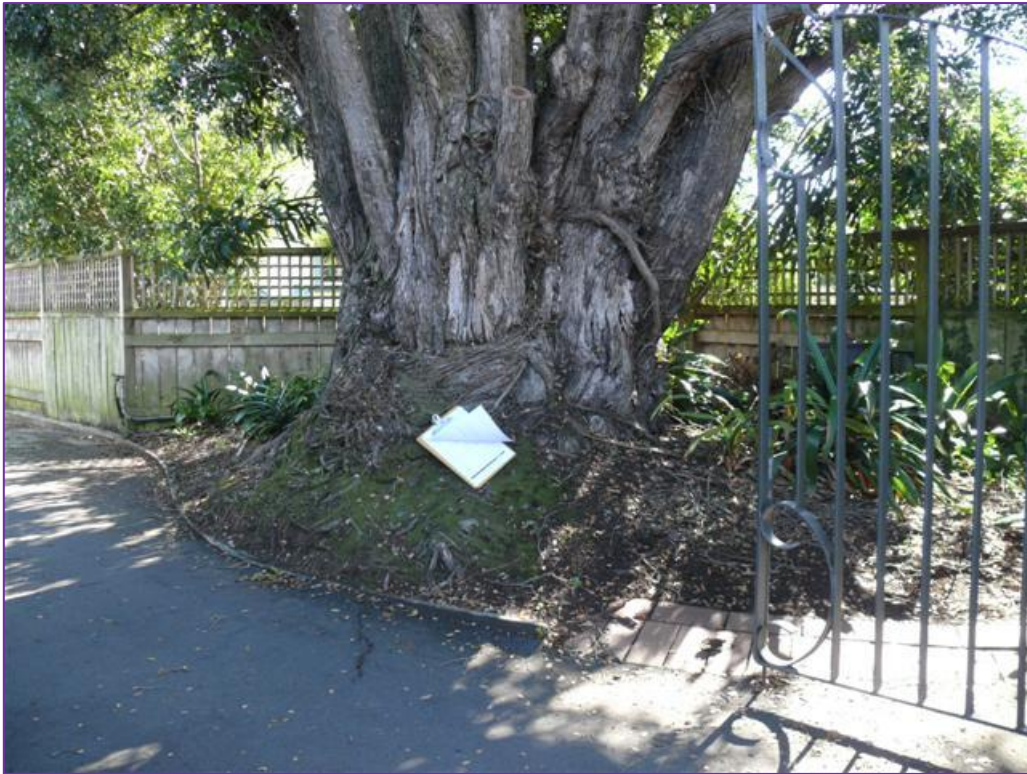
Figure 6. The tree has survived a considerable amount of root pruning. The driveway will continue to crack and should be repaired frequently

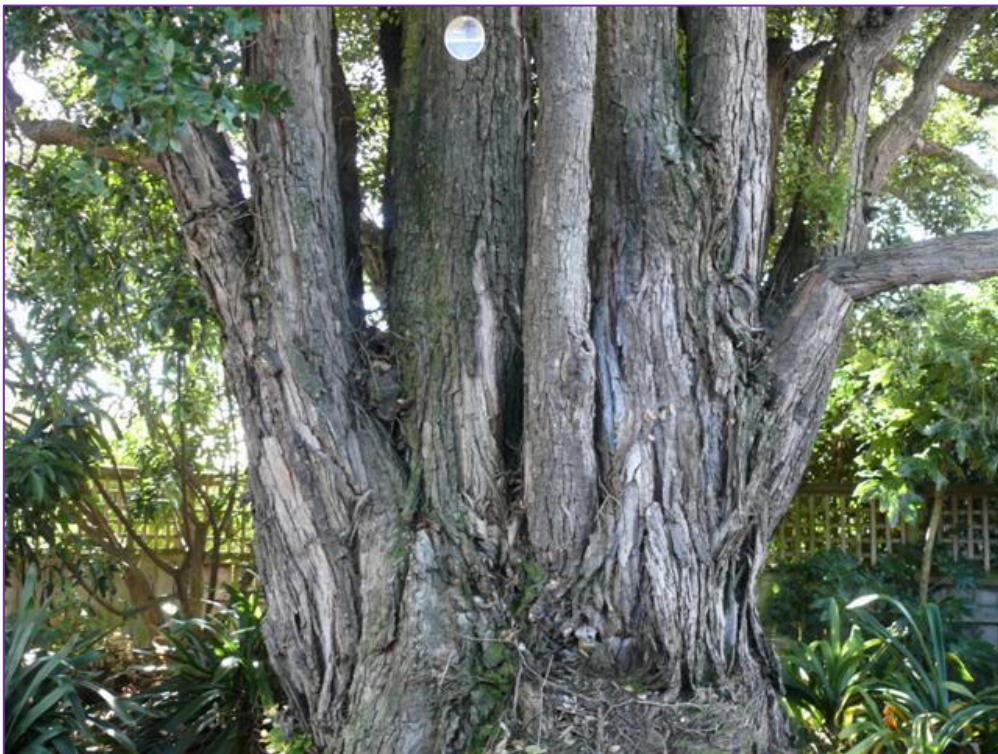
Figure 7. the trunk with its innumerable stems
