# Palmerston North City Council

## Notable Tree Survey March and April 2011

<b>Address</b>	179 Fitzherbert Avenue	
<b>Tree name</b>	Deodar ( <i>Cedrus deodora</i> )	
<b>Location of the tree on the site</b>	Front garden, on driveway	
<b>Owner's name</b>		
<b>Date of Inspection</b>	29 March 2011	<b>Inspected by</b> John Wakeling

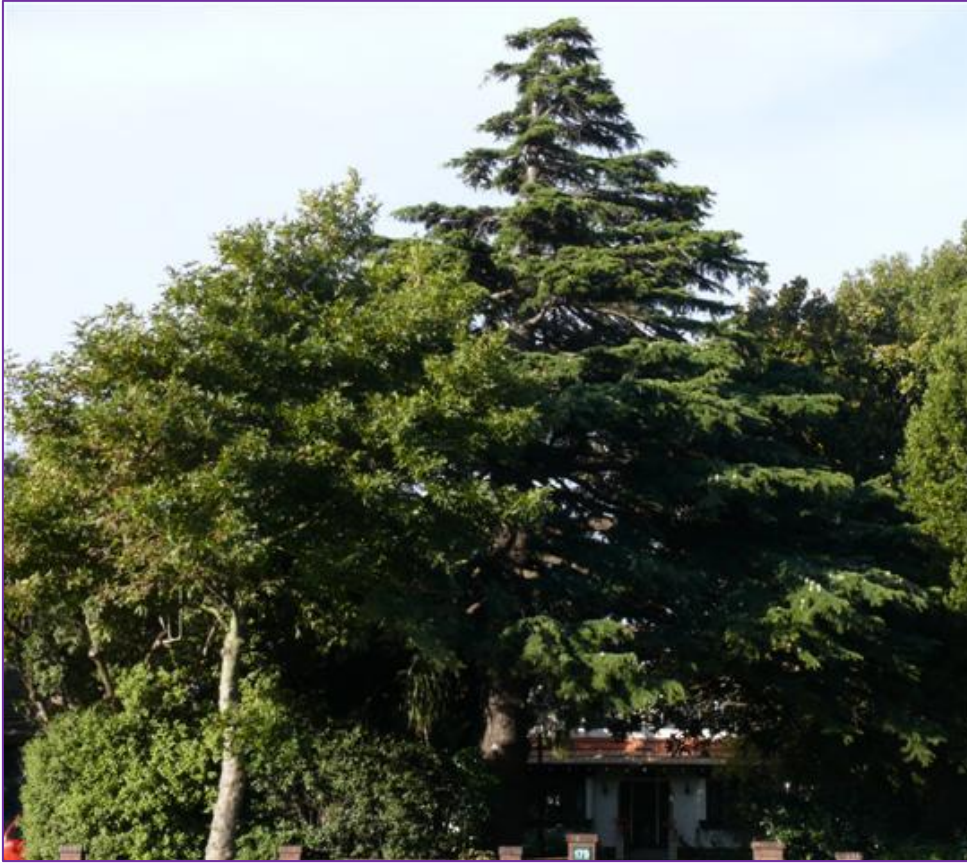
Figure 1 The tree and the front of the garden

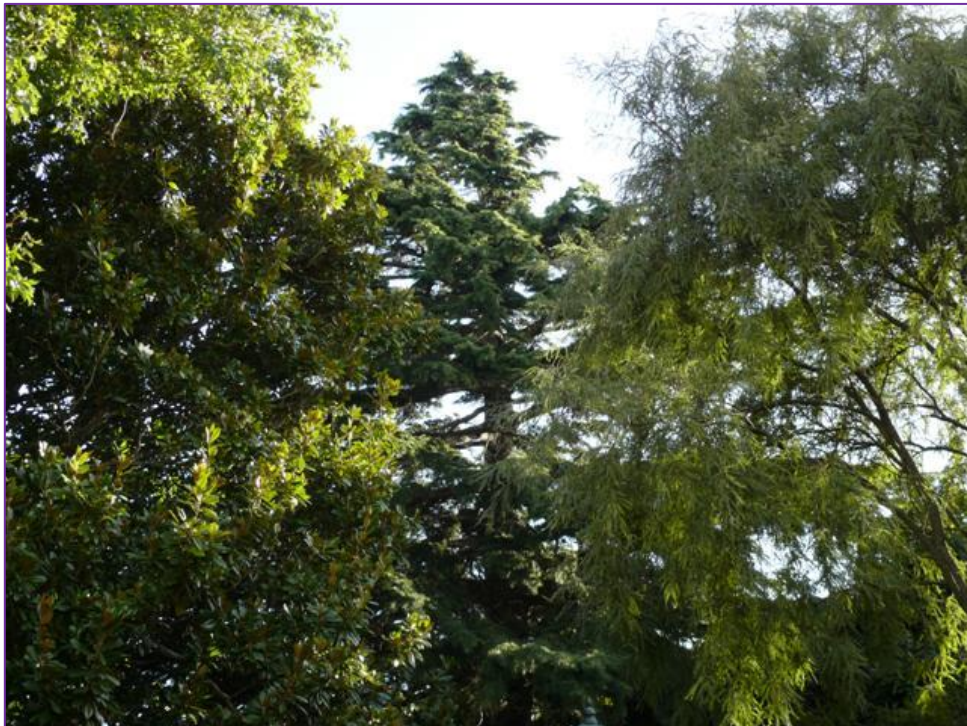
Figure 2. From the front door

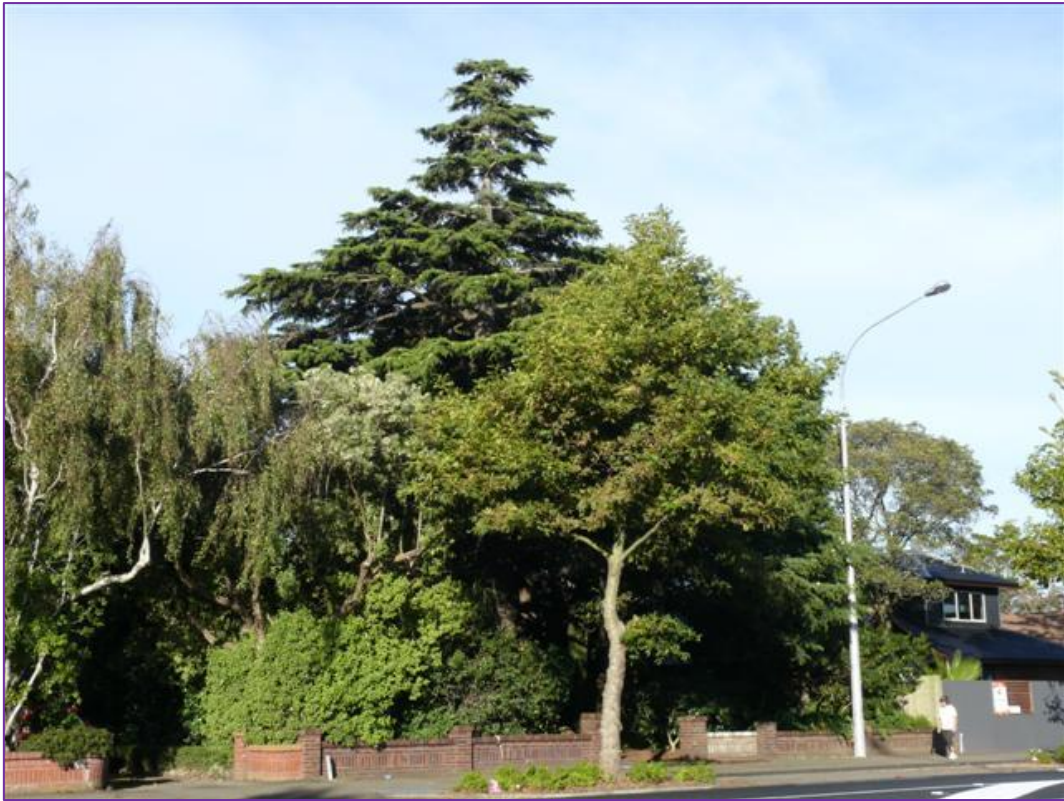
Figure 3. From across the street.
