Palmerston North City Council

Notable Tree Survey March and April 2011

Address	263 Featherston Street	
Tree name	Turkey oak (<i>Quercus cerris</i>)	
Location of the tree on the site	Front lawn	
Owner's name		
Date of Inspection	30 March 2011	Inspected by John Wakeling

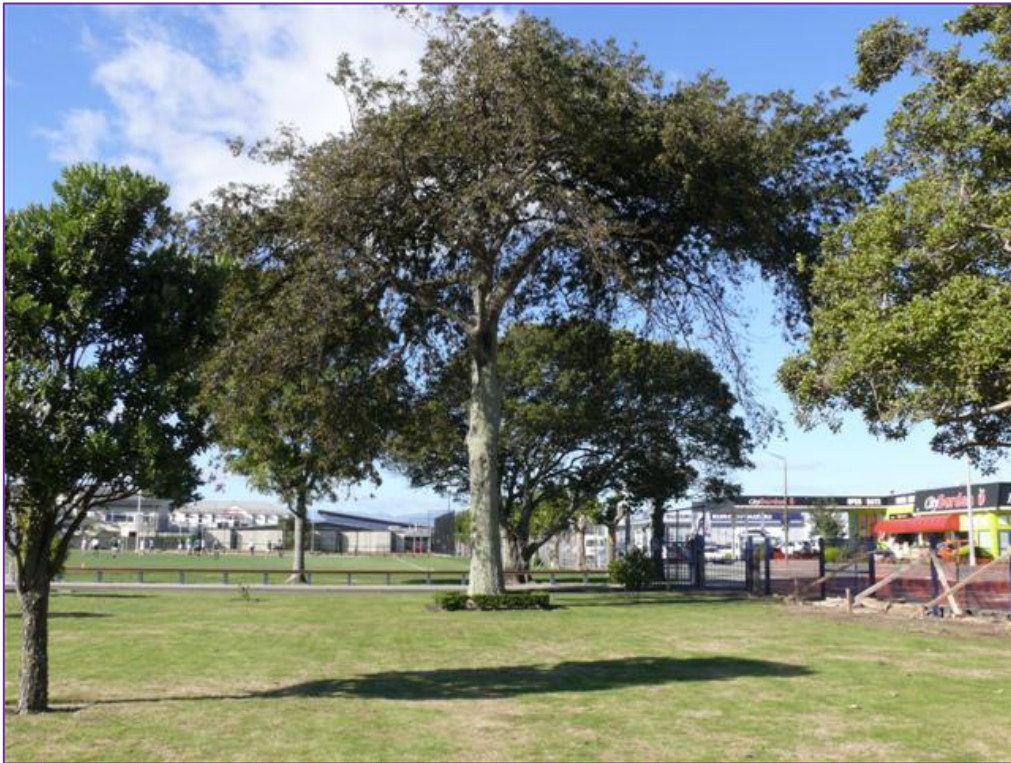
Root Zone	Garden	Natural	Lawn/paddock	U/g services apparent?	Hard surface, if so, explain	
Comments	The tree has never looked healthy in the 15 years that I have known it. Turkey oak is normally a vigorous and fast growing species. This specimen is almost 100 years old and less than twelve metres tall. It is an historical tree, worthy of much greater consideration than it is being given.

Figure 1. the Memorial Turkey Oak, PNBHS.

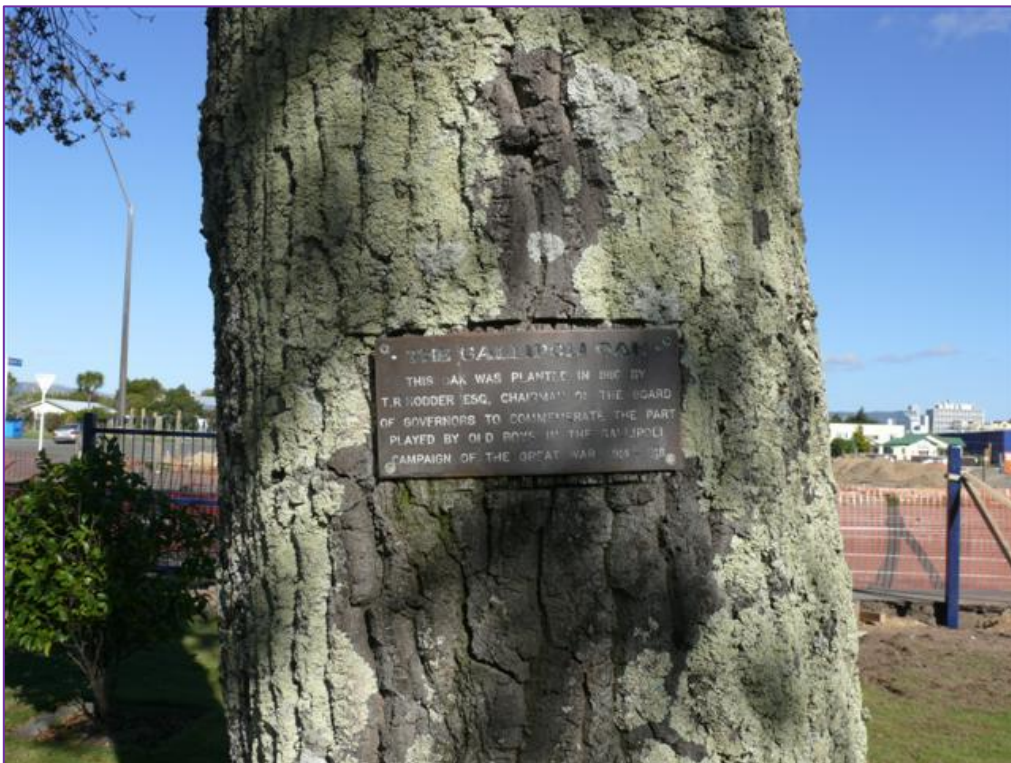
Requested for/by	Routine	Storm Damage	Owner	Developer	DP Review	
Pruning History	None recently					
Built Environment	Small tight dev'pment	Standard suburban	Large house and grounds	Other (Boys' High School)		
Garden environment	Solo tree	Few trees	Many trees	Mainly exotic/native		
Local Environment	Few trees	Some trees	Well treed neighbourhood			
Age Class	young	Semi mature	Mature	Post mature		
Special value	Horticultural	Landscape	Specimen	Historical	Botanical	
Structural Character	Single leader	Double leader	Multi-stemmed	Included bark unions	Typical	Atypical
Form	Refer to STEM scoresheet					
Crown Shape	Typical	Atypical	Wide/spreading/low crown	Influenced by wind	Affected by other trees	
Foliage Health	Good	Poor, if so, explain	The tree is not thriving – it is growing slowly.			
Limb Structure	Typical or sound	Atypical, unshapely				
Trunk character	Someone has inserted a memorial plaque into the trunk. The trunk is straight and cylindrical

Figure 2. Please remove this plaque from the living tree.

Category	Priority	Recommended Action	Timing (from April 2011)	Actioned	Completed
Amenity	One off	Remove the metal plaque from the trunk of the tree			
Health	routine	Install a mulch layer around the tree, and perhaps plant shrubs around the base of the tree (perhaps transplant the commemorative camellias nearby)	Annually if possible		
Safety	-				
Overhanging b'dry

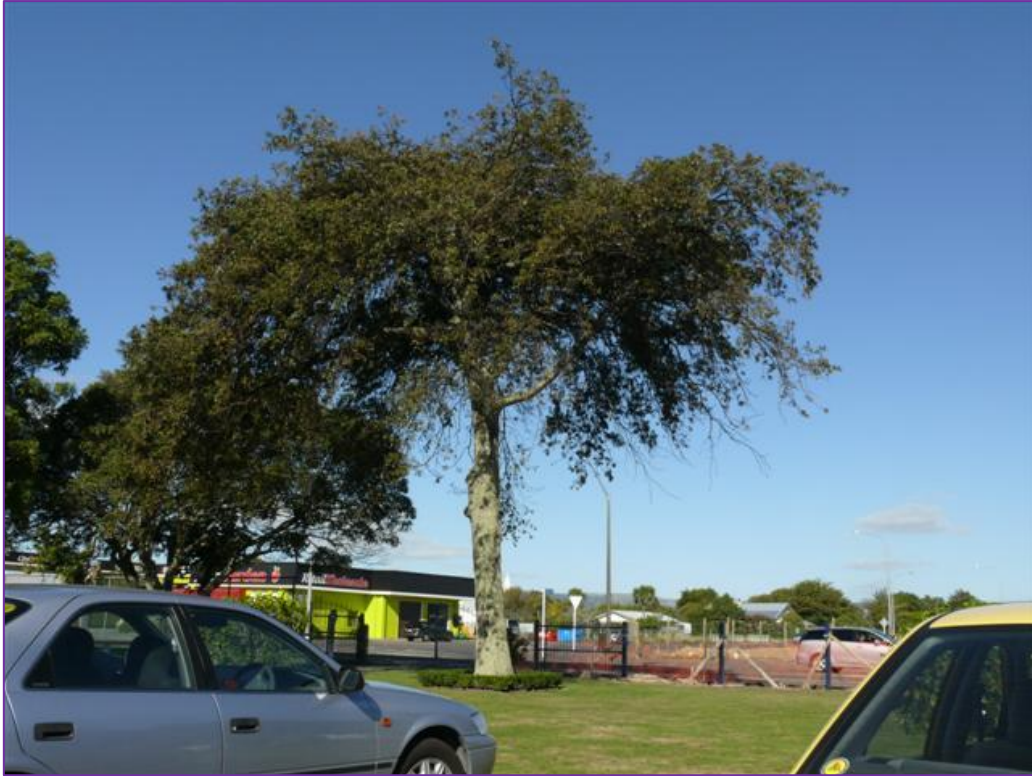
Figure 3. This is not a typical shape for a Turkey Oak
