Palmerston North City Council

Notable Tree Survey March and April 2011

Address	On road reserve outside 9 Pastoral Lane	
Tree name	<i>Ginkgo biloba</i>	
Location of the tree on the site	On the road reserve, front of no. 9.	
Owner's name	PNCC	
Date of Inspection	31 March 2011	Inspected by John Wakeling

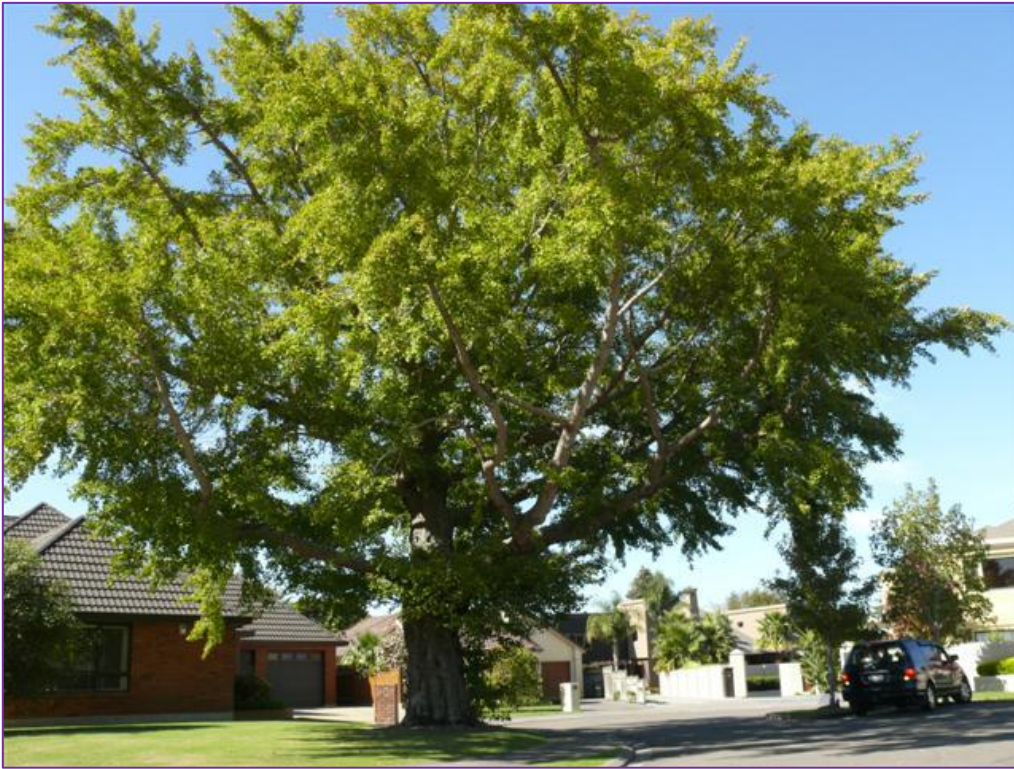
Figure 1. healthy crown, minor wind shaping

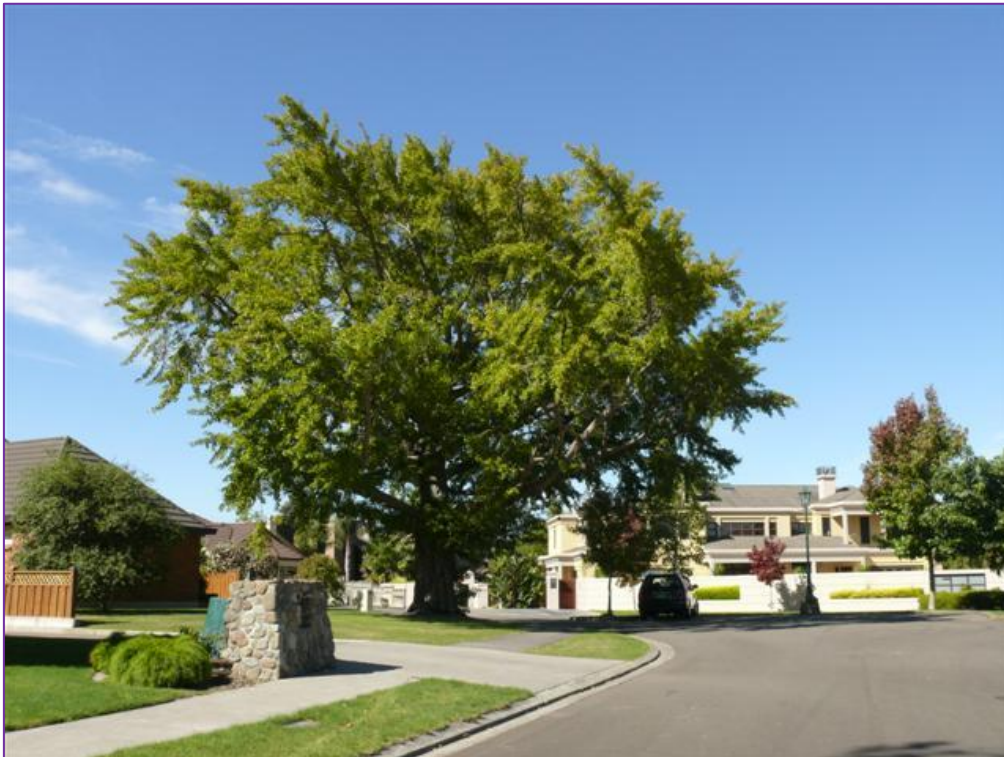
Comments	The landscape around the tree has been extensively modified over the last 12 years, but he tree appears to have been unaffected by all the changes.

Figure 2 Tree in the landscape
