Palmerston North City Council

Notable Tree Survey March and April 2011

Address	666 Tremain Ave	
Tree name	17 Phoenix palm (<i>Phoenix canariensis</i>)	
Location of the tree on the site	Around the frontage of the factory	
Owner's name		
Date of Inspection	30 March 2011	Inspected by John Wakeling

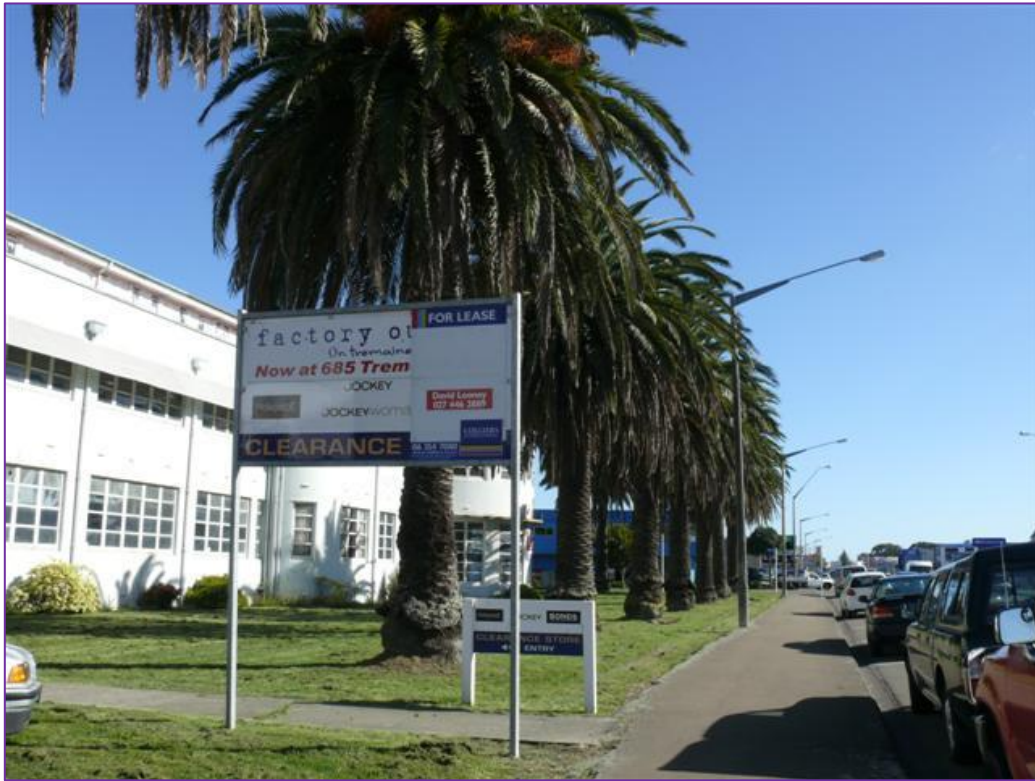
Figure 3. the building and trees are perfectly matched
