# Palmerston North City Council

## Notable Tree Survey March and April 2011

| <b>Address</b> | Buick Crescent | |
| <b>Tree name</b> | Several old totara trees, one large beech | |

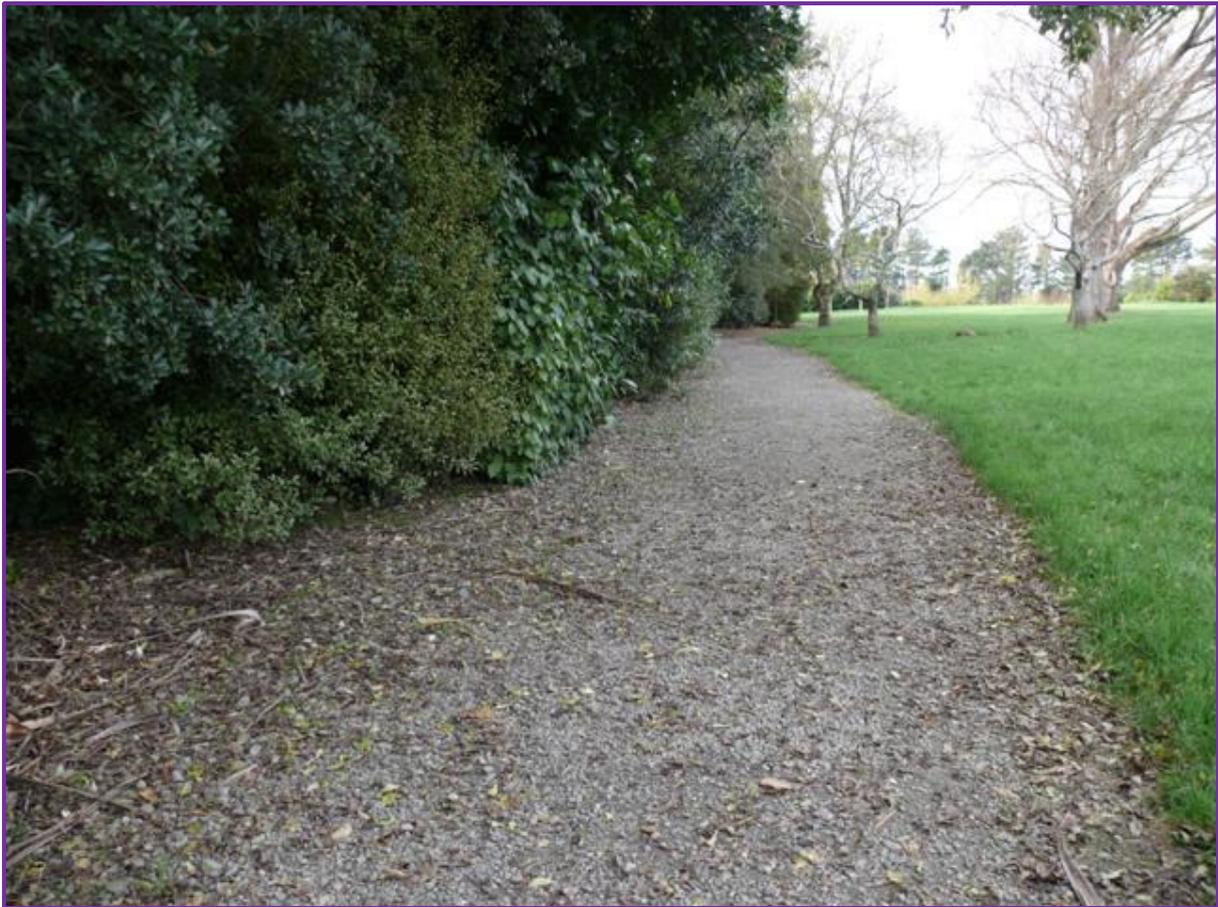
Figure 1, the dense edge effectively reduces weed ingress

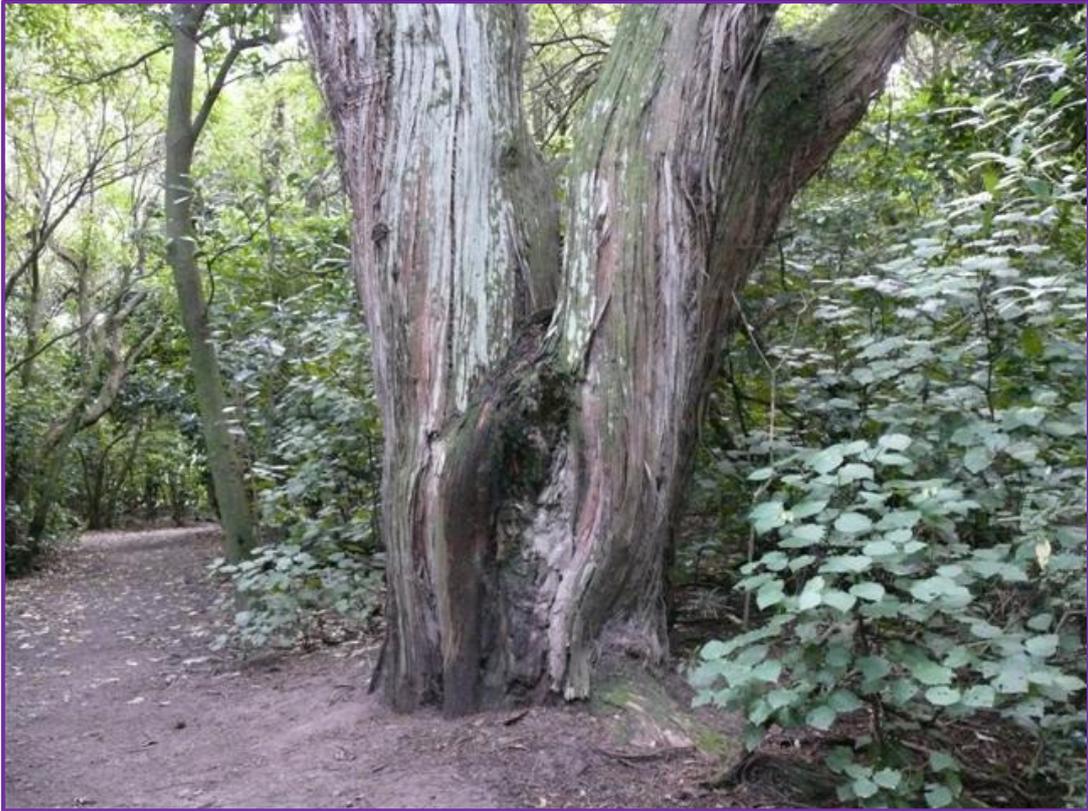
Figure 2, one of the old totara trees alongside the path

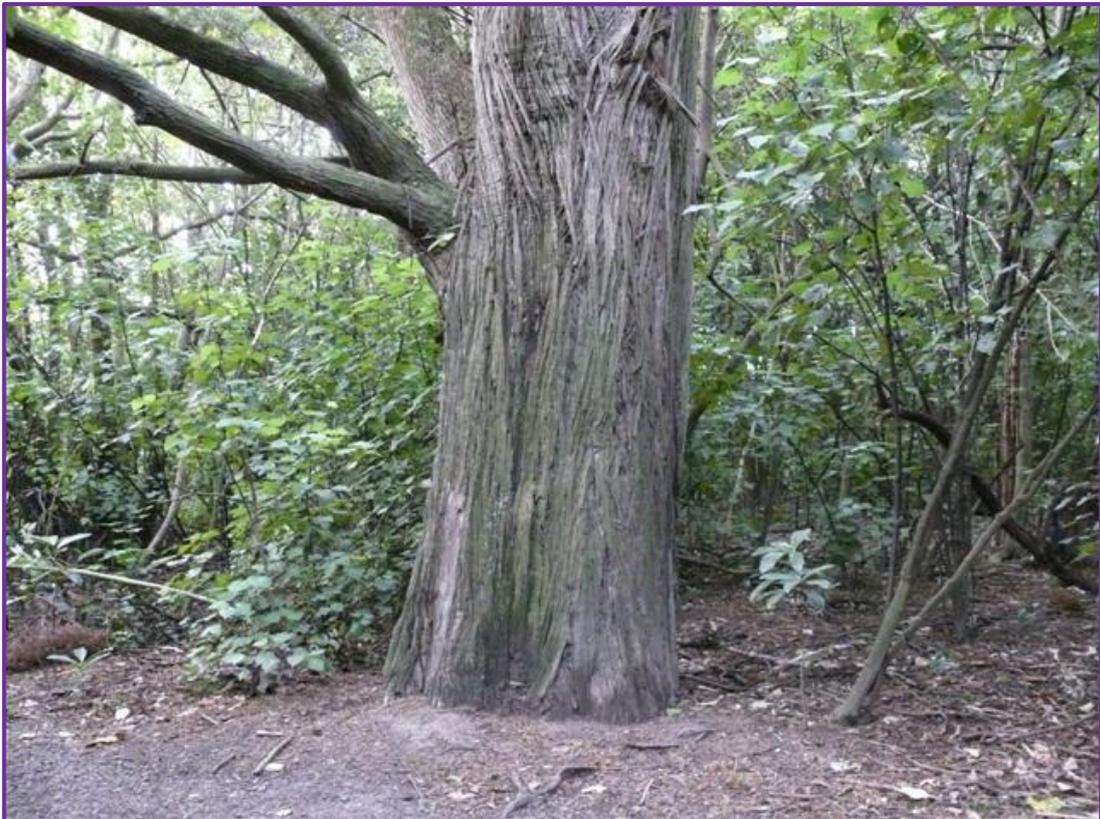
Figure 3, one of the original totara trees

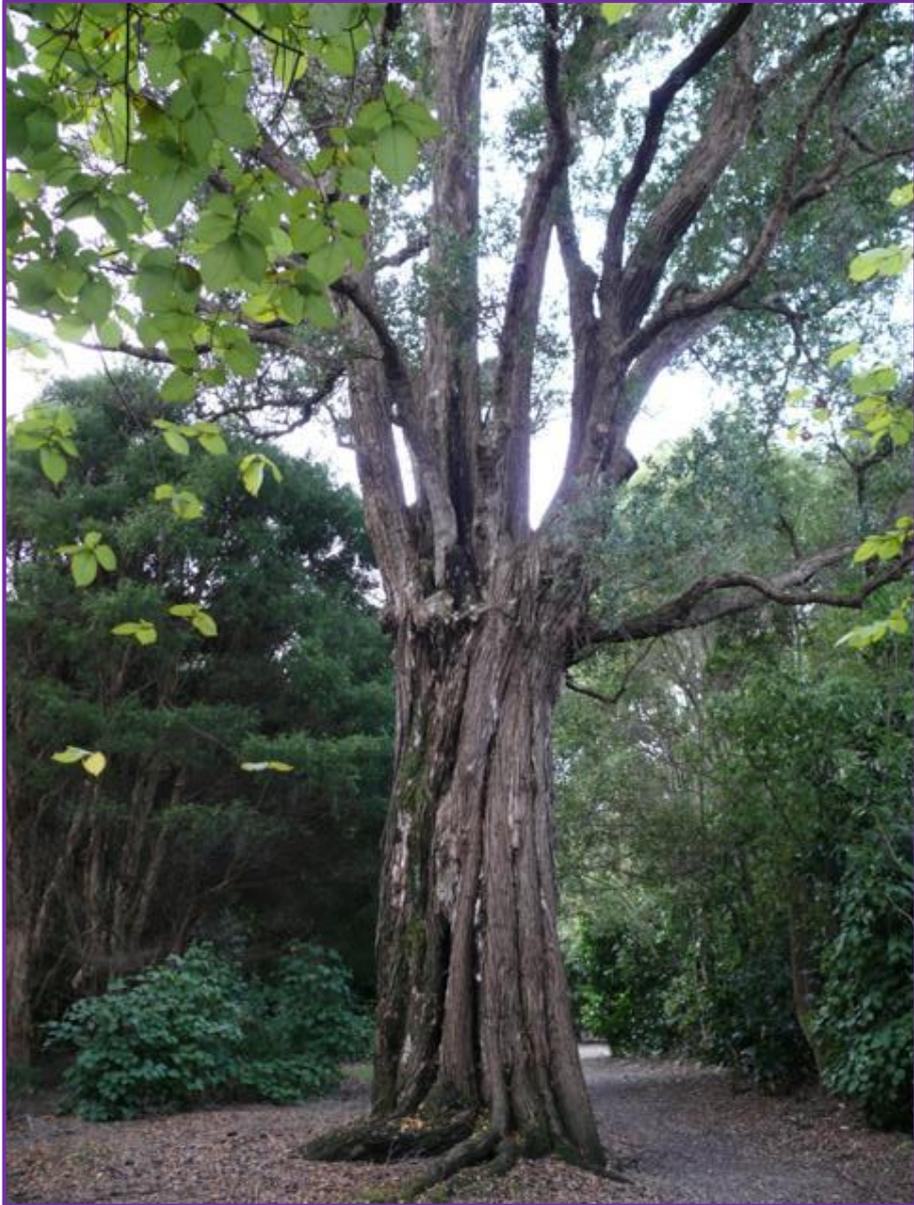
Figure 4, the rata trunk

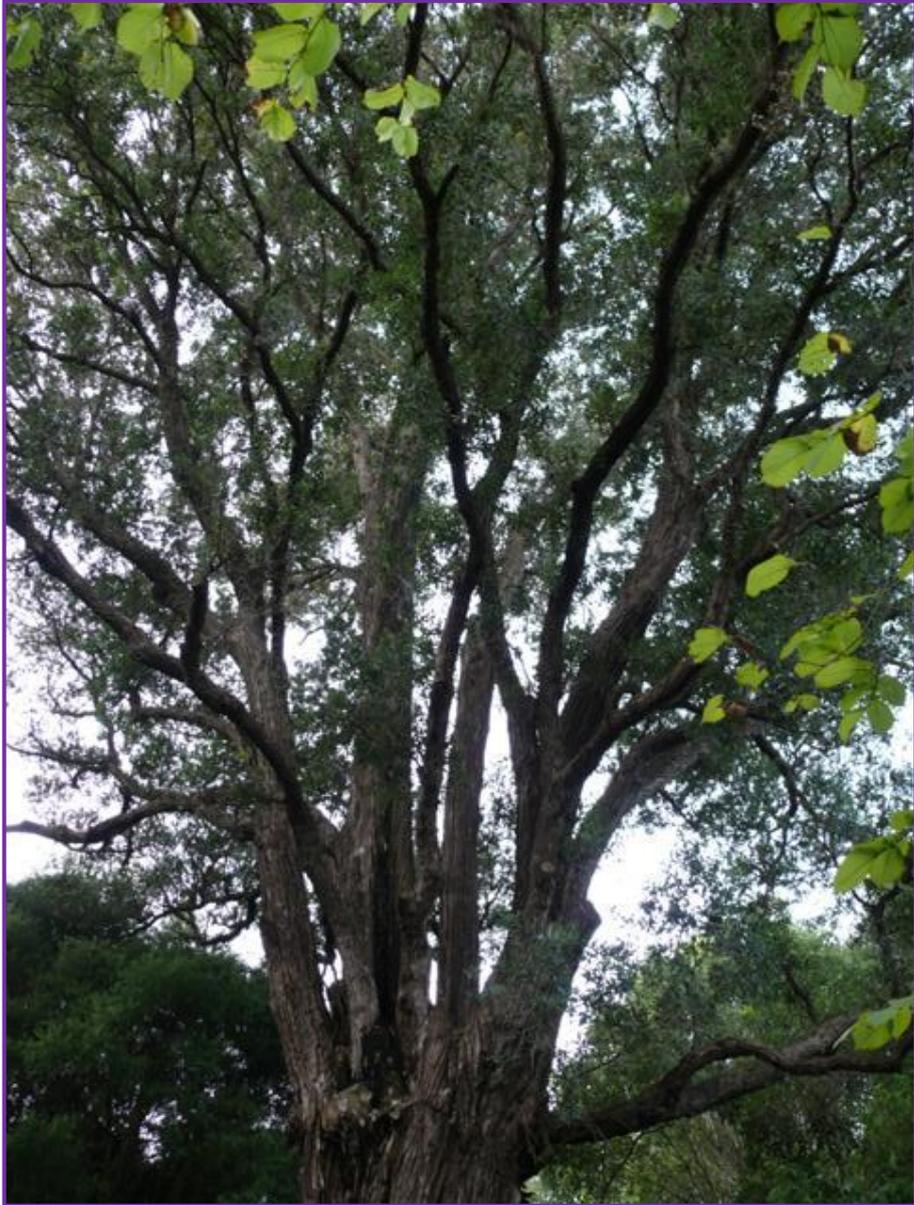
Figure 5, the rata crown

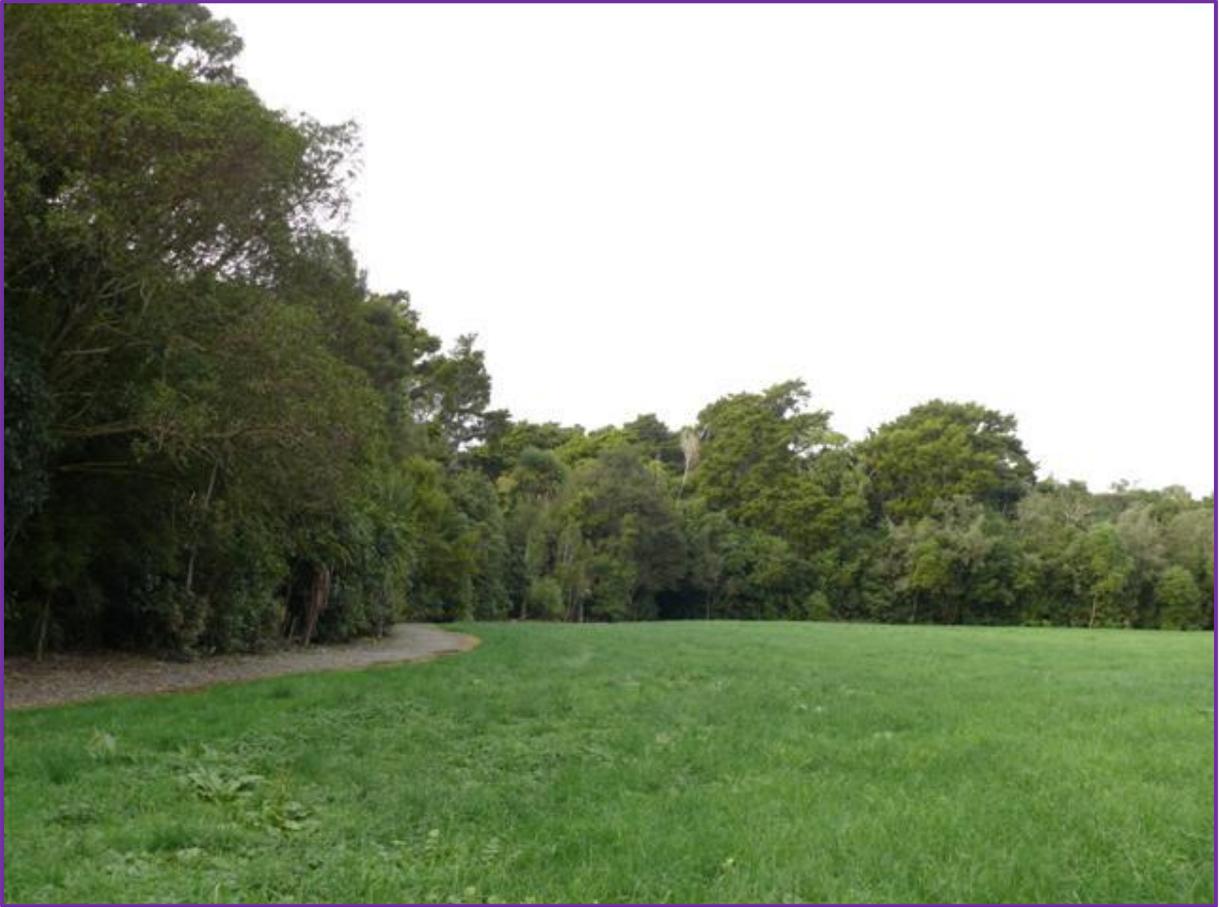
Figure 6, the new plantings cover a large area.
