# Palmerston North City Council

## Notable Tree Survey March and April 2011

<b>Address</b>	863 Main Street	
<b>Tree name</b>	Oak ( <i>Quercus robur</i> )	
<b>Location of the tree on the site</b>	Rear garden	
<b>Owner's name</b>		
<b>Date of Inspection</b>	30 March 2011	<b>Inspected by</b> John Wakeling

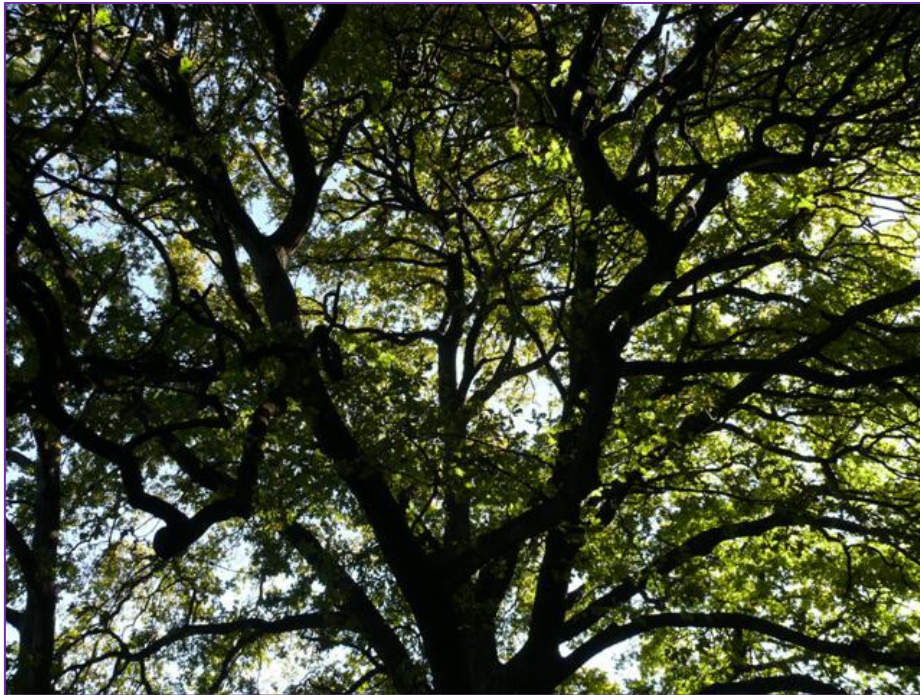
Figure 1. good leaf cover in the crown.

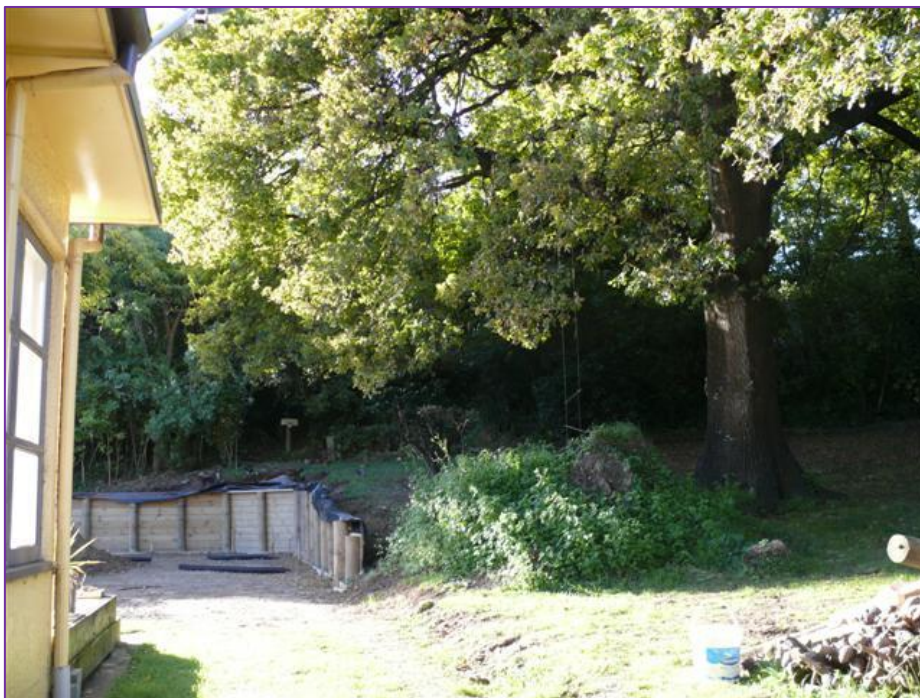
<b>Trunk character</b>	Straight, cylindrical, well buttressed, decorated nicely. No slime flux or splits in the bark				
<b>Root Zone</b>	Garden	Natural	Lawn/paddock	U/g services apparent?	New earthworks just within the drip line. Topsoil stored within the drip line one small section only.
<b>Comments</b>	Alert! There is a hard, dark fungus bracket at the base of the tree. This bracket was present at my last inspection, and has not grown much larger in five years. Nonetheless, it is a symptom of basal infection and possibly decay of the wood nearby. Invasive core sampling could identify whether wood decay is far advance but this is not a conclusive or very accurate technique. I am not sure how long the tree will continue to thrive as it is at present. Eventually its 'Vigour and Vitality' will have to be down-grade.

Figure 2. Earthworks under the dripline

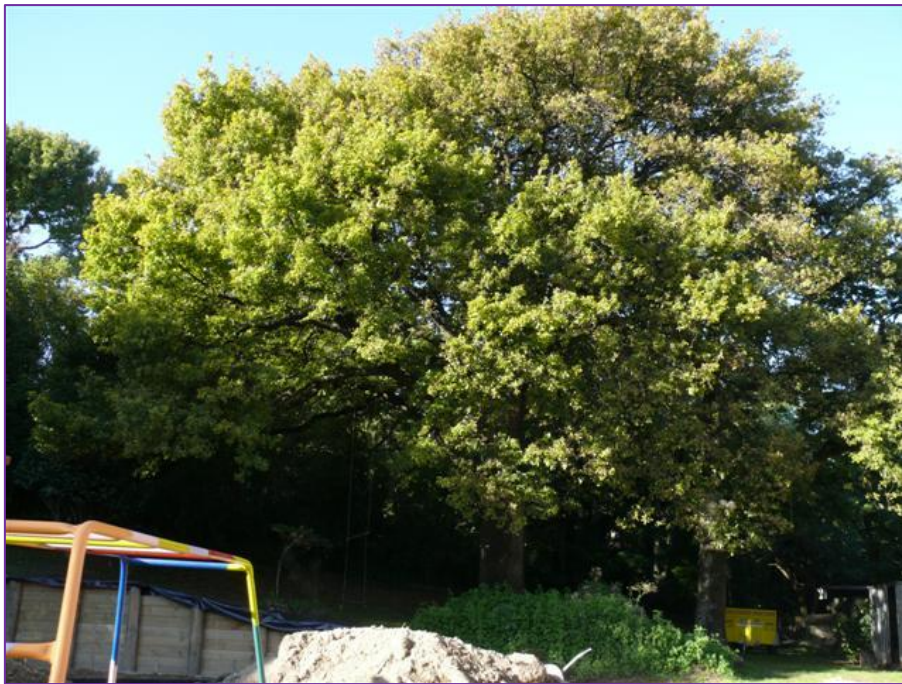
Figure 4. Crown fully leafed

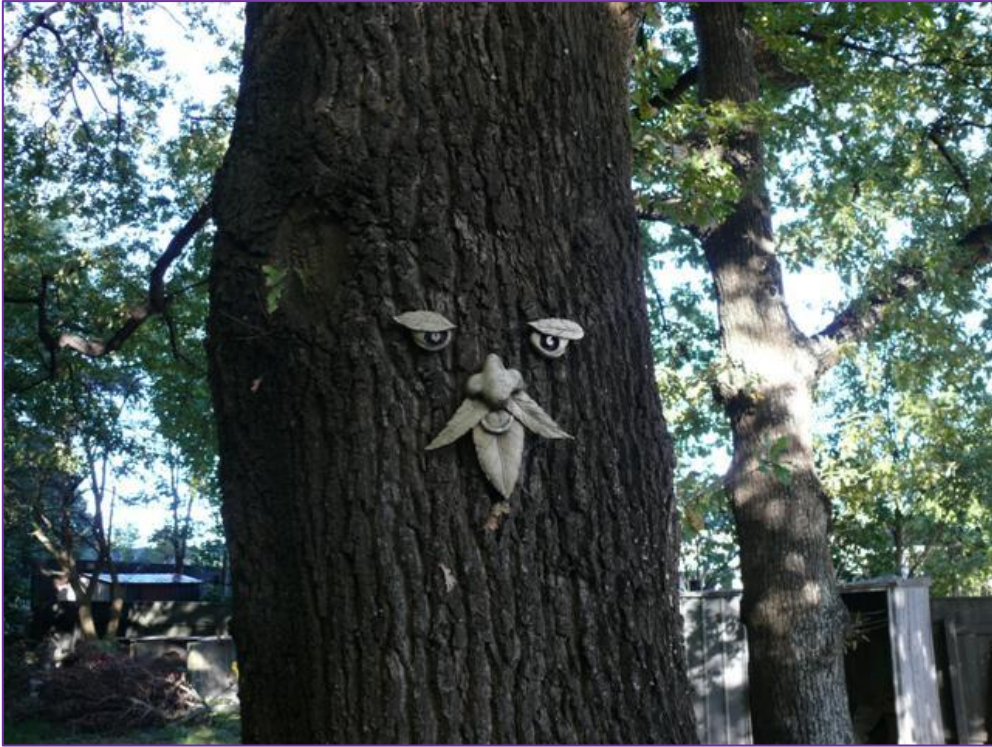
Figure 5. Reversion to Ent-like State

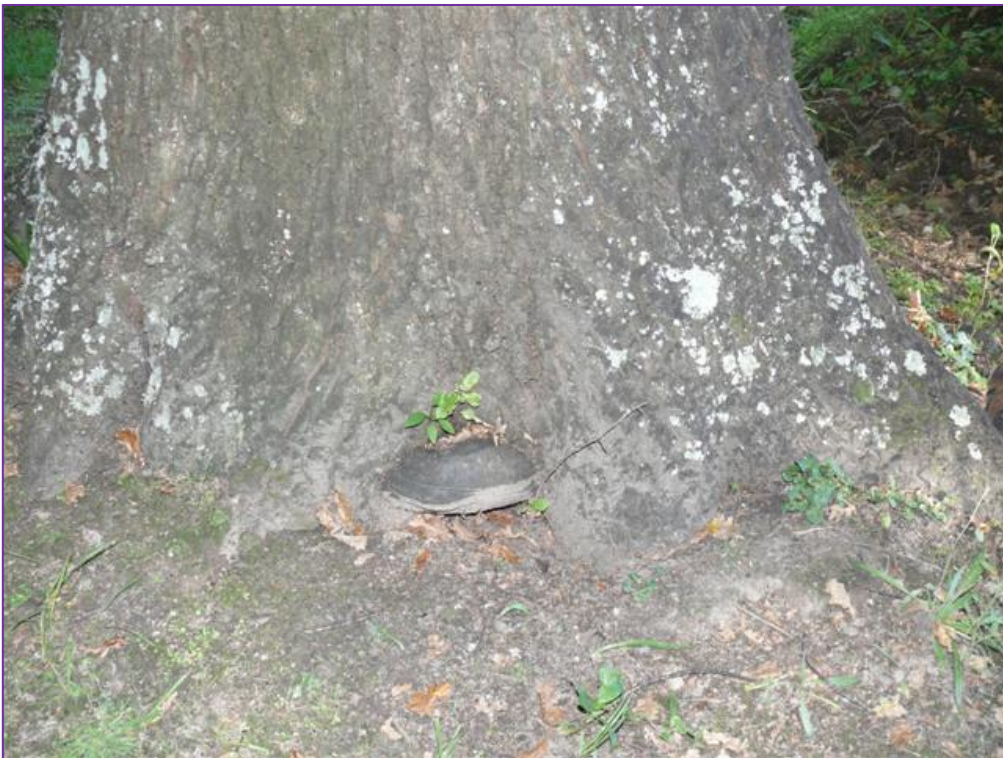
Figure 6. The fungus bracket. (*Ganoderma* sp?)

Category	Priority	Recommended Action	Timing (from April 2011)	Actioned	Completed
<b>Amenity</b>	routine	Deadwood removal	Now, then 5 yearly		
<b>Health</b>		Monitor health of the foliage and size of the fungal bracket annually			
<b>Safety</b>		Safety is largely dependent on health in this case.			
<b>Overhanging b'dry</b>
