Palmerston North City Council

Notable Tree Survey March and April 2011

Address	240a Victoria Avenue		
Tree name	Red oak (<i>Quercus rubra</i>)		
Location of the tree on the site	Front of garden, close to bndy		
Owner's name			
Date of STEM Assessment	12 Sept 2013	Inspected by John Wakeling

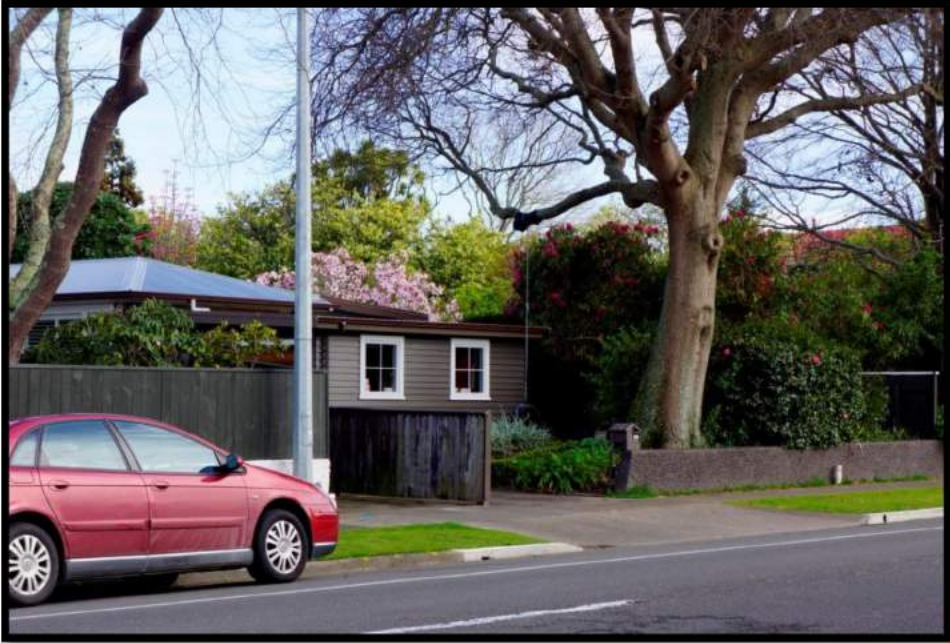
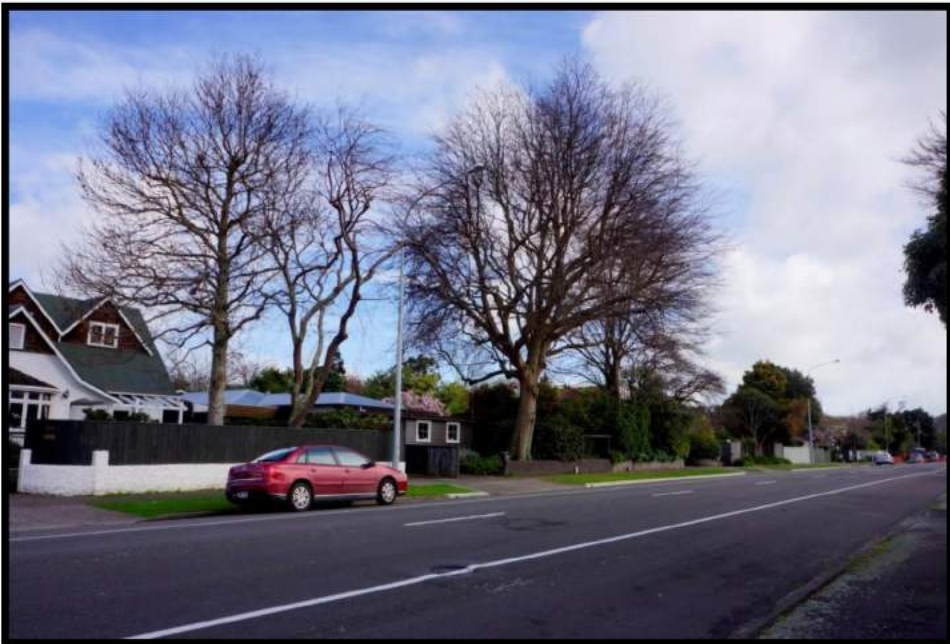
Photographs.

Requested for/by	Routine	Storm Damage	Owner	Developer	DP Review
Pruning History	Recent deadwooding and minor re-shaping by Guardian Tree Services				
Built Environment	Small tight dev'pment	Standard suburban	Large house and grounds	Sub-divided off side of older section	
Garden environment	Solo tree	Few trees	Many trees	Mainly exotic/native	
Local Environment	Few trees	Some trees	Well treed neighbourhood		
Age Class	young	Semi mature	Mature	Post mature	
Special value	Horticultural	Landscape	Specimen	Historical	Botanical
Structural Character	Single leader	Double leader	Multi-stemmed	Included bark unions	Typical Atypical
Form	Refer to STEM score sheet				
Crown Shape	Typical	Atypical	Wide/spreading/low crown	Influenced by wind minor	Affected by other trees
Foliage Health	Good	Poor, if so, explain			
Limb Structure	Typical or sound	Atypical, if so, explain			
Trunk character	Smooth, cylindrical				
Root Zone	Garden	Natural	Lawn/paddock	U/g services apparent?	Hard surface, if so, explain garden and driveway infrastructure. No adverse symptoms yet

Category	Priority	Recommended Action	Timing (from April 2011)	Actioned	Completed
Amenity	low	deadwood	2020		
Health	None needed at present				
Safety		As above			
Overhanging b'dry	yes	Over street
