LATERAL SPREADING ASSESSMENT

Rangitikei Line & Flygers Line, Palmerston North

Document Number: J00367AA

Prepared For: Flygers Investment Group Limited

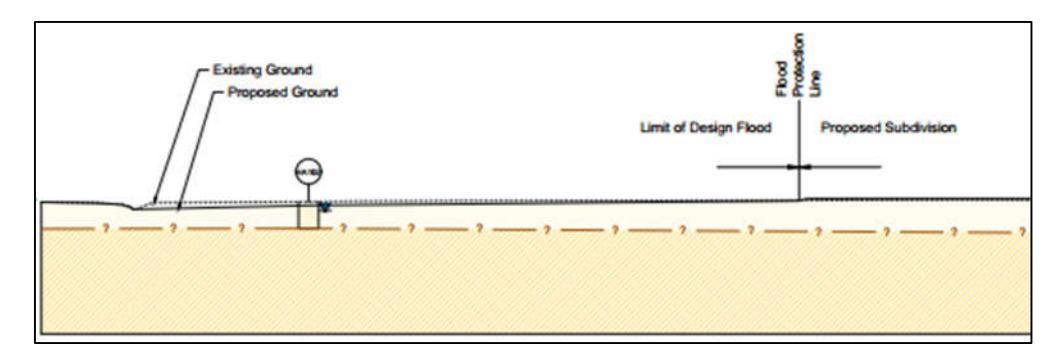
The subsurface conditions encountered during our field investigation generally comprised a layer of Holocene aged river deposits being stiff to very stiff silts with subordinate fractions of sands and clays interbedded with lenses of medium dense to dense sands, overlying dense to very dense river gravels at depth, in general accordance with the mapped geology and previous field investigations. The geological profile is shown in Figure 5 extracted from cross section A-A' attached in Appendix C.

Figure 5, Cross section A-A' showing approx 4.0m-5.0m of silts and sands overlying dense river gravels

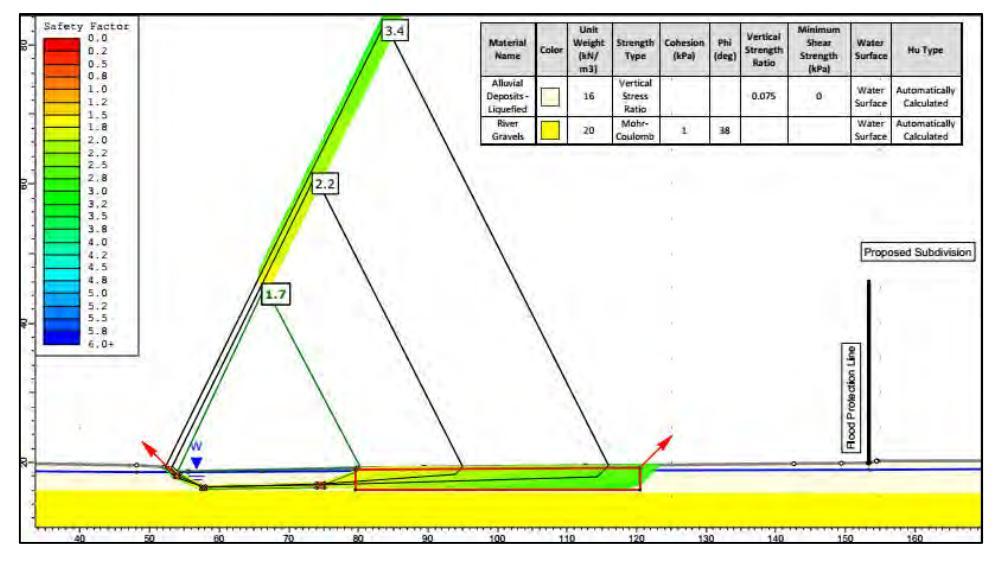
Figure 7. Section A-A'. Factor of safety for lateral spreading.

Analysis shows that at Section A-A' where the proposed overland flow channel is broad, and the gradient of the surface is shallow, the factor of safety for lateral spreading exceeds 1.0 and there is little risk of lateral spreading, especially beyond the flood protection line.

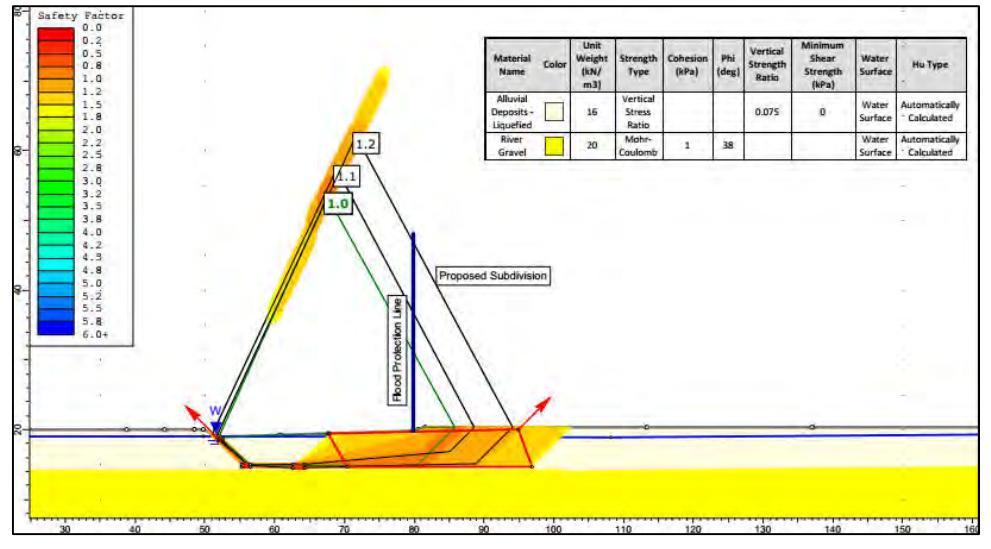
At Section B-B' the overland flow channel narrows with a consequently steeper gradient. Figure 8 indicates that lateral spreading would encroach beyond the flood protection line into the subdivision. Adopting a factor of safety of 1.2 as the minimum criteria under ULS seismic loading would result in a building restriction line being imposed within the propose subdivision. We refer to this as Option 1 whereby the lots would need to be reconfigured with a likely reduction in the number of lots, all remaining outside the building restriction line.

Figure 8. Section B-B'. Lateral Spreading; Option 1.

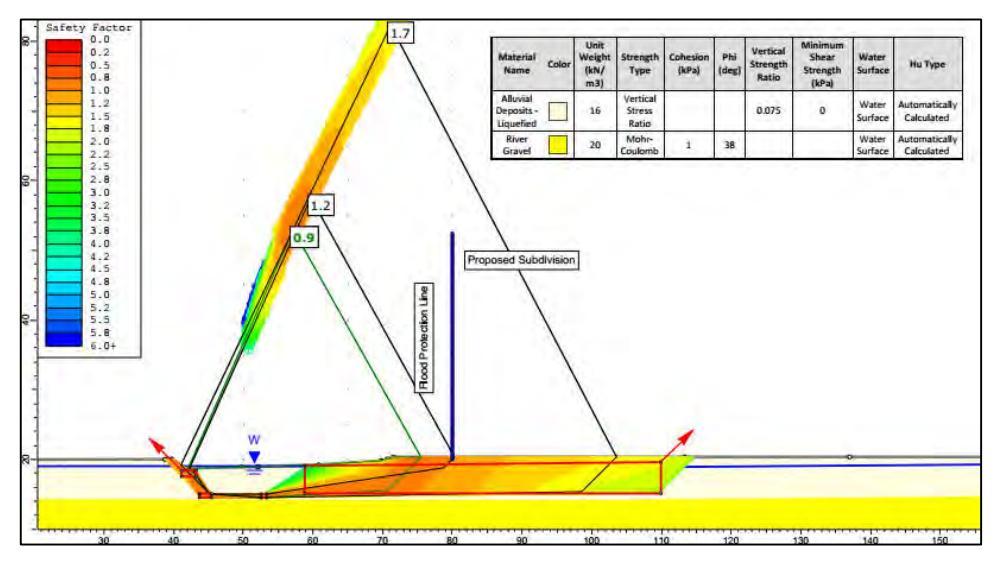
In order for potential lateral spreading to remain within the flood protection zone, we have widened the overland flow path, reducing the slope gradient until the slip-surface associated with the minimum factor of safety is within the flood zone. Figure 9 shows the results of this scenario which we refer to as Option 2.

Figure 9. Section B-B'. Lateral Spreading; Option 2.

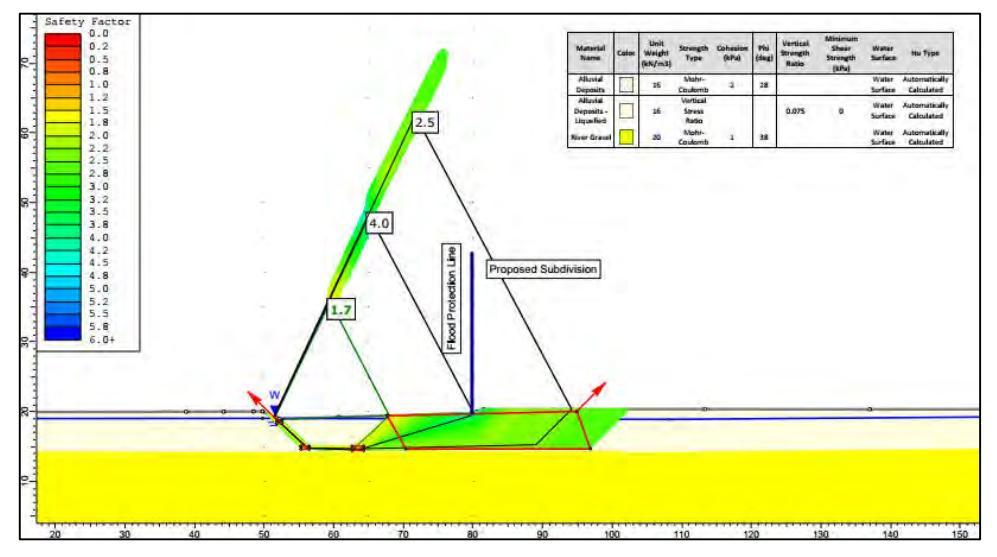
For Option 3, we have re-analysed the proposed narrow floodpath, with an 8m wide zone of "improved" soil which remains un-liquefied. The improved zone is obscured by the green shaded zone of analysis results shown in Figure 10. The analysis demonstrates that the zone of improved material acts as a shear-key preventing lateral spreading extending into the proposed subdivision.

Figure 10. Section B-B'. Lateral Spreading; Option 3.

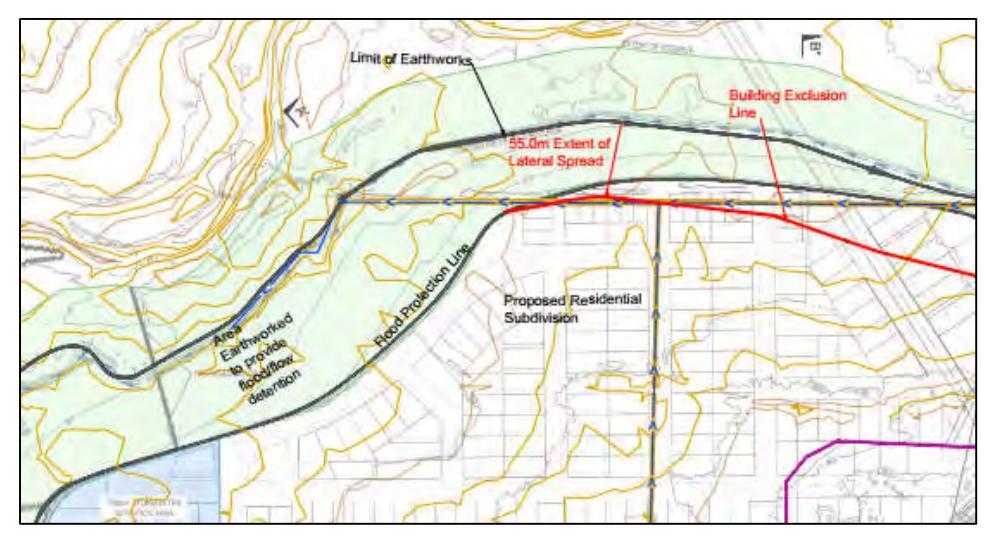
Our investigations confirm the groundwater levels assumed by Riley Consultants and our analysis indicates that under the current earthworks scheme, Option 1 would comprise a building exclusion line, 55 m from the limit of earthworks as shown in Figure 11.

Figure 11. Option 1. Impose Building Restriction Line.

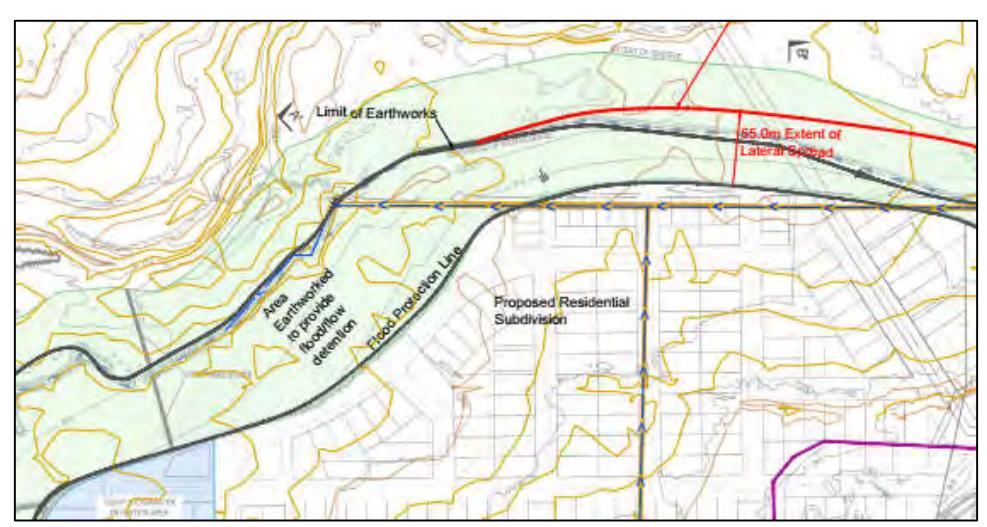
Option 2 would comprise widening the overland flow channel to a minimum width of 55 m from the flood protection line as shown in Figure 12. This would allow the current lot layout to be maintained.

Figure 12. Option 2. Translate extent of earthworks. Maintain lot arrangement.

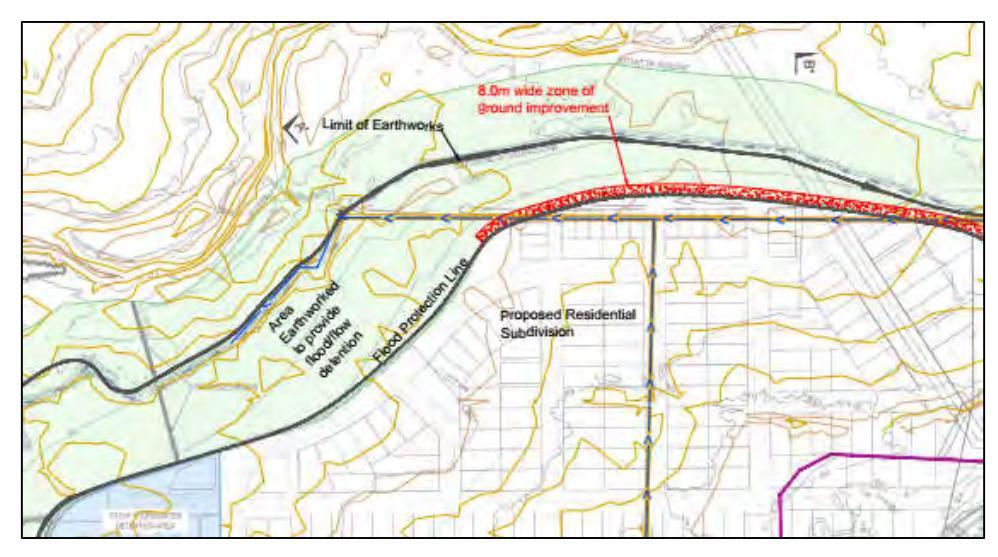
Figure 13 shows Option 3 comprising an 8 m wide band of ground improvement which would isolate the proposed subdivision from lateral spread by acting as a shear key.

Figure 13. Install ground improvement. Maintain lot arrangement.

For Option 3, there are several methods which could be adopted as follows:

- 1. Excavate and replace the sediments with river gravels. Temporary stability of the saturated alluvial soils could result in a wide excavation and some excavation trials would be prudent.
- 2. Dynamic compaction. Densifying the materials could be achieved by heavy dynamic compaction. Square or triangular "rollers" have been used successfully, but trials and testing would be required to demonstrate the effectiveness of this method through the entire column of alluvial sands and silts. There is a high degree of uncertainty attached to this option.
- 3. Stone columns. Installing stone columns through the alluvial sands and silts, would provide a high-shear composite zone with capacity for high pore pressures to be rapidly relieved by the stone columns.
