Palmerston North City Council

Notable Tree Survey March and April 2011

Address	117 Park Road	
Tree name	Black beech (<i>Nothofagus solandri</i>)	
Location of the tree on the site	Rear garden	
Owner's name		
Date of STEM Assessment	29 March 2011	Inspected by John Wakeling

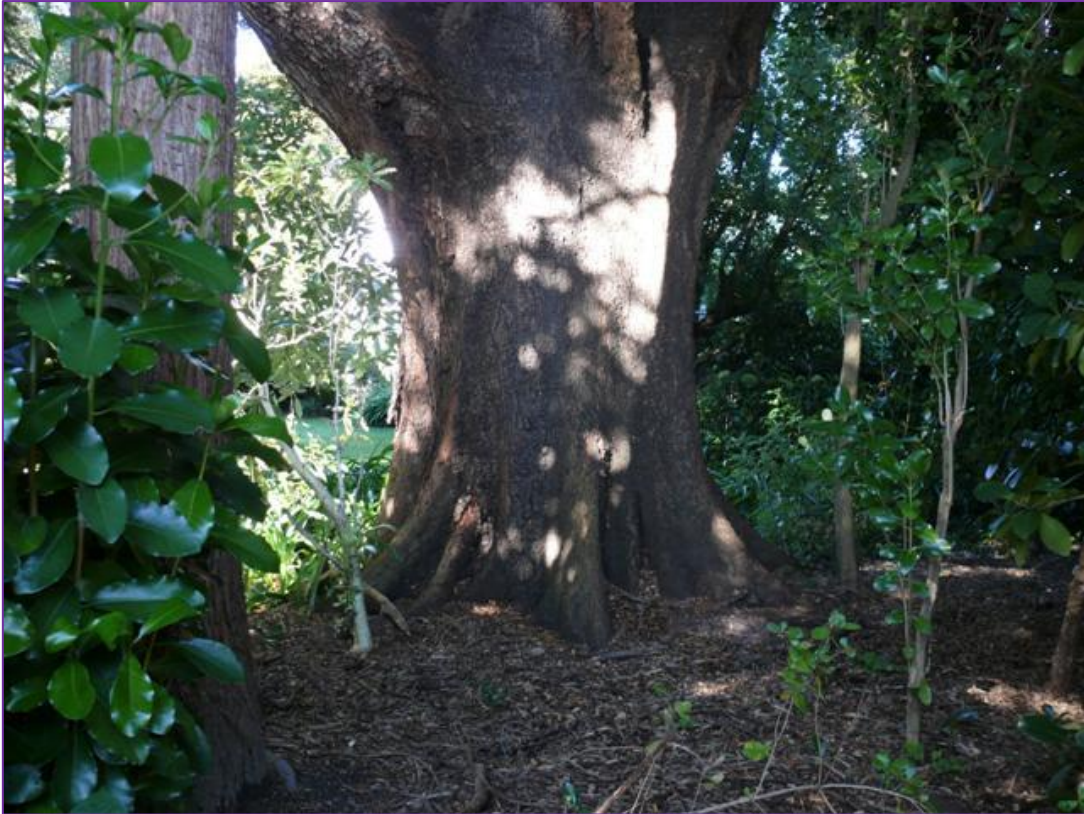
Requested for/by	Routine	Storm Damage	Owner	Developer	DP Review	
Pruning History	No recent pruning, old work was well done					
Built Environment	Small tight dev'pment	Standard suburban	Large house and grounds	Other (describe)		
Garden environment	Solo tree	Few trees	Many trees	Mainly exotic/native		
Local Environment	Few trees	Some trees	Well treed neighbourhood			
Age Class	young	Semi mature	Mature	Post mature		
Special value	Horticultural	Landscape	Specimen	Historical	Botanical	
Structural Character	Single leader	Double leader	Multi-stemmed	Included bark unions	Typical	Atypical
Form	Refer to STEM score sheet					
Crown Shape	Typical	Atypical	Wide spreading crown	Influenced by wind	Affected by other trees	
Foliage Health	Good	Poor, if so, explain				
Limb Structure	Typical or sound	Atypical, if so, explain	The long limbs and spreading crown are vulnerable to storm damage			
Trunk character	Well buttressed, fluted trunk; vigorous growth on the buttresses

Figure 2, the trunk in a fairly natural setting

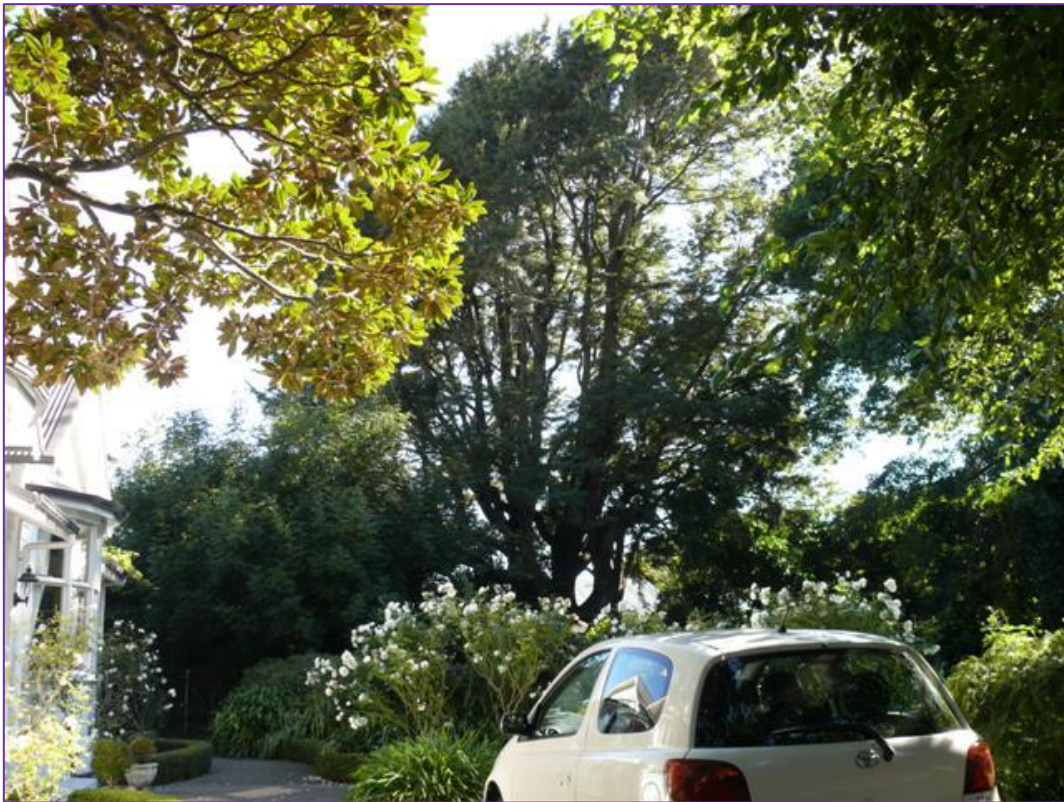
Figure 3, House and gardens
