Palmerston North City Council

Notable Tree Survey March and April 2011

Address	123 Park Road	
Tree name	Oak (<i>Quercus robur</i>)	
Location of the tree on the site	Front, close to the driveway	
Owner's name		
Date of STEM Assessment	29 March 2011	Inspected by John Wakeling

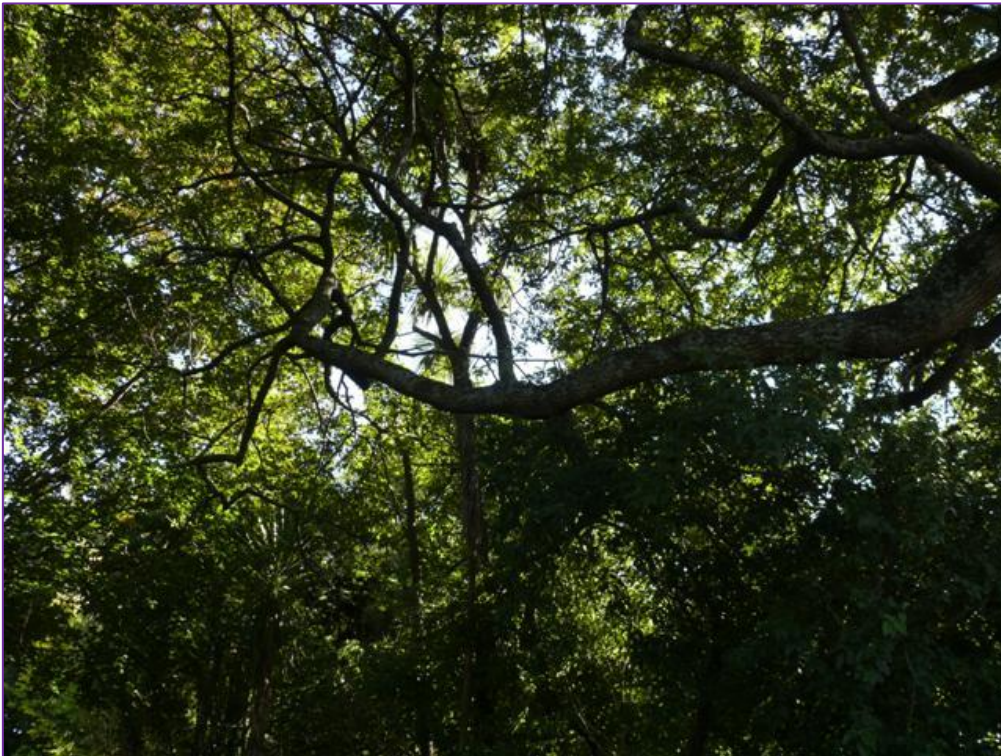
Figure 1, this branch to be shortened to allow more light to the garden nearby.

Category	Priority	Recommended Action	Timing (from April 2011)	Actioned	Completed
Amenity	One off	One long limb growing to the north could be shortened to allow more light into 121	soon		
Health					
Safety		Part of Amenity – dead wood removal	Now and thereafter 5 -6 yearly		
Overhanging b'dry
