Palmerston North City Council

Notable Tree Survey March and April 2011

Address	127 Fitzherbert Avenue	
Tree name	Oak (<i>Quercus robur</i>)	
Location of the tree on the site	Street frontage	
Owner's name		
Date of Inspection	29 March 2011	Inspected by John Wakeling

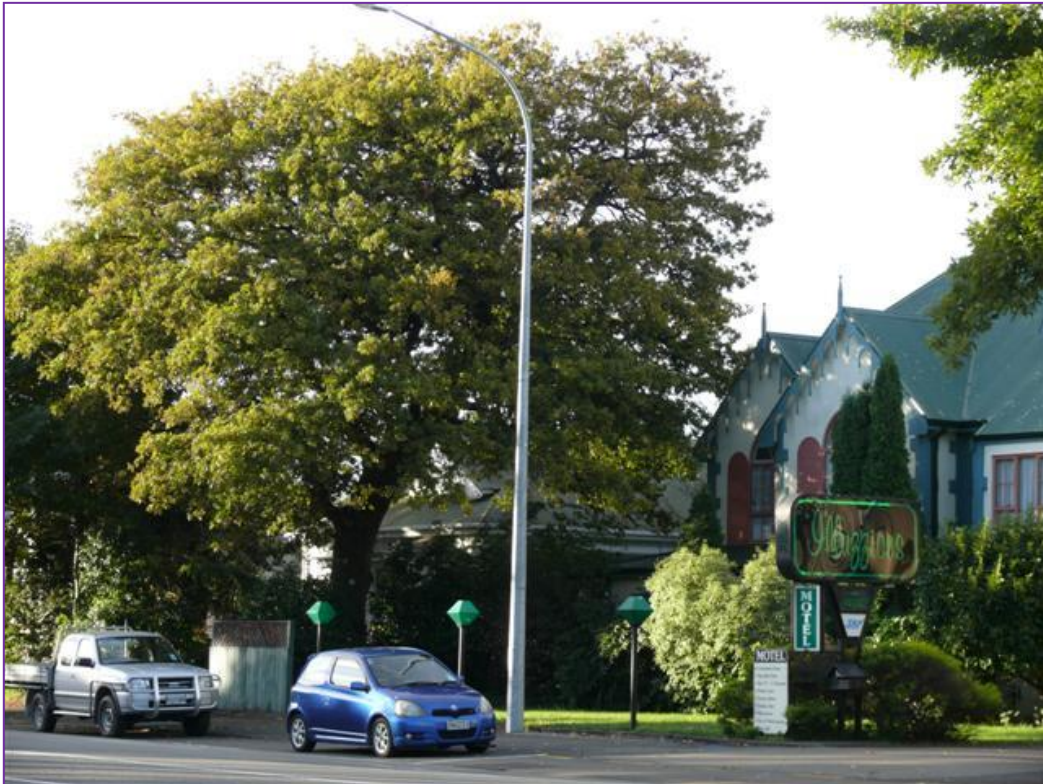
Figure 1. the tree in its setting

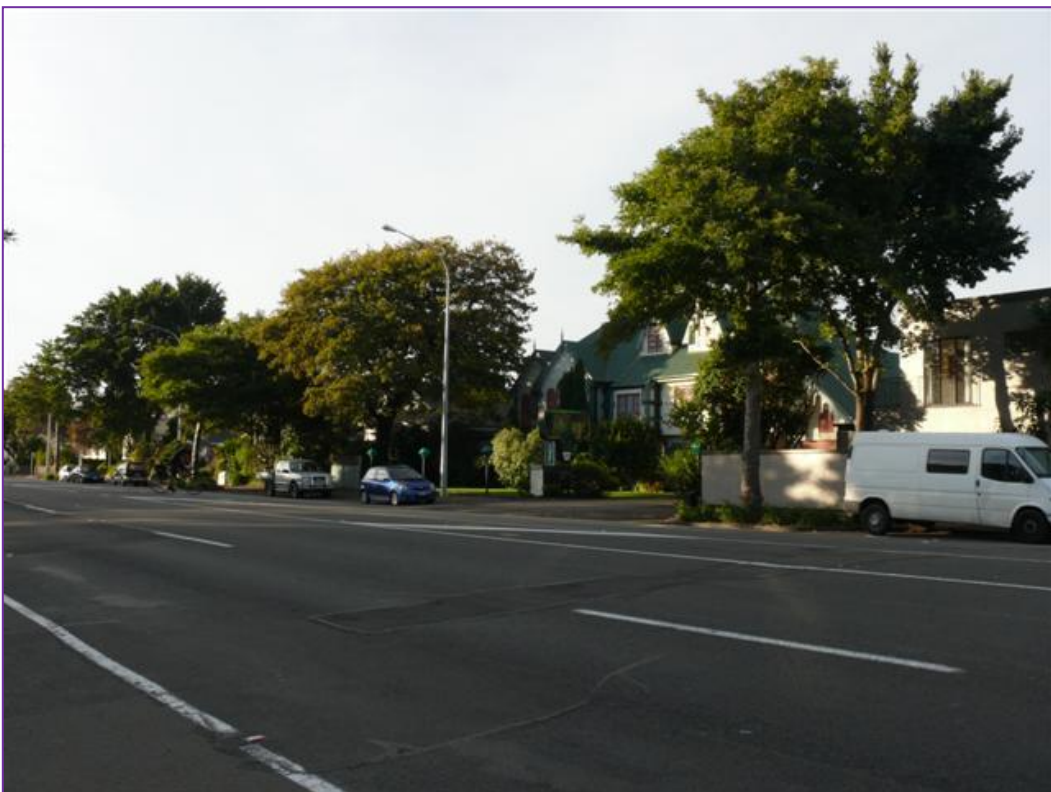
Figure 2. the tree in the overall street scene

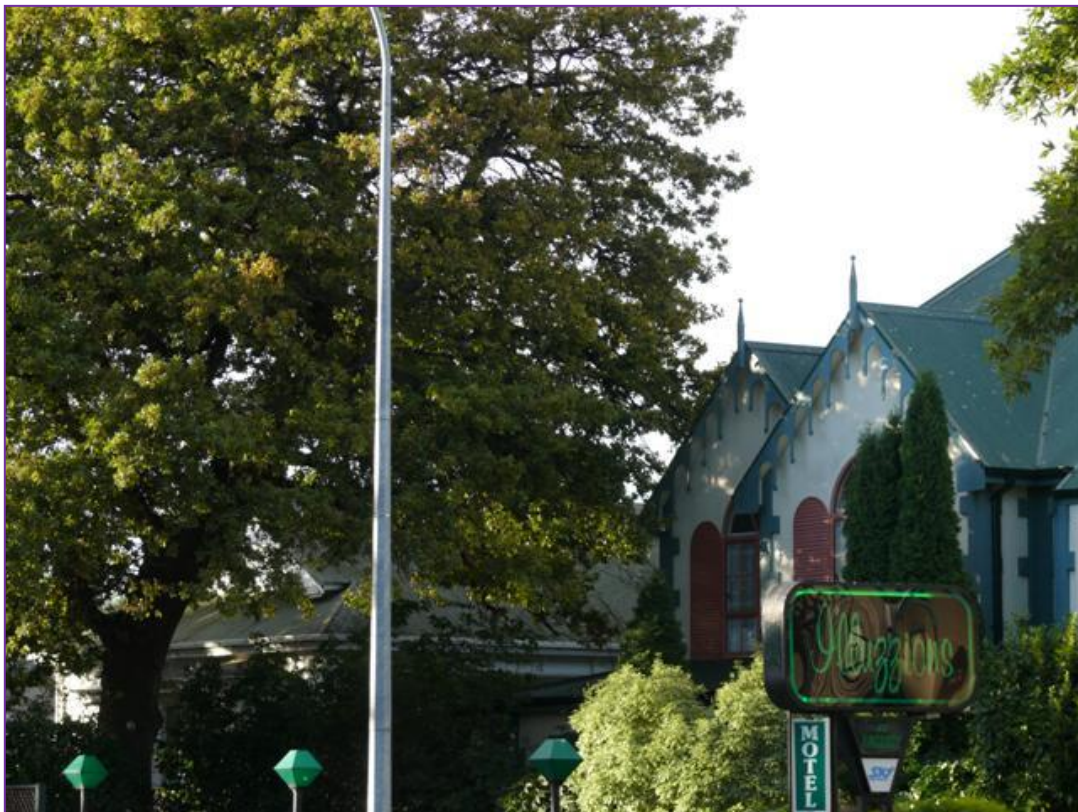
Figure 3. The overhanging branches could be reduced to give more clearance from the windows.

Category	Priority	Recommended Action	Timing (from April 2011)	Actioned	Completed
Amenity	routine	The tree had been regularly crown lifted and cleared from the roof. The inner crown is quite twiggy – it would benefit from some crown thinning.	Carry out thinning and roof clearance every 5 years.		
Health	-				
Safety	-				
Overhanging b'dry		Reduce some of the longer branches – it is not desirable to reduce the crown by a large amount.
