# Palmerston North City Council

## Notable Tree Survey March and April 2011

<b>Address</b>	128 Salisbury Street, Ashhurst	
<b>Tree name</b>	Oak ( <i>Quercus robur</i> )	
<b>Location of the tree on the site</b>	Front, close to the boundary	
<b>Owner's name</b>		
<b>Date of Inspection</b>	1 April 2011	<b>Inspected by</b> John Wakeling

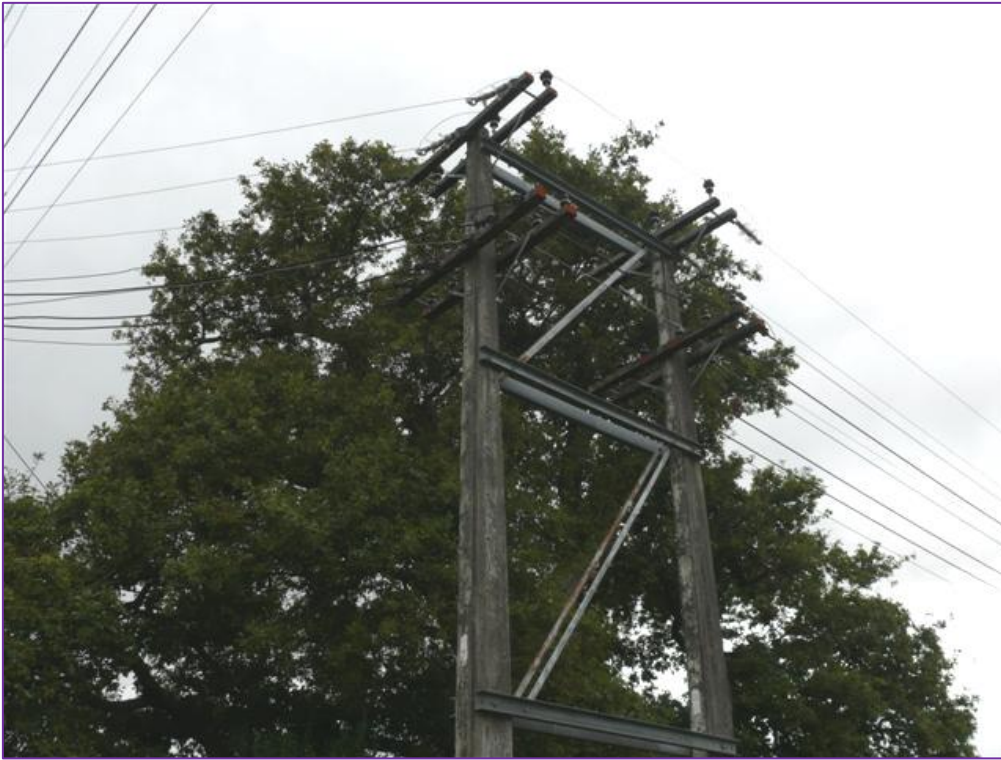
Figure 1. Tangle of overhead power lines and supporting poles

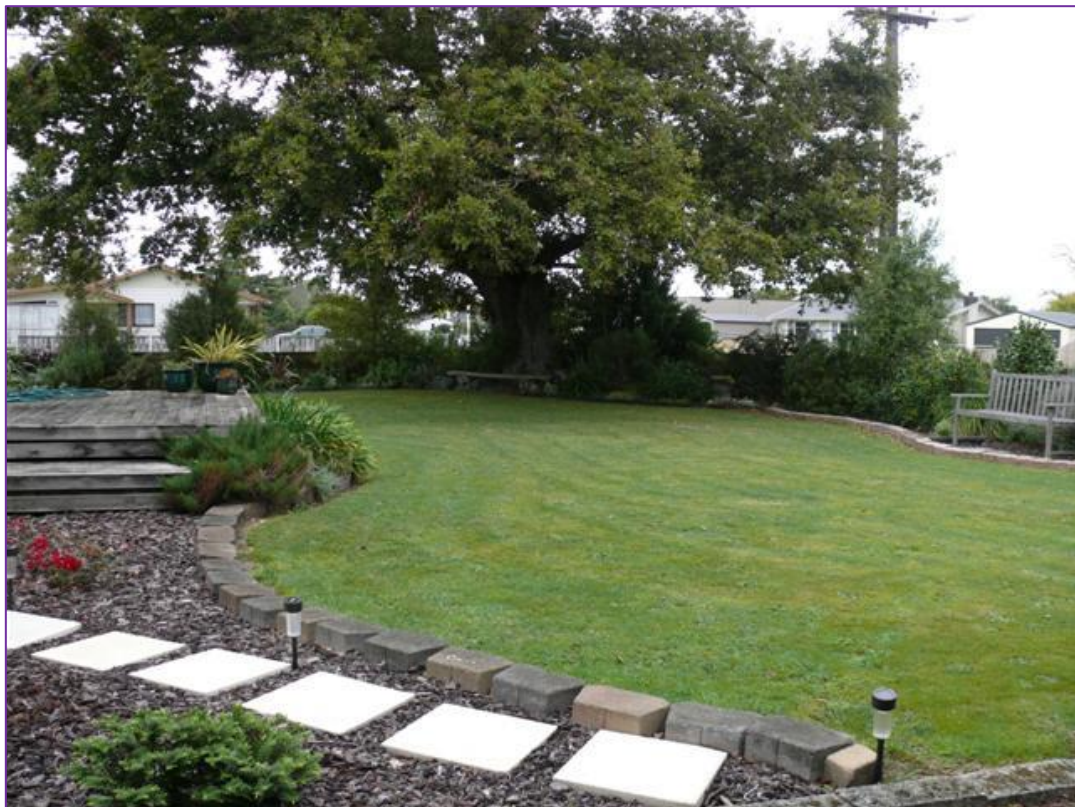
<b>Trunk character</b>	Short bole, slight lean away from wind, massive and solid looking					
<b>Root Zone</b>	Garden	Natural	Lawn/paddock	U/g services apparent?	Hard surface, if so, explain	
<b>Comments</b>	The tree is looking better with each visit. The garden is well tended and designed around the tree.

Figure 3. Tree and Garden

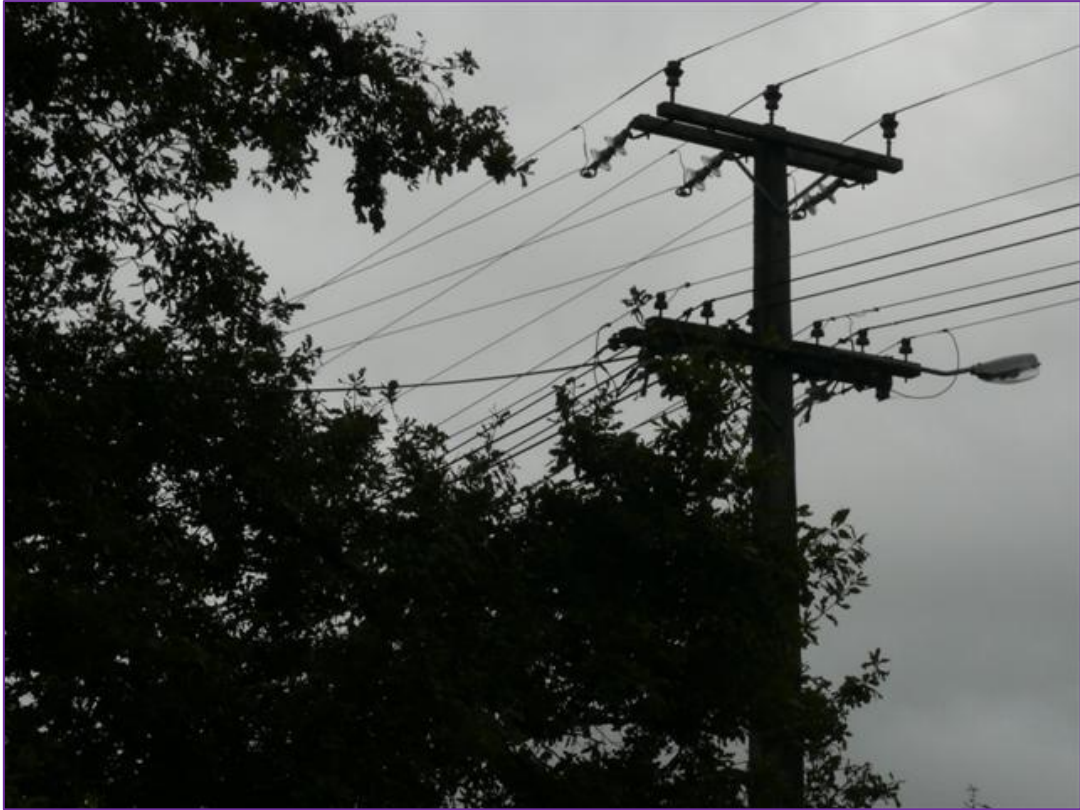
Figure 4. The need to prune away from the high tension lines is apparent.

Category	Priority	Recommended Action	Timing (from April 2011)	Actioned	Completed
<b>Amenity</b>	<b>routine</b>	Raise/trim crown when needed	5 years		
<b>Health</b>	-				
<b>Safety</b>	-				
<b>Overhanging b'dry</b>	<b>routine</b>	The outer edges of the crown are kept pruned by the power company	As required

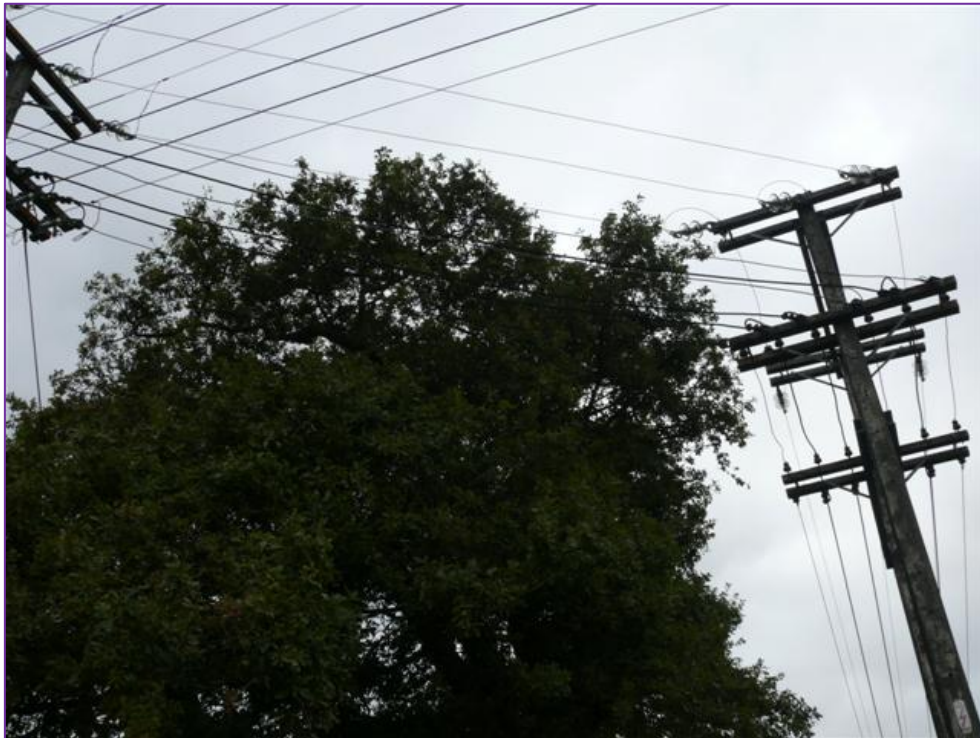
Figure 5. The challenge: to reduce the impact of the overhead lines outside the property.
