Palmerston North City Council

Notable Tree Survey March and April 2011

Address	161 Fitzherbert Avenue	
Tree name	Blue Atlas cedar (<i>Cedrus atlantica</i> 'Glauca')	
Location of the tree on the site	On the street frontage	
Owner's name		
Date of Inspection	29 March 2011	Inspected by John Wakeling

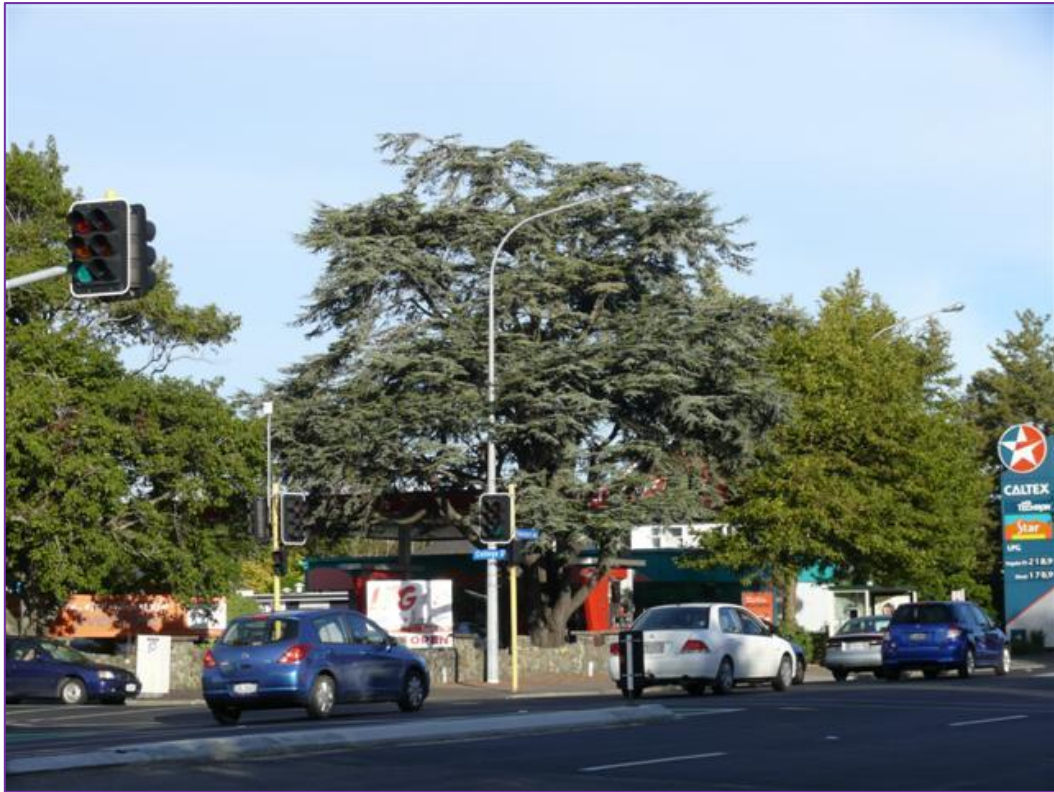
Figure 3. The tree near the cross roads, makes a considerable statement.
