Palmerston North City Council

Notable Tree Survey March and April 2011

Address	632 Pioneer Highway	
Tree name	Black beech (<i>Nothofagus solandri</i>)	
Location of the tree on the site	Close to the entrance drive, near holiday cabins	
Owner's name		
Date of Inspection	31 March 2011	Inspected by John Wakeling

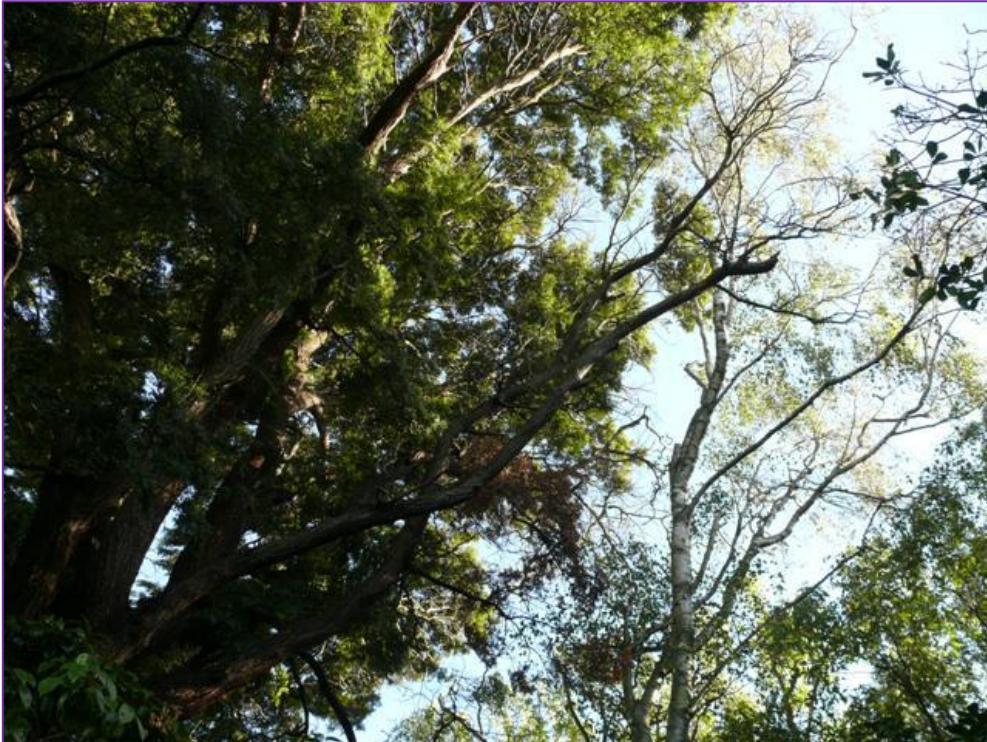
Trunk character	Rugged looking trunk much character with bulges, deep interstices between the buttresses.				
Root Zone	Garden	Natural	Lawn/paddock	U/g services apparent?	Hard surface, (if so, explain) – the driveway is being affected by root growth -
Comments	The tree appears quite healthy, but there is a lot of dead wood in the crown, and one dead branch at a lower level – a chain supporting a swing has constricted the sap flow.

Figure 1 dead limbs in upper canopy

Category	Priority	Recommended Action	Timing (from April 2011)	Actioned	Completed
Amenity	urgent	Remove dead wood in the crown.	This year. Then 5 yearly		
Health	-	Apply a layer of mulch	On an annual basis		
Safety	See Amenity section above		ditto		
Overhanging b'dry

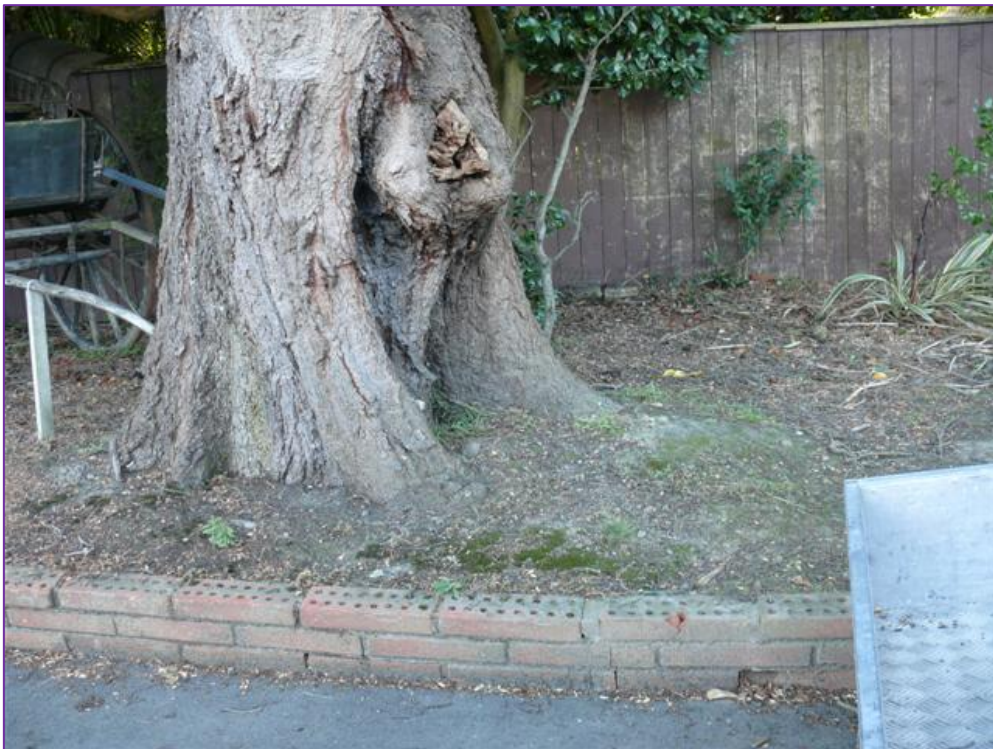
Figure 2. trunk appears sound and growing well. Needs mulch

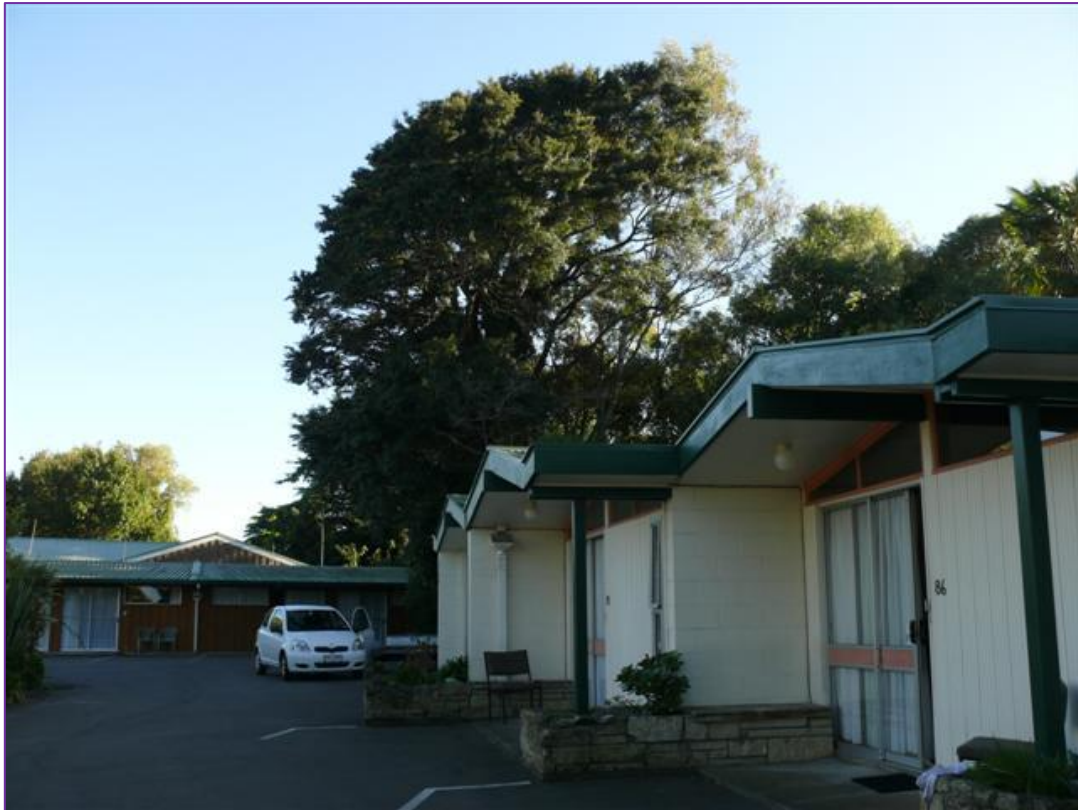
Figure 3. sparser foliage on eastern side. Can be examined during deadwooding programme

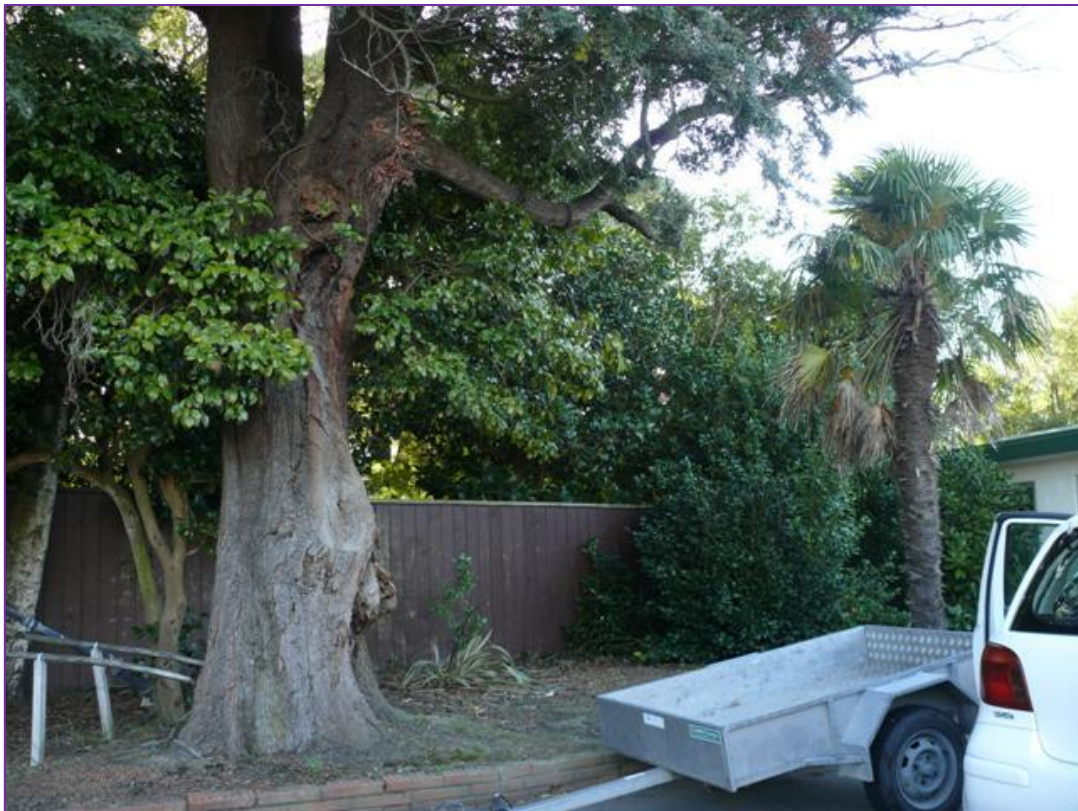
Figure 4. the dead lower limb should be removed
