Palmerston North City Council

Notable Tree Survey March and April 2011

Address	636 Ferguson Road	
Tree name	English Oak (<i>Quercus robur</i>)	
Location of the tree on the site	Rear of property	
Owner's name		
Date of STEM Assessment	11 May 2011 and 30 March 2011	Inspected by John Wakeling

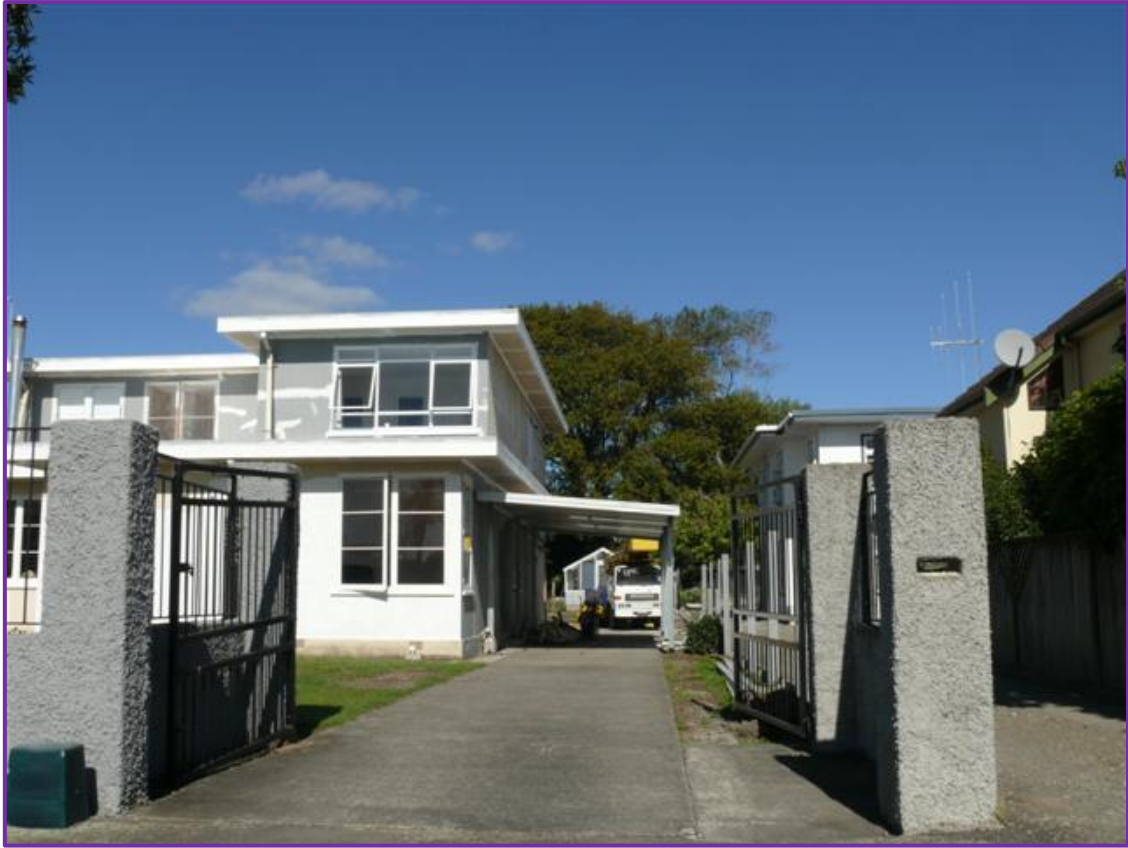
Figure 1, the oak behind the house

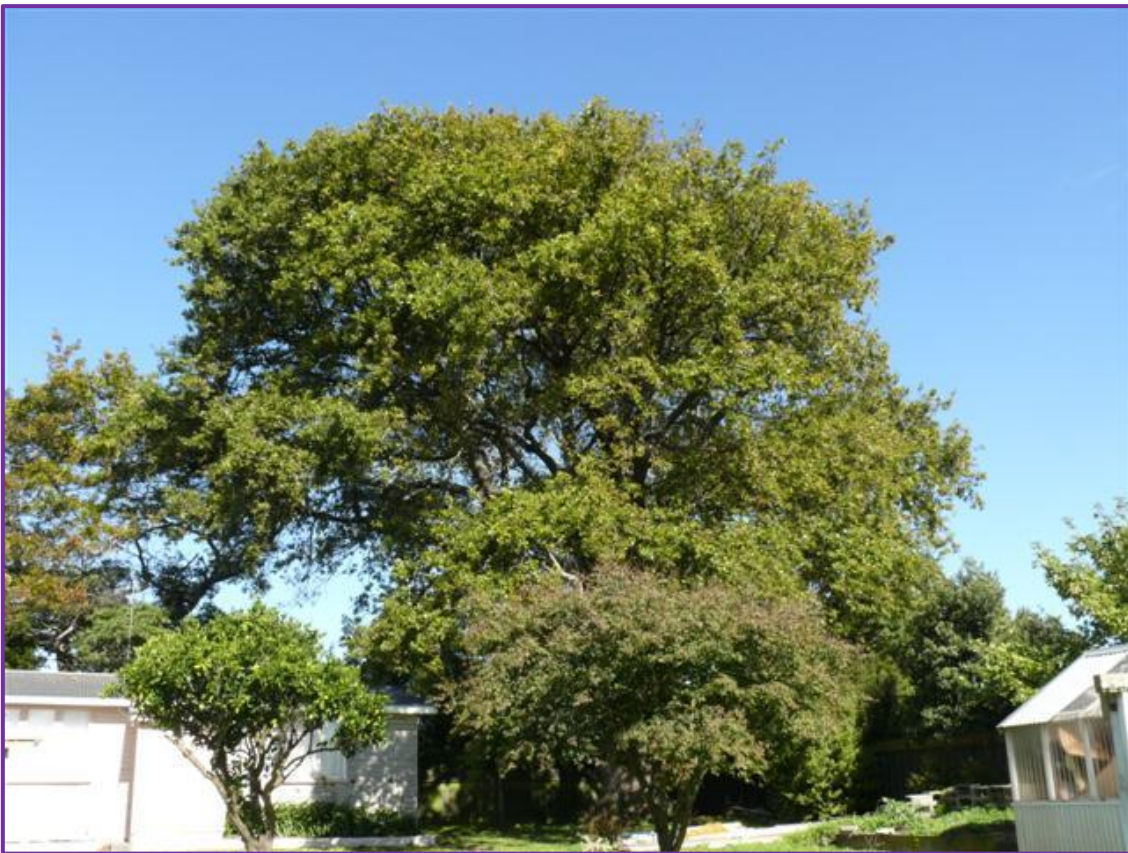
Figure 2, the oak in the rear garden

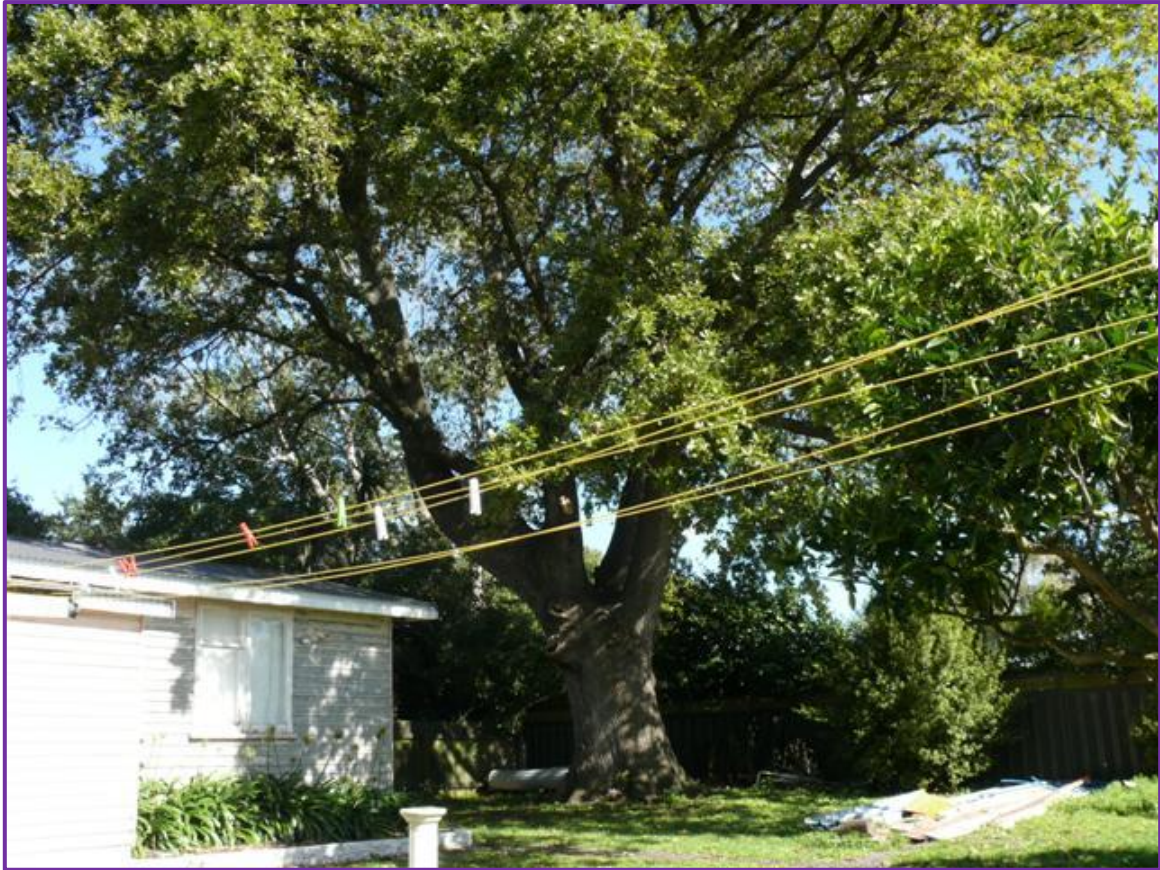
Requested for/by	Routine	Storm Damage	Owner	Developer	DP Review	
Pruning History	Dead wooded and crown lifted					
Built Environment	Small tight dev'pment	Standard suburban	Large house and grounds	Other (describe)		
Garden environment	Solo tree	Few trees	Many trees	Mainly exotic/native		
Local Environment	Few trees	Some trees	Well treed neighbourhood			
Age Class	young	Semi mature	Mature	Post mature		
Special value	Horticultural	Landscape	Specimen	Historical	Botanical	
Structural Character	Single leader	Double leader	Multi-stemmed	Included bark unions	Typical	Atypical
Form	Refer to STEM score sheet					
Crown Shape	Typical	Atypical	Wide/spreading/low crown	Influenced by wind	Affected by other trees	
Foliage Health	Good	Poor, if so, explain				
Limb Structure	Typical or sound	Atypical, if so, explain	One sub-dominant limb in the main fork has got a significant amount of decay on the top of the branch. This decay does not penetrate deep into the trunk. It would be acceptable to either reduce the length of the limb, or even to remove it. The branch extends over a separate flat.

Figure 3, the Tree and the garden flat

Category	Priority	Recommended Action	Timing (from April 2011)	Actioned	Completed
Amenity		Removed deadwood	Five yearly		
Health					
Safety		Reduce by one half the length of the sub-dominant branch with decay. If desired, this branch could cut back to the trunk, but this would leave a large open wound, and thus, length reduction would be preferable.			
Overhanging b'dry

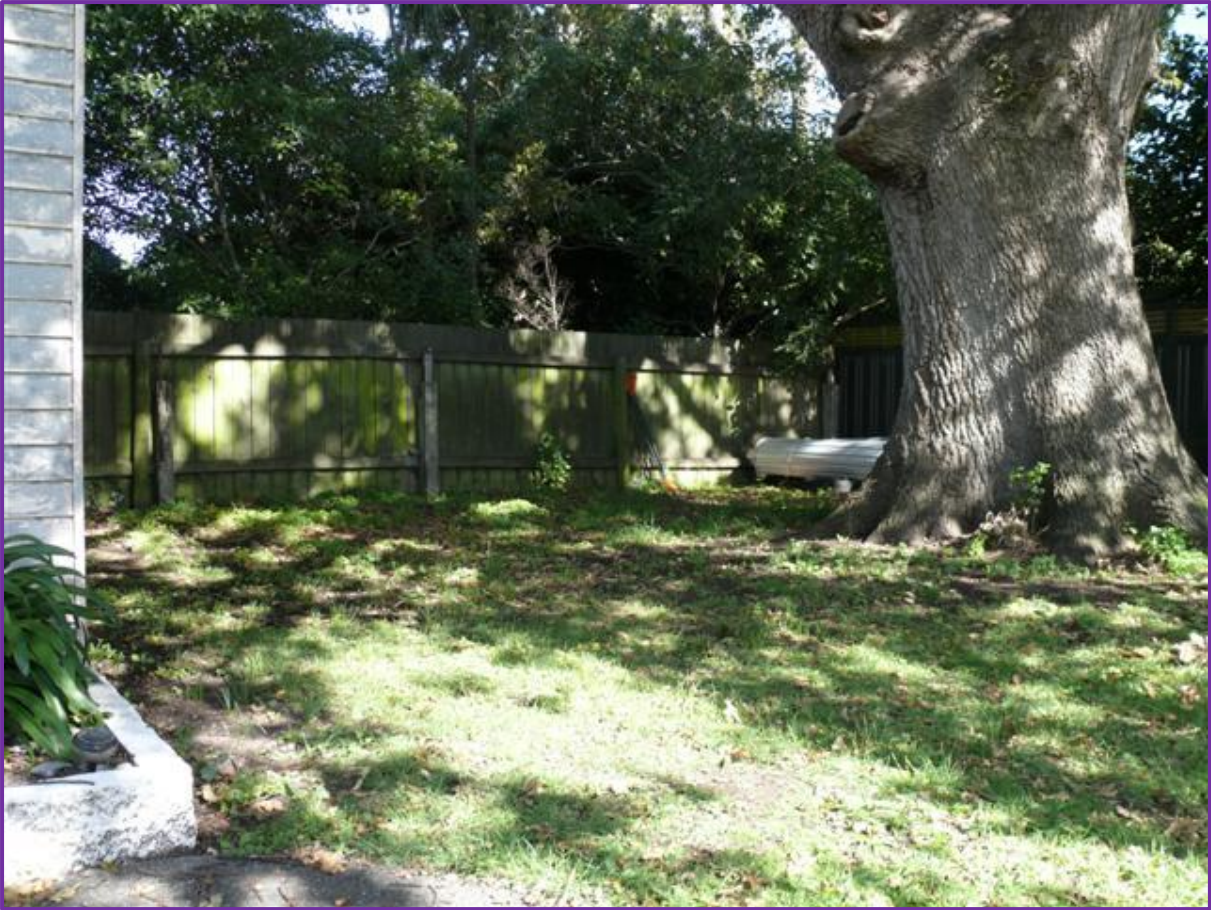
Trunk character	Slight lean away from wind, cylindrical and well buttressed					
Root Zone	Garden	Natural	Lawn/paddock	U/g services apparent?	Hard surface, if so, explain	
Comments

Figure 4, the trunk and buttresses
