Palmerston North City Council

Notable Tree Survey March and April 2011

Address	121 Park Road	
Tree name	Oak (<i>Quercus robur</i>)	
Location of the tree on the site	Front centre of front garden	
Owner's name		
Date of STEM Assessment	29 March 2011	Inspected by John Wakeling

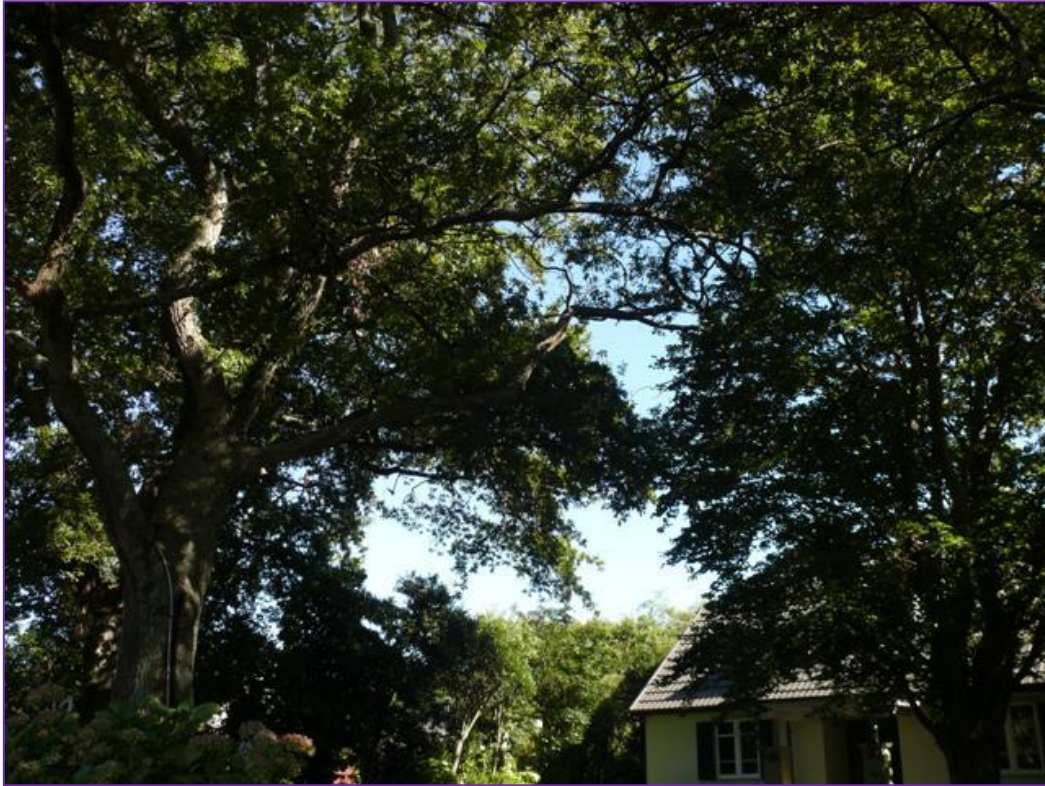
Requested for/by	Routine	Storm Damage	Owner	Developer	DP Review	
Pruning History	Frequent programmes of dead wood and low limb removal. The tree is well looked after					
Built Environment	Small tight dev'pment	Standard suburban	Large house and grounds	Other (describe)		
Garden environment	Solo tree	Few trees	Many trees	Mainly exotic/native		
Local Environment	Few trees	Some trees	Well treed neighbourhood			
Age Class	young	Semi mature	Mature	Post mature		
Special value	Horticultural	Landscape	Specimen	Historical	Botanical	
Structural Character	Single leader	Double leader	Multi-stemmed	Included bark unions	Typical	Atypical
Form	Refer to STEM score sheet					
Crown Shape	Typical	Atypical	Wide/spreading/low crown	Influenced by wind	Affected by other trees	
Foliage Health	Good	Poor, if so, explain				
Limb Structure	Typical or sound	Atypical, if so, explain				
Trunk character	Sound, preparations for in-crown lighting – not completed

Root Zone	Garden	Natural	Lawn/paddock	U/g services apparent?	Hard surface, if so, explain	
Comments	the garden has been designed around the trees

Figure 1, this report refers to the tree on the left (European beech to the right)

Category	Priority	Recommended Action	Timing (from April 2011)	Actioned	Completed
Amenity	Routine	Lower limb reduction	As required		
Health					
Safety					
Overhanging b'dry

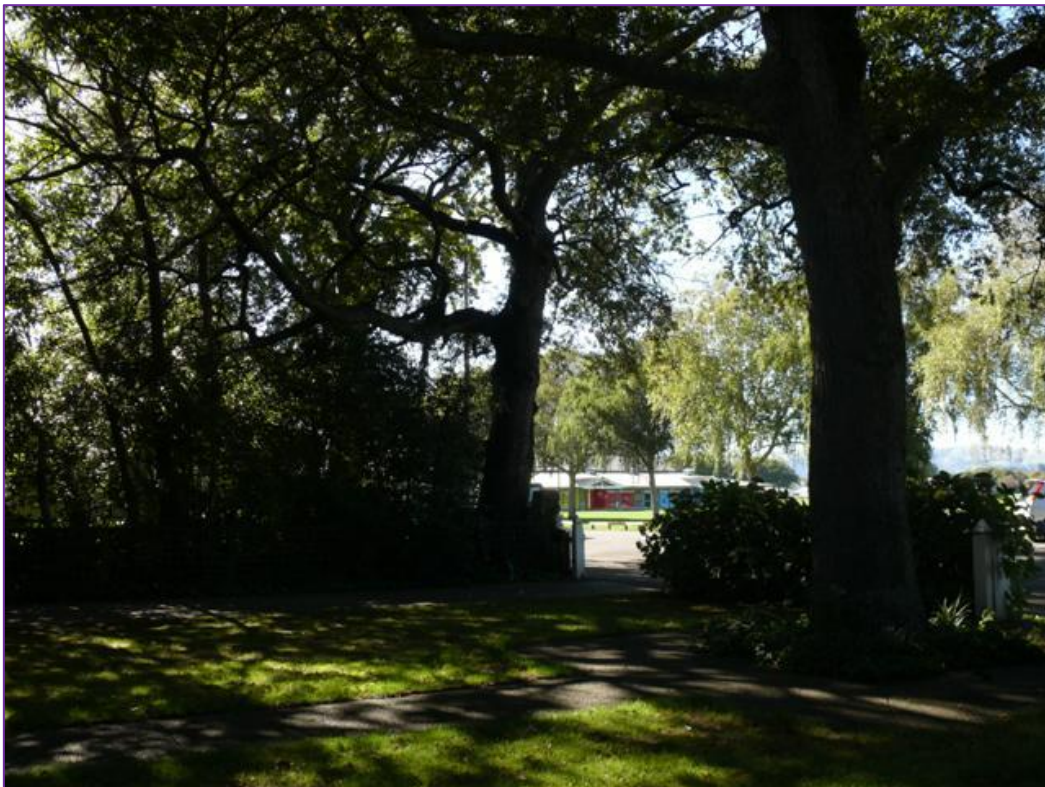
Figure 2, this report refers to the tree on the right

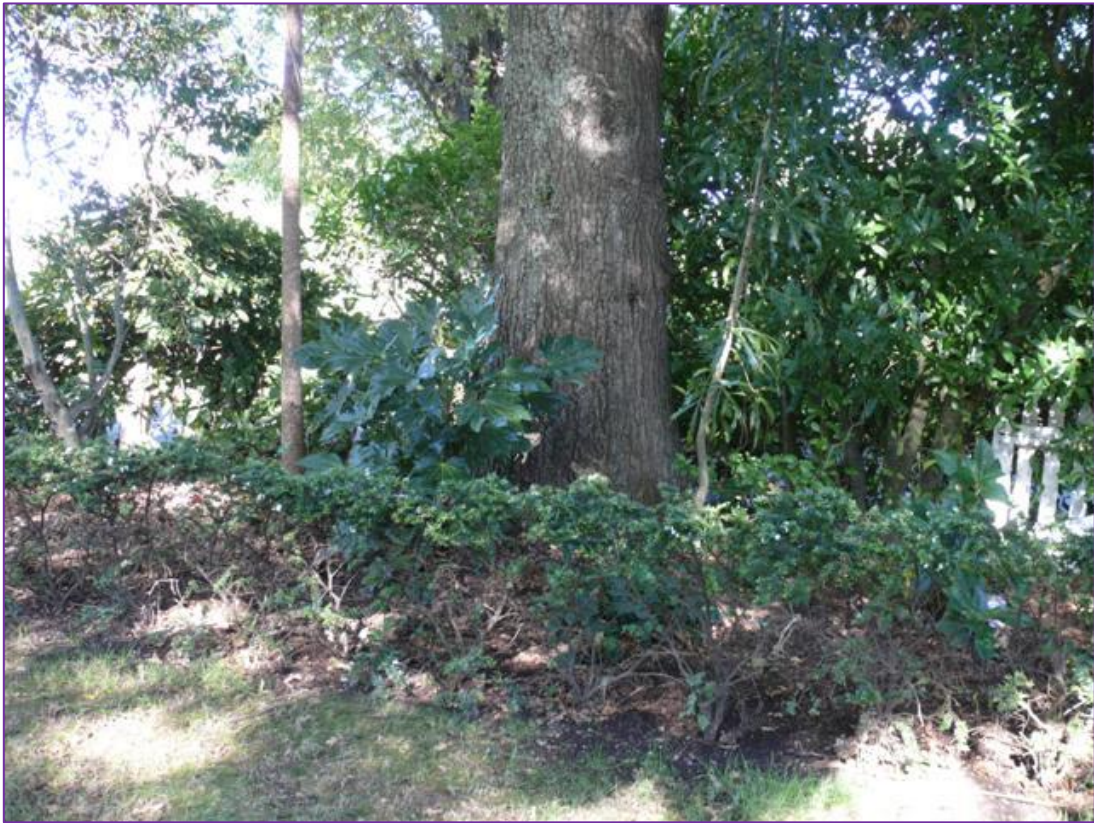
Comments	The two trees in the garden and the two oak trees nearby are thought to be part of the driveway planting to an old house and garden, long since gone. (pers comm., A. McKay)

Figure 1, the tree in its location

Category	Priority	Recommended Action	Timing (from April 2011)	Actioned	Completed
Amenity	routine	Crown lift, thin and dead wood	5 yearly – no urgency in this tree		
Health	-				
Safety	-				
Overhanging b'dry	check	Consensus with neighbours when the matter is raised
