+ Preliminary Site Investigation

Kākātangiata Structure Plan and District Plan Change

Prepared for  
Palmerston North City Council

Prepared by  
Tonkin & Taylor Ltd

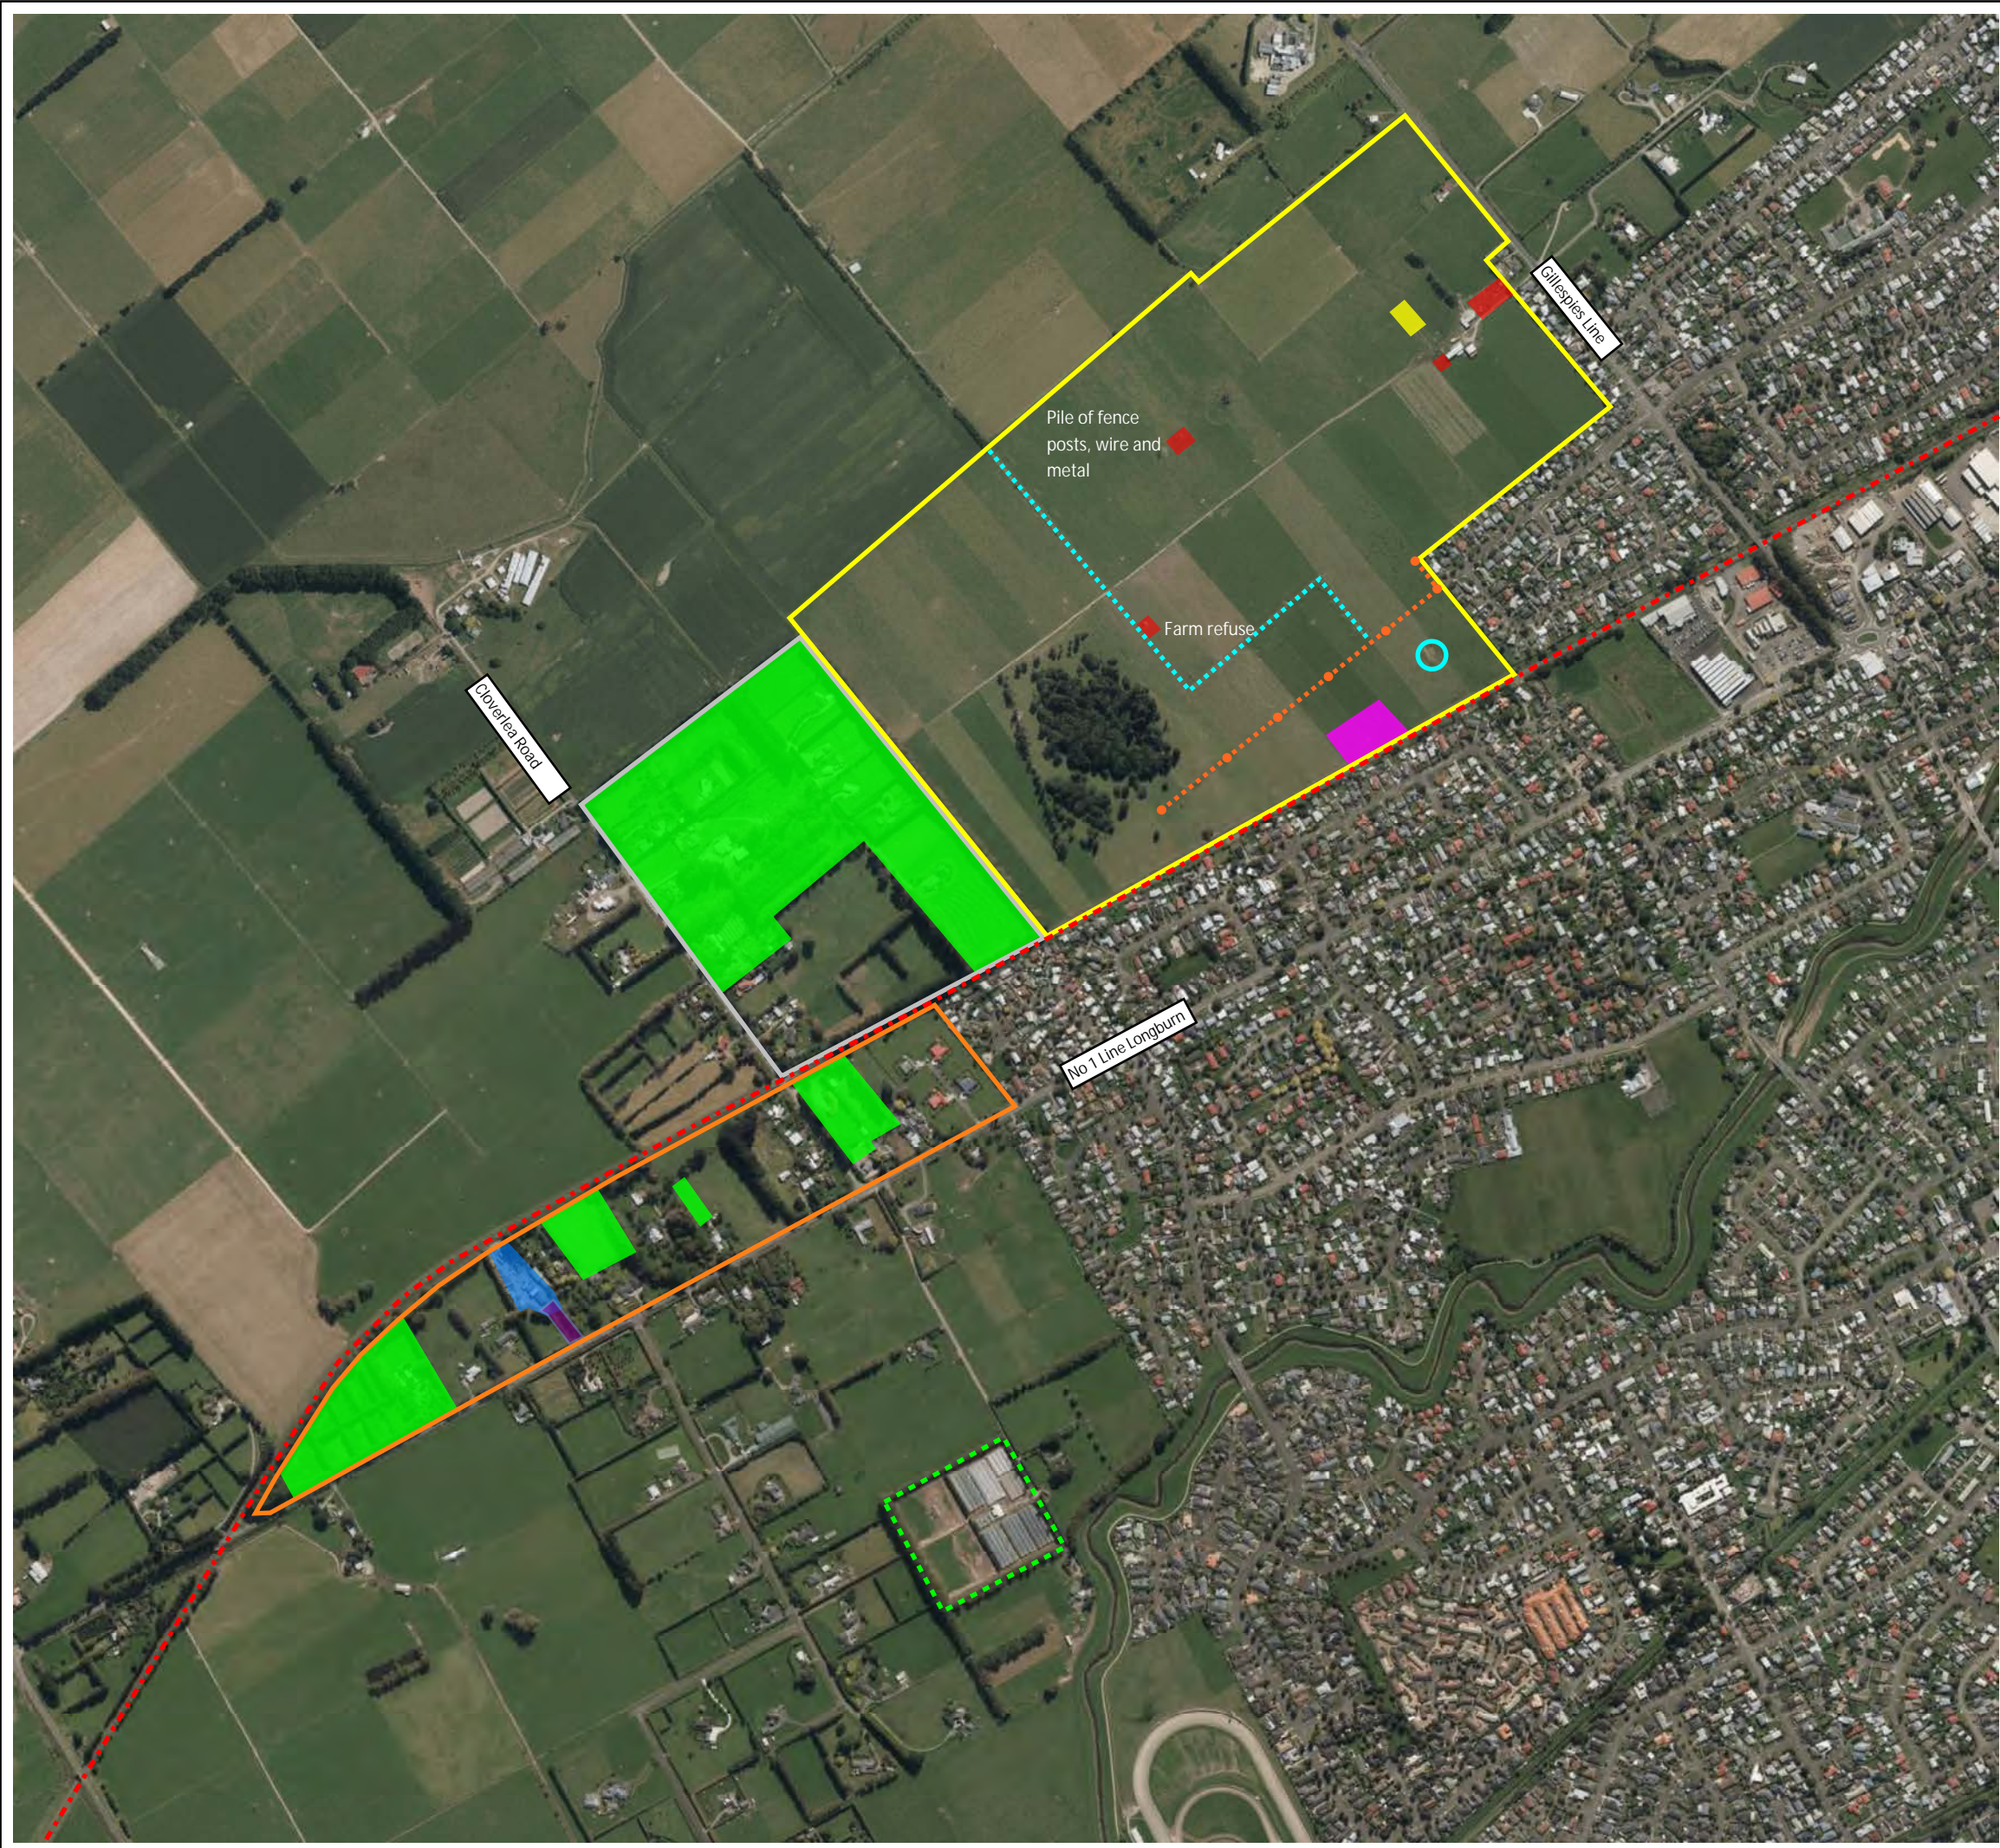
**PALMERSTON NORTH CITY COUNCIL**  
 85442.0200  
 Kakatangiata - Manderson, Cloverlea and No 1 Line  
 Key Site Features

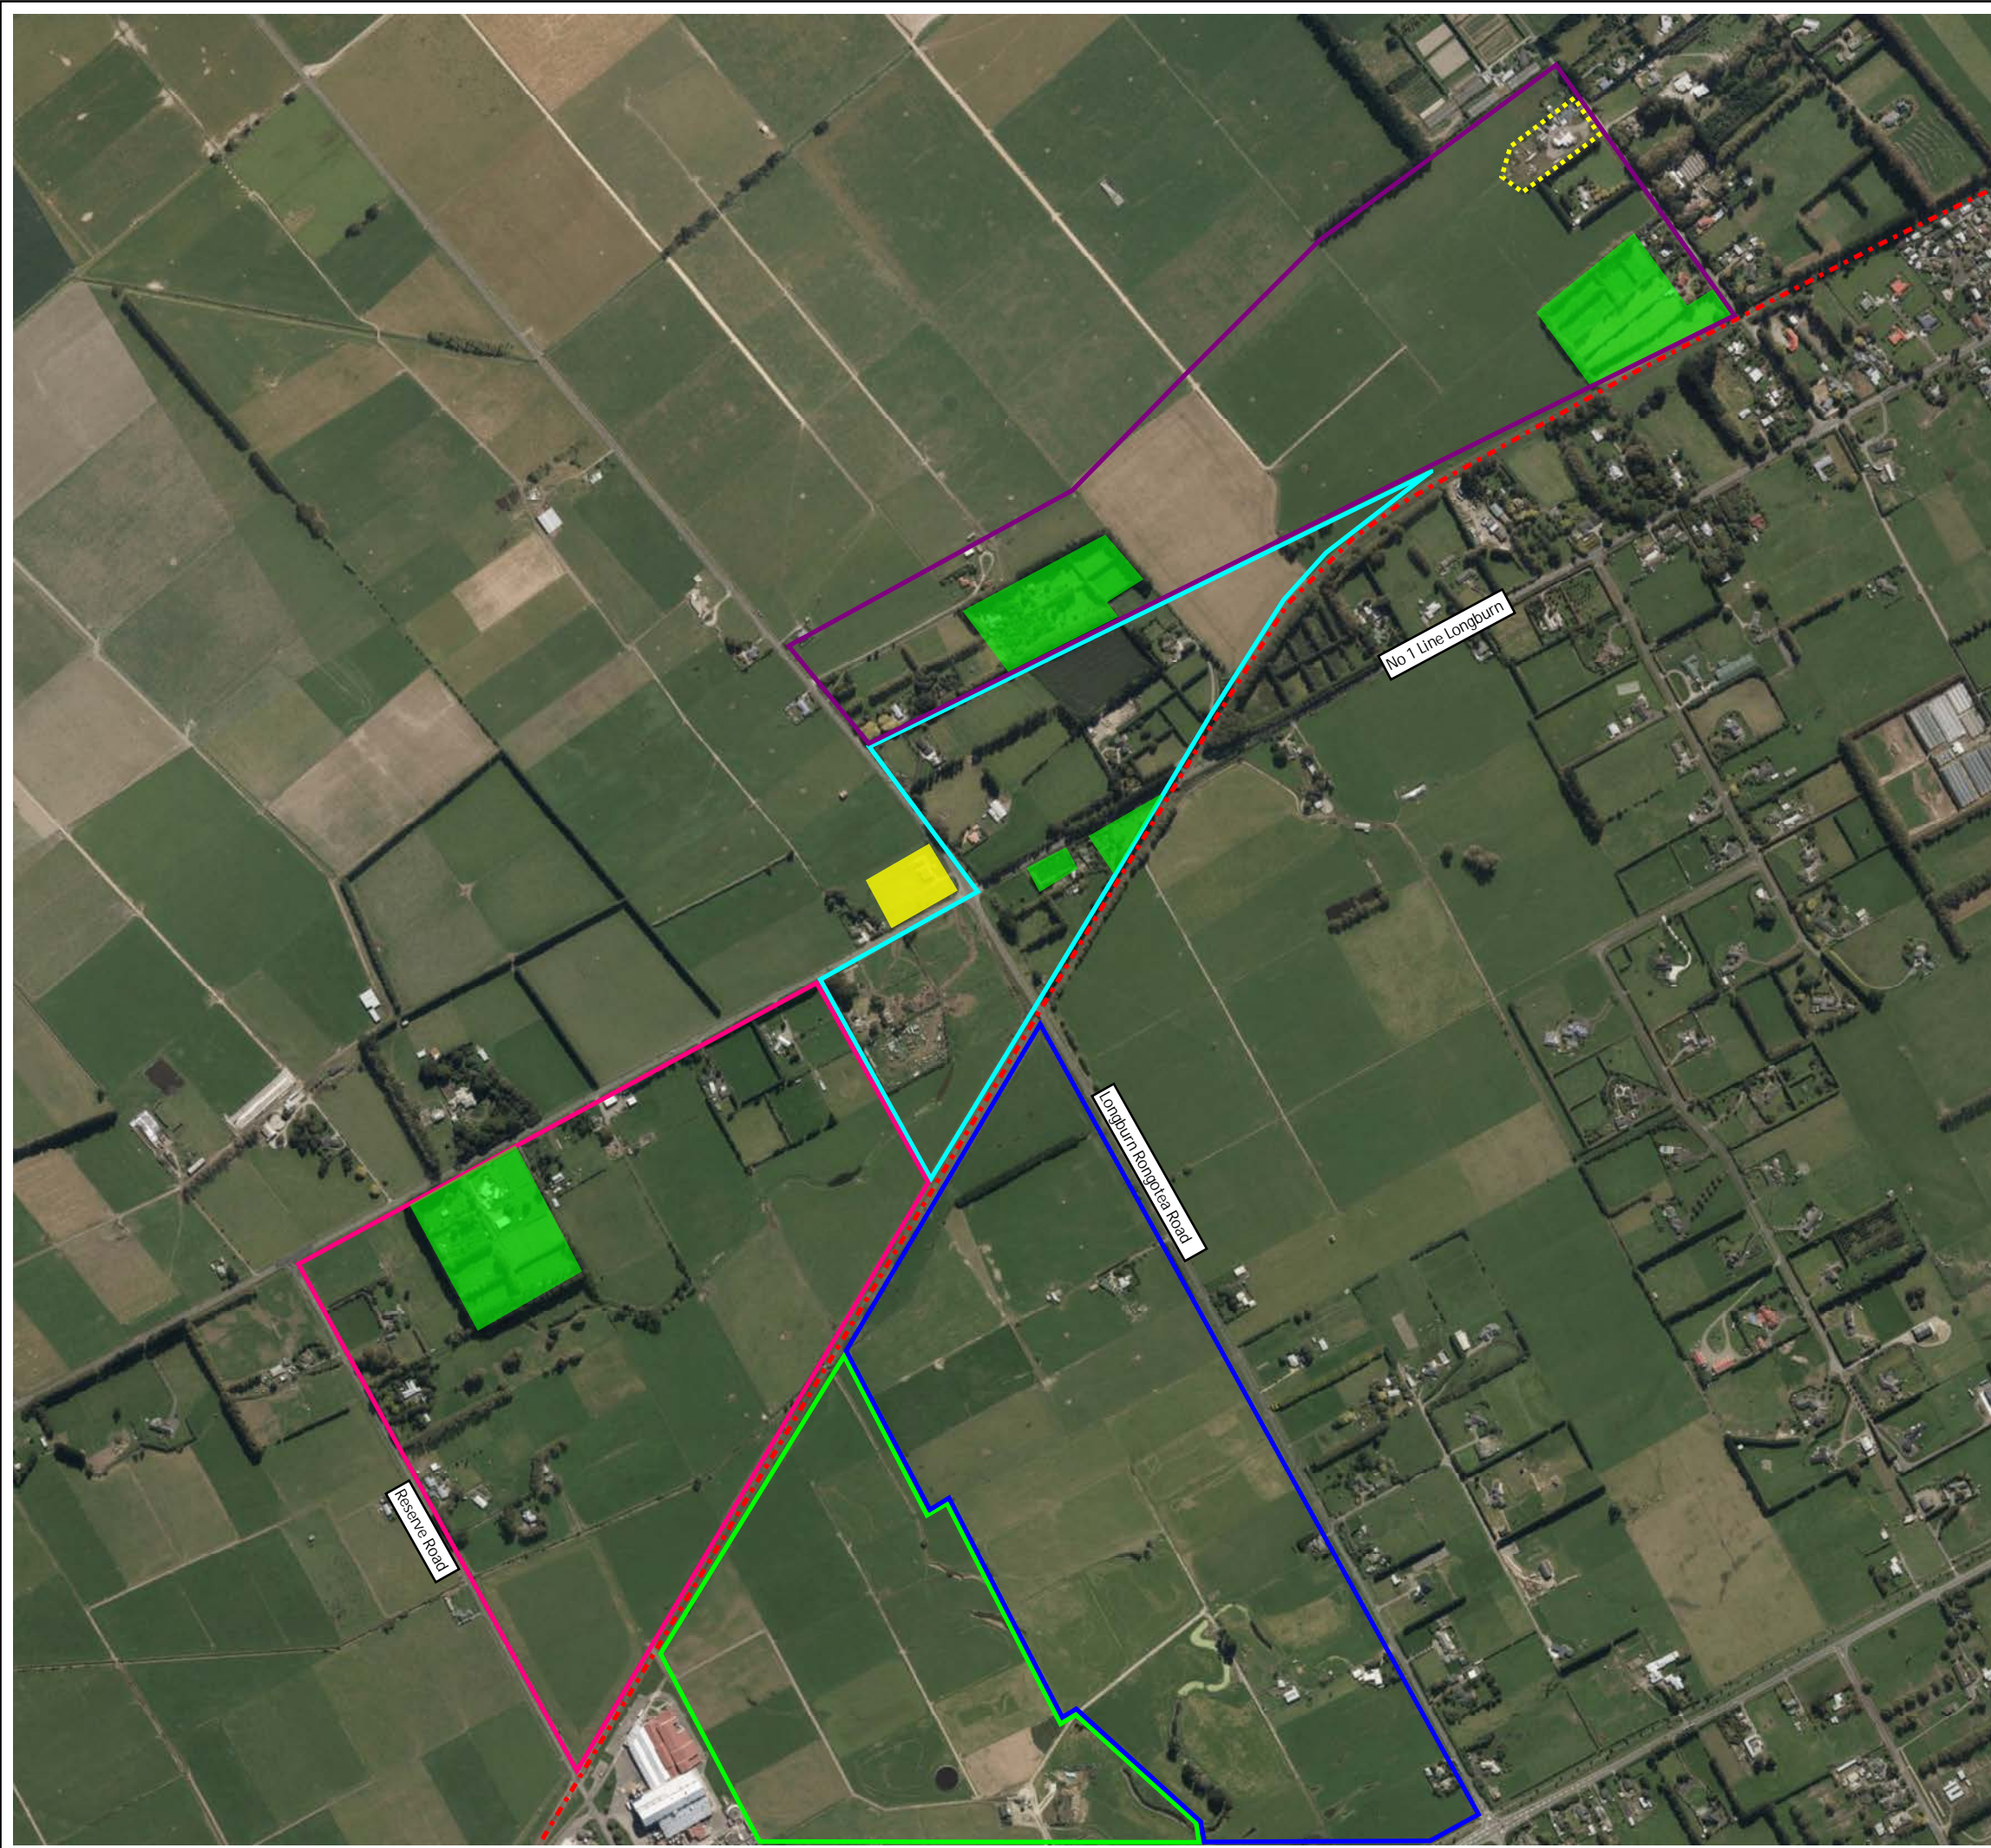
**PALMERSTON NORTH CITY COUNCIL**  
 85442.0200  
 Kakatangiata - Central Areas  
 Key Site Features

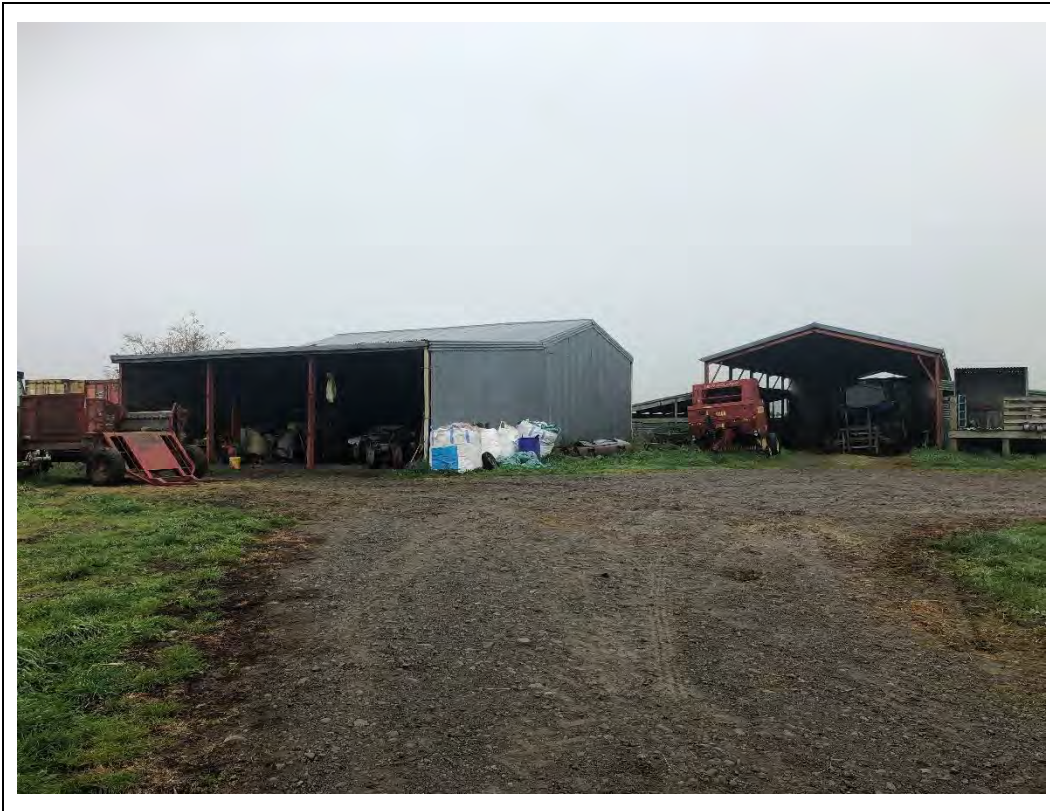
- An implement shed, a hay shed, and a milking shed was present at the end of the driveway. The buildings appeared to have been constructed of corrugated iron, steel beams, timber and cinderblocks (see photographs 1 and 2). Brick fragments were observed in the driveway near to the sheds (see photograph 3);

*Photograph 1 Appendix B.1: Implement (forefront of image) and hay sheds.*

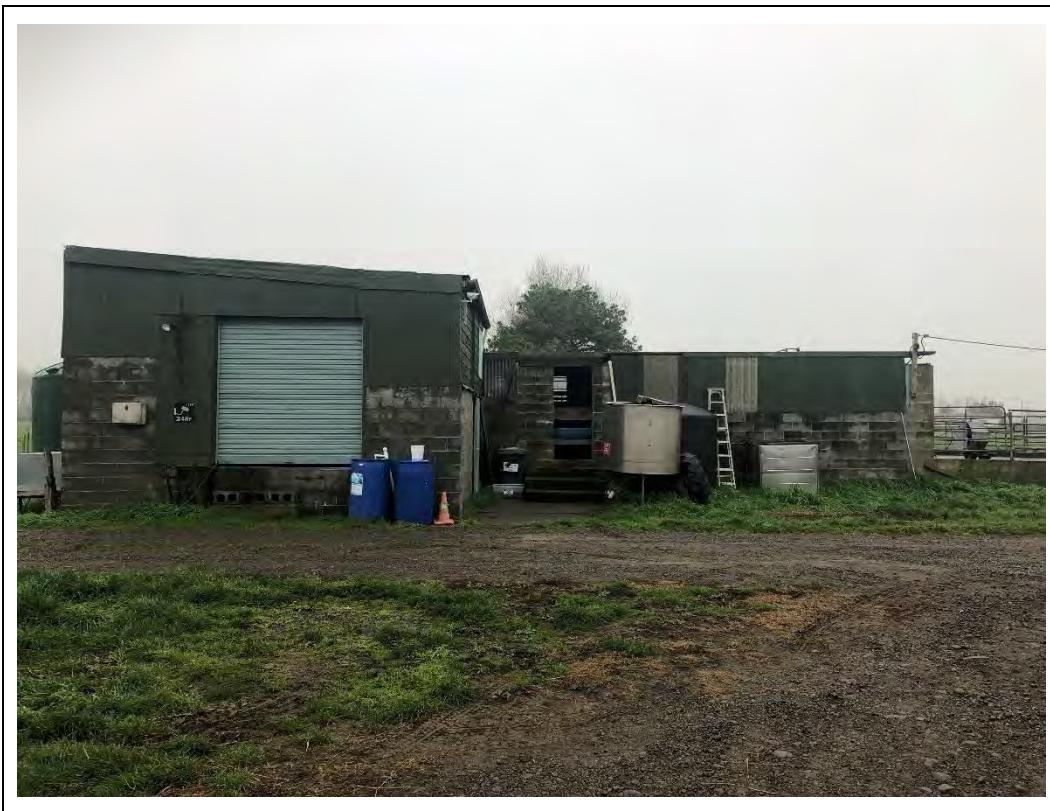
*Photograph 2 Appendix B.1: Milking shed constructed of cinderblock, corrugated iron and 'clearlite' panels.*

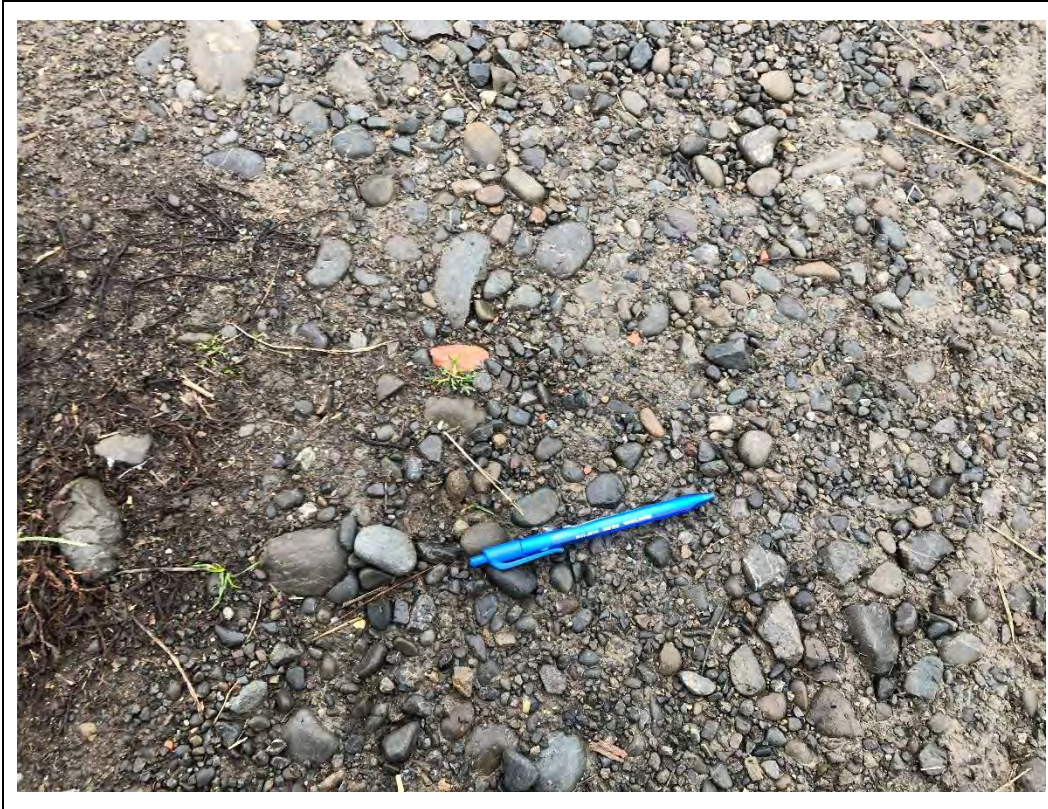
*Photograph 3 Appendix B.1: Brick fragments observed in driveway.*

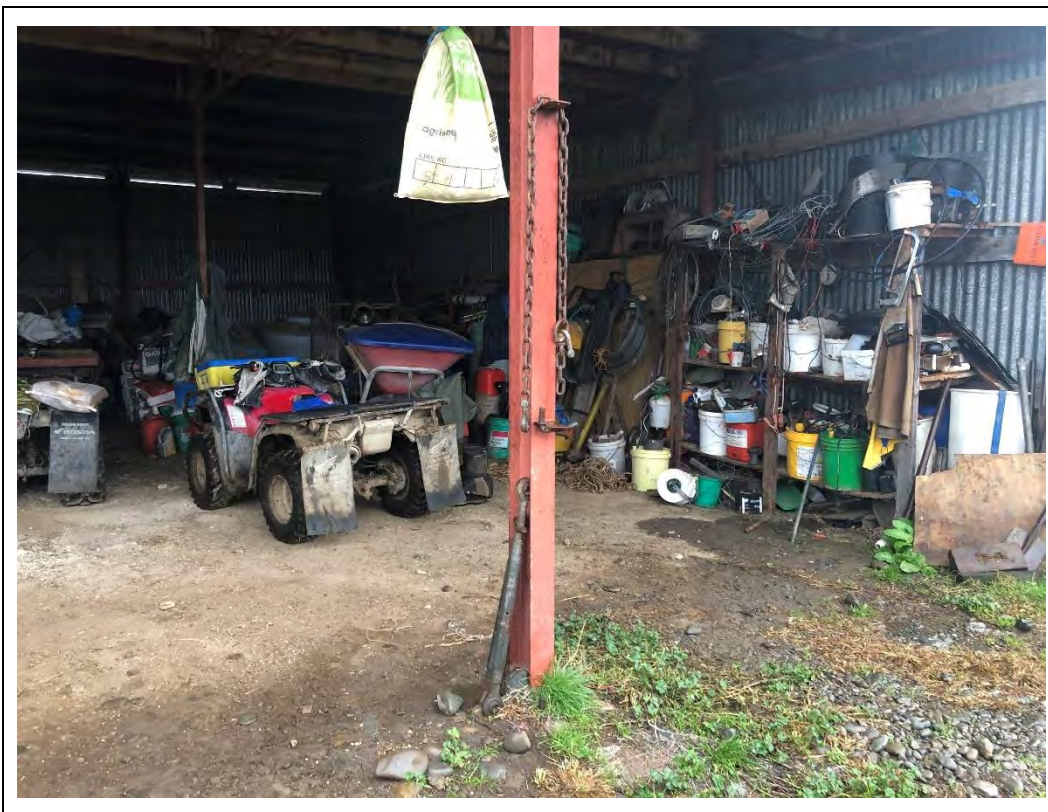
*Photograph 4 Appendix B.1: Within implement shed showing example of equipment and vehicle stored.*

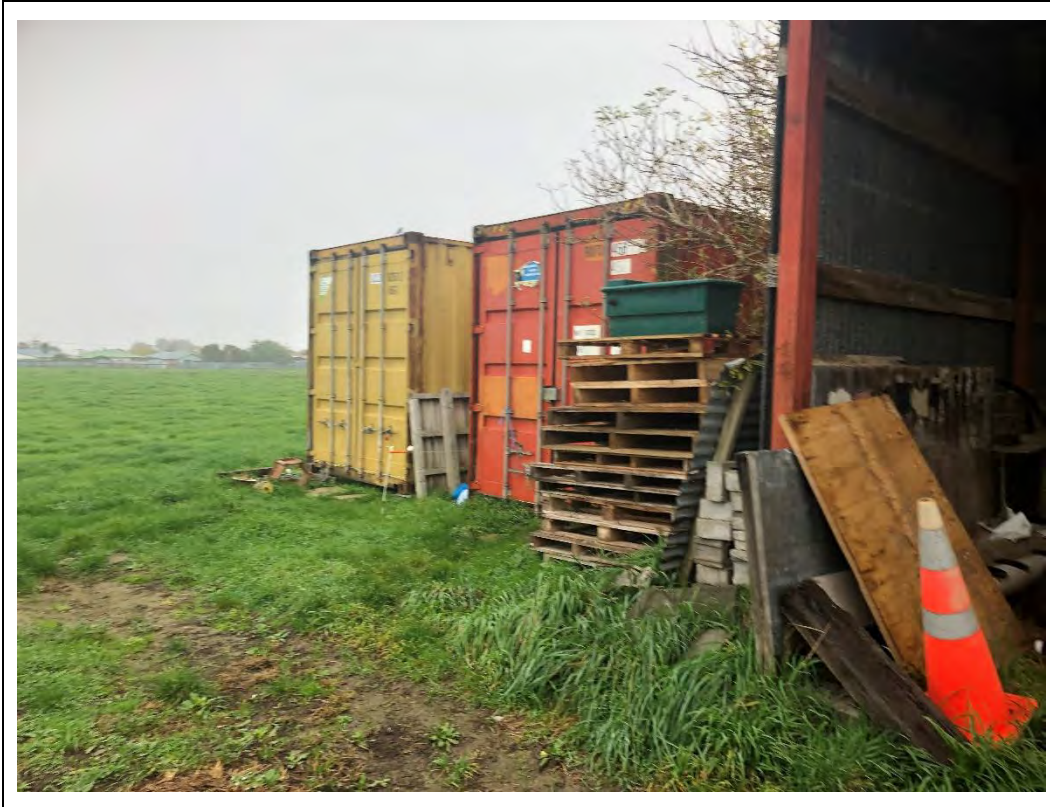
*Photograph 5 Appendix B.1: Shipping containers present to the south of the implement shed.*

- The implement shed contained farm equipment, machinery and vehicles including (but not limited to); motorbikes, animal feeders, empty drums and both electrical and fencing wire (see photograph 4). Two shipping containers were present to the south of the implement shed (see photograph 5);

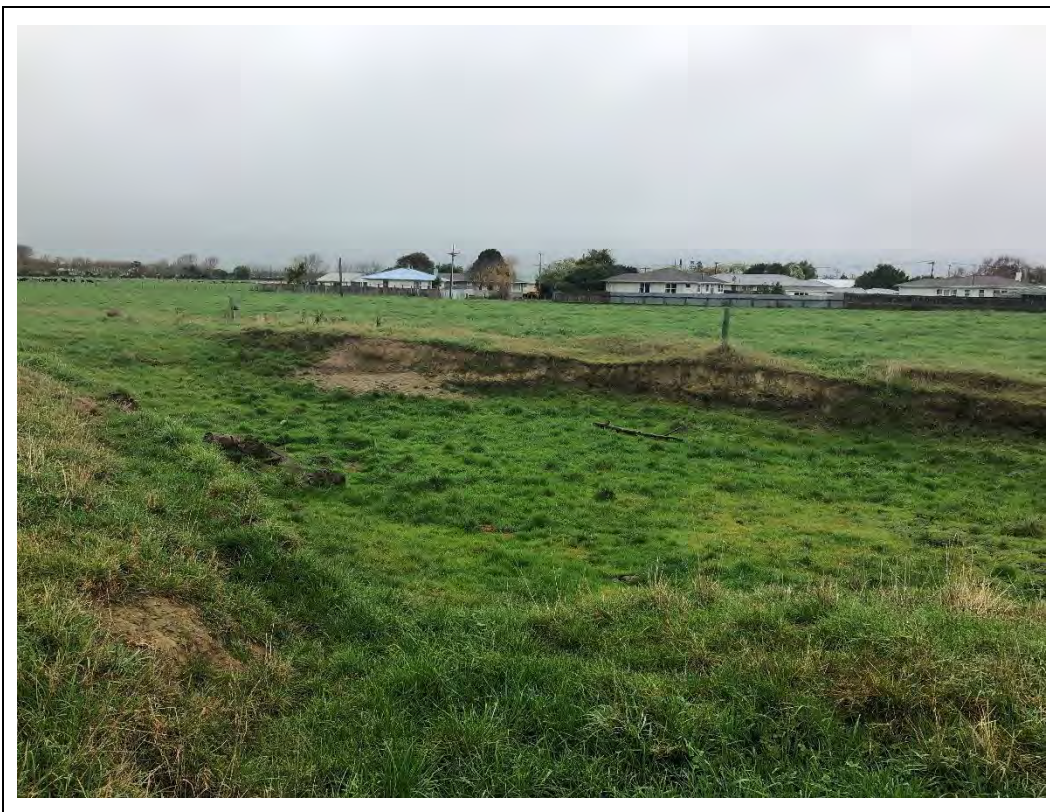
- The area previously used as a gravel quarry was observed and a 400 mm thick layer of rounded gravel and cobbles was present in the cut on the north-eastern side of the excavation. Concrete fenceposts, a piece of a concrete trough, fencing wire and a large metal bucket with pitting were observed within the excavated area (see photographs 6-8);

*Photograph 6 Appendix B.1: Former gravel quarry, looking north towards Peters and Tararua Avenue.*

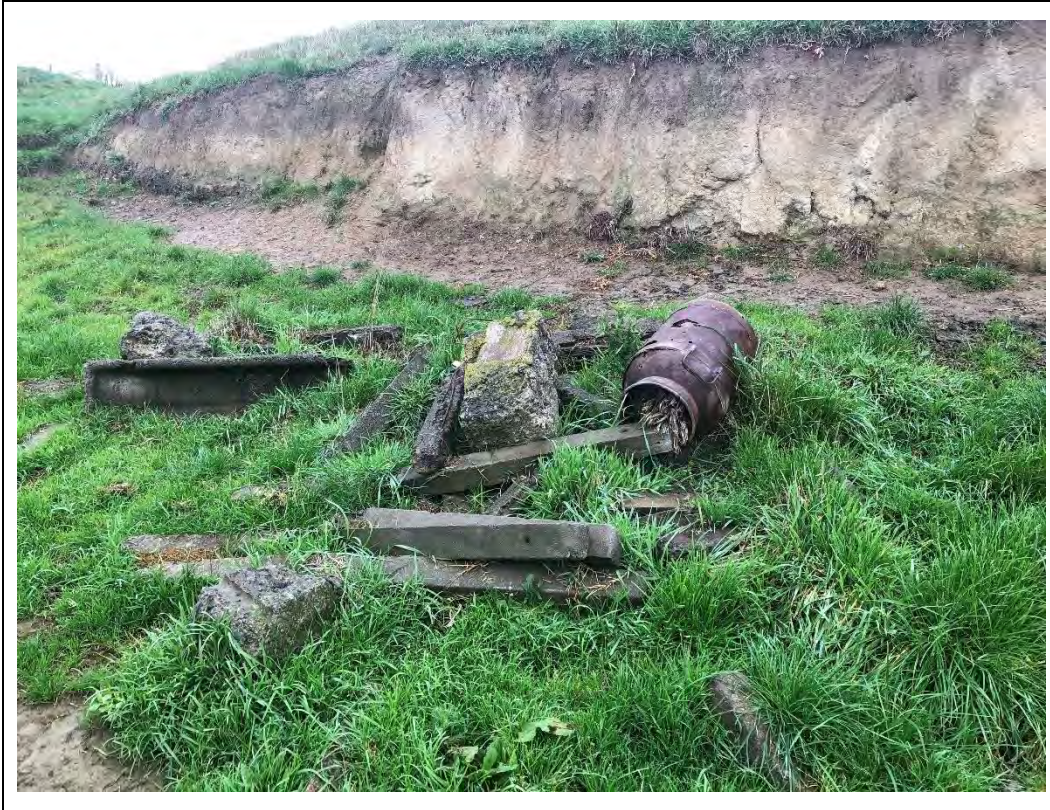
*Photograph 7 Appendix B.1: Concrete fence posts, a trough and a metal bucket within former quarry area.*

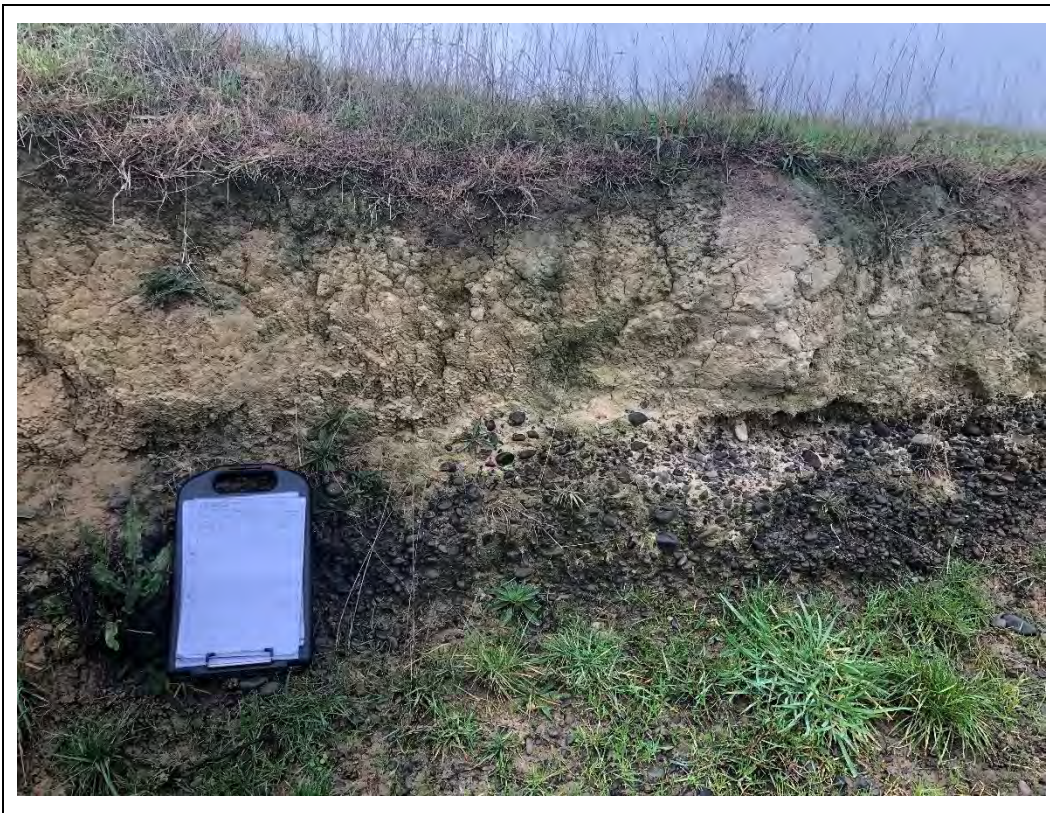
*Photograph 8 Appendix B.1: Layer of gravel observed in north eastern wall of former quarry.*

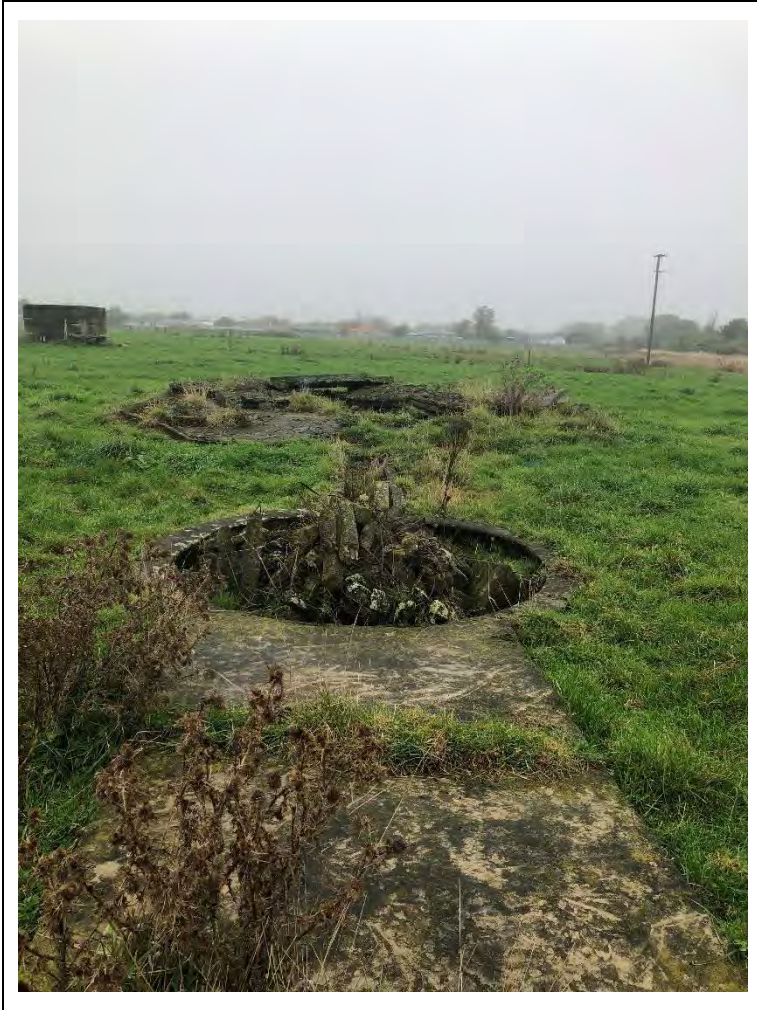
*Photograph 9 Appendix B.1: Remnants of former plunge sheep dip filled with concrete and fenceposts to prevent stock access, looking north east. Rectangular tank visible beyond the dip.*

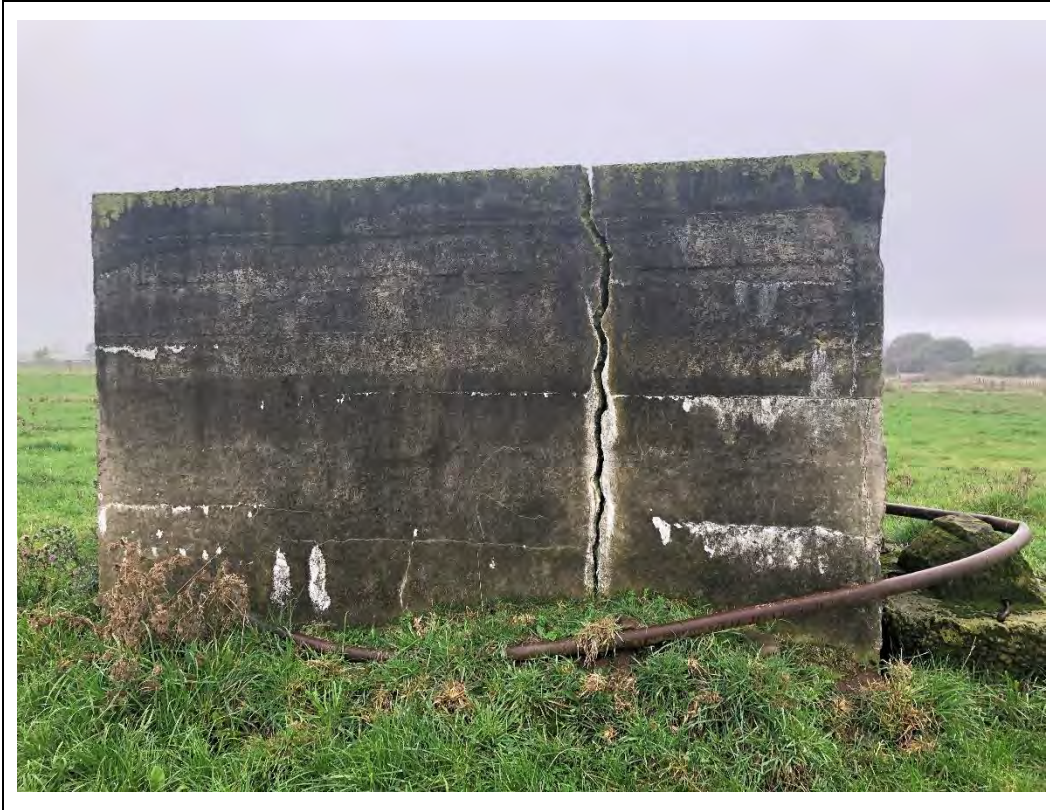
- A rectangular structure, resembling a tank, is present approximately 30 m north-east of the sheep dip. Large cracks were evident on all sides of the structure. Rusted pipework, a rusted chain, a glass bottle and metal sheets surround the tank (see photograph 10 and 11);

*Photograph 10 Appendix B.1: Rectangular tank, pipework and cracking evident in image.*

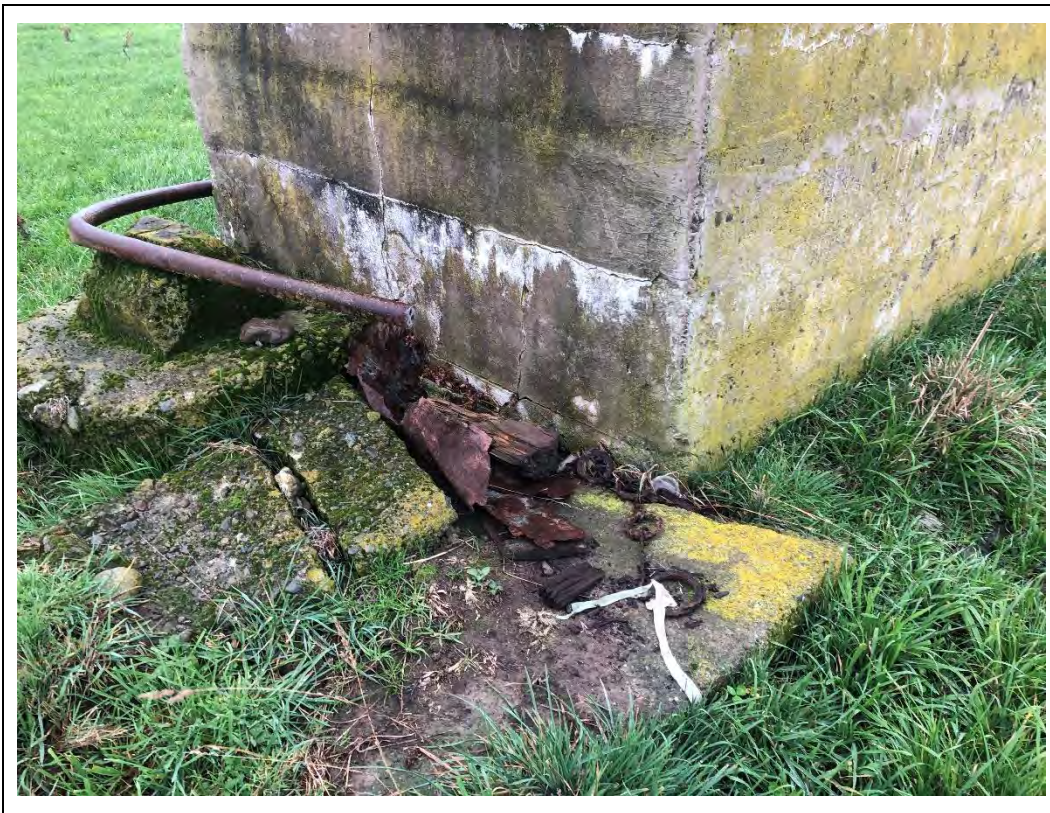
*Photograph 11 Appendix B.1: Metal and concrete fragments present at base of tank.*

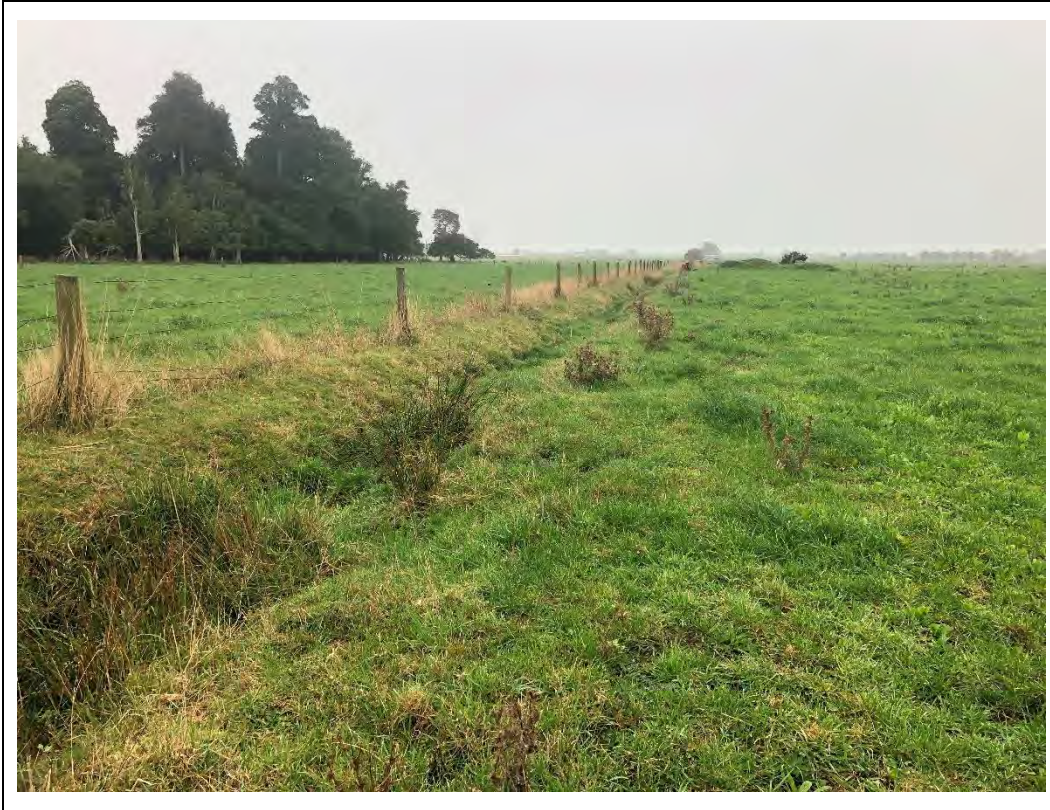
*Photograph 12 Appendix B.1: Open stormwater drain extending north, dense vegetation top left of image.*

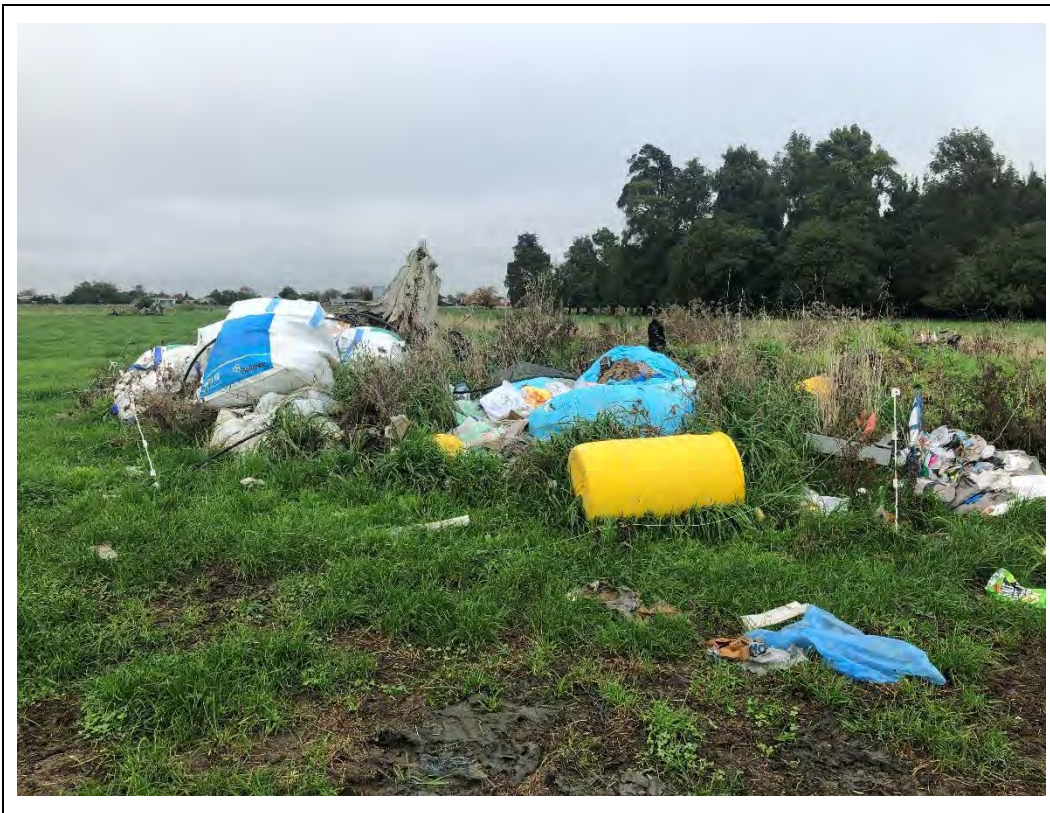
*Photograph 13 Appendix B.1: Large rubbish pile in centre of site.*

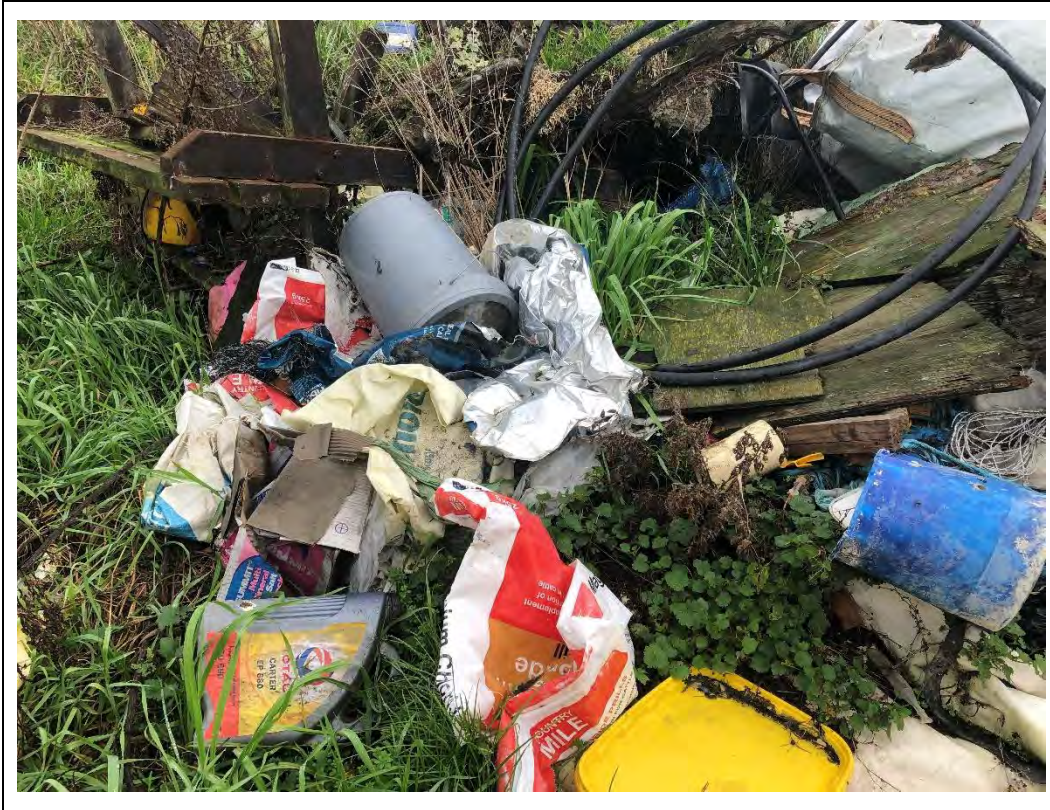
*Photograph 14 Appendix B.1: An example of disposed material in large rubbish pile.*

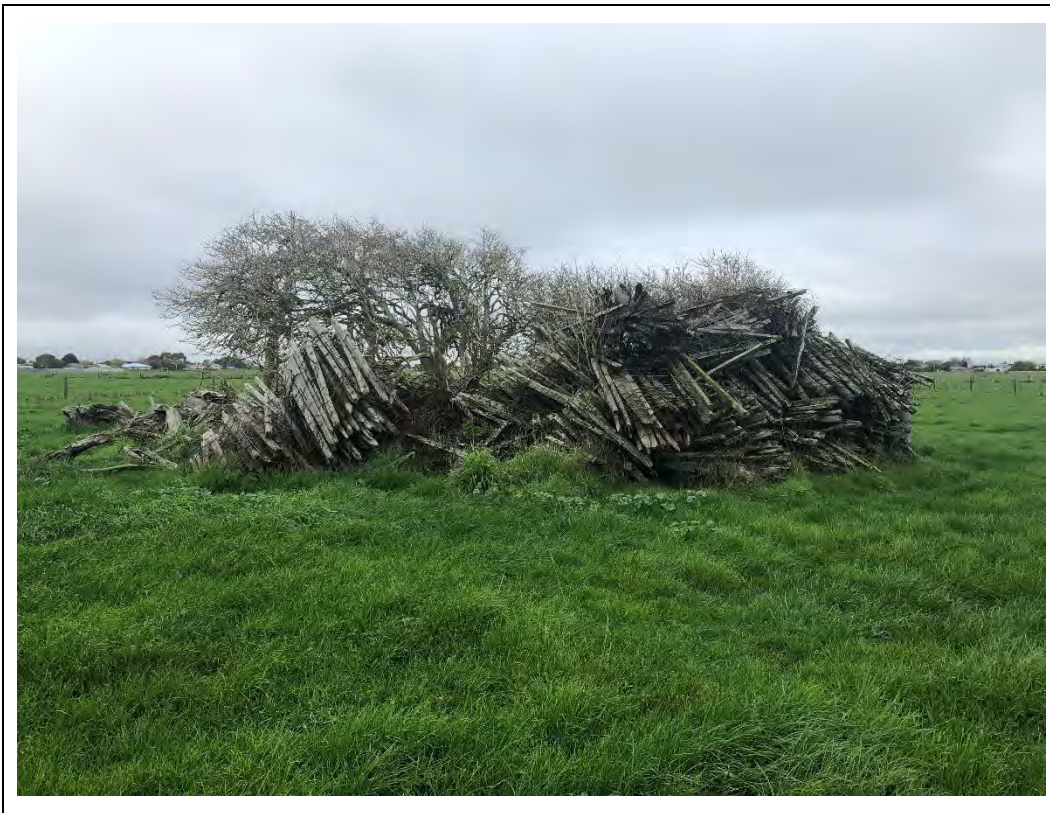
- A large pile of wire and timber from former fences and warped and rusted pieces of metal were observed to be discarded adjacent to and beneath a tree within a paddock on the northern portion of the site (see photographs 15 and 16);

*Photograph 15 Appendix B.1: Fenceposts and wire discarded by trees on northern portion of property.*

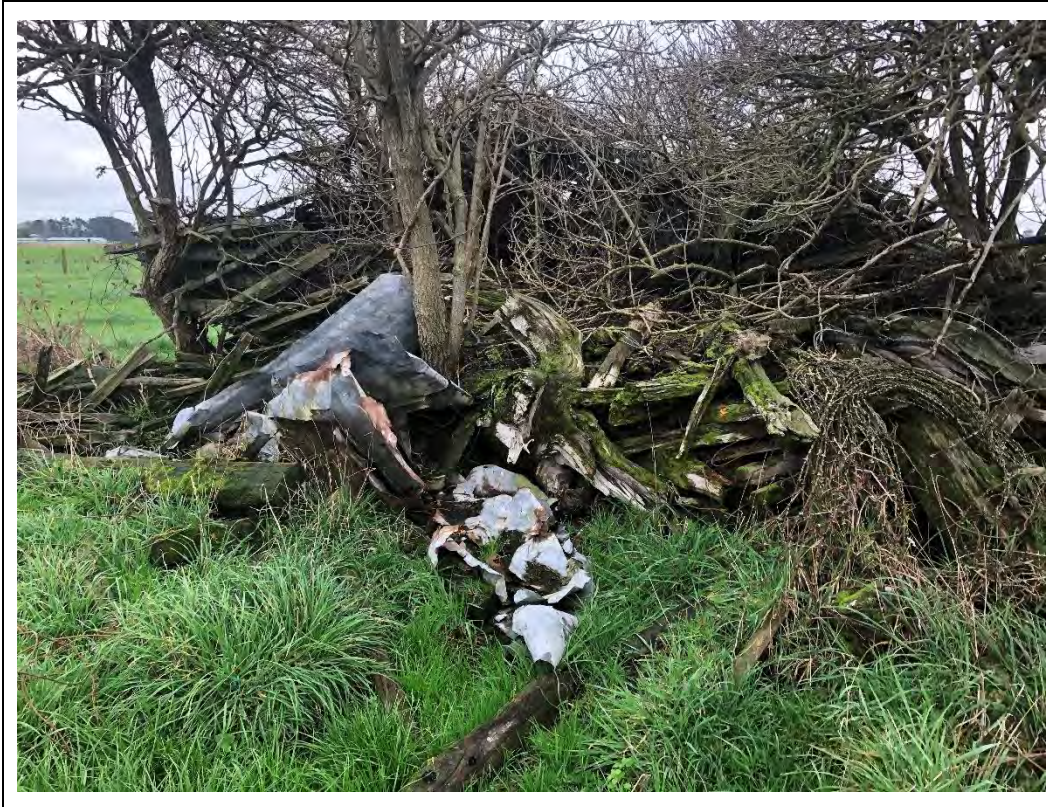
*Photograph 16 Appendix B.1: Large pieces of metal discarded by trees with fence posts and wire.*

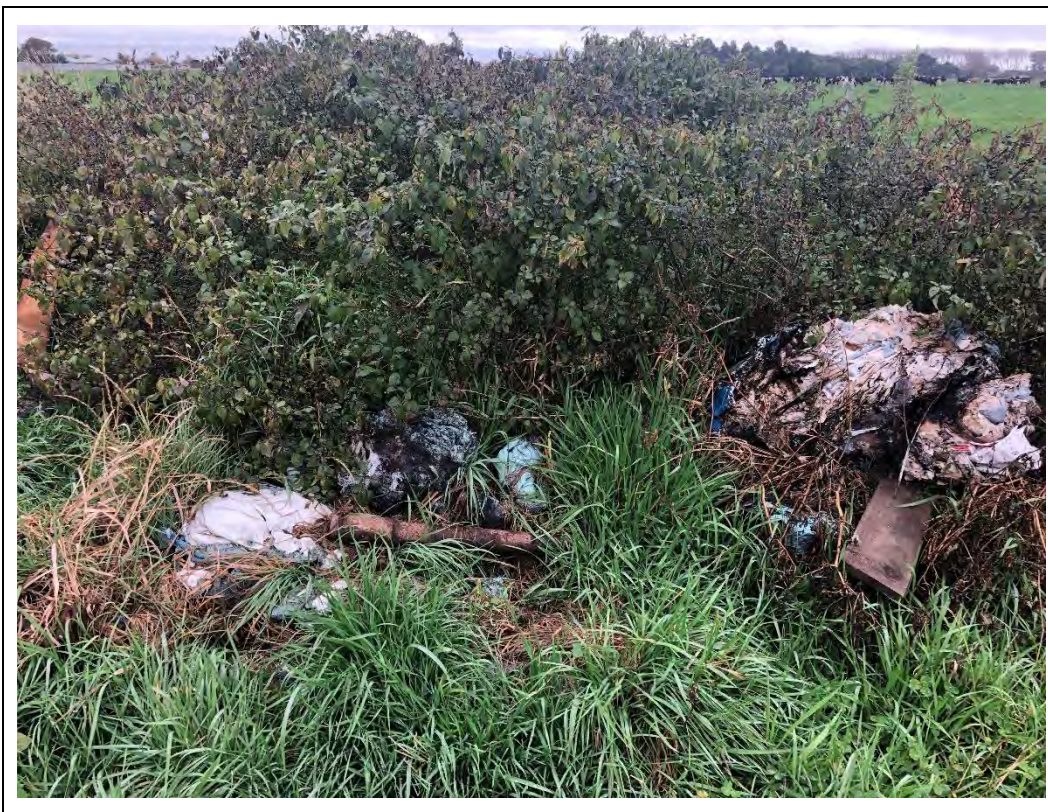
- A pile of partially burnt waste material is present to the rear of the hay shed. The pile contained plastic bale wrap, paper, metal items, timber, and wire. Burning of the pile does not appear to have occurred recently as it has mostly been covered by pest plants (see photograph 17);

*Photograph 17 Appendix B.1: Partially burnt waste material present to the rear of the hayshed.*
