+ Preliminary Site Investigation

Kākātangiata Structure Plan and District Plan Change

Prepared for  
Palmerston North City Council

Prepared by  
Tonkin & Taylor Ltd

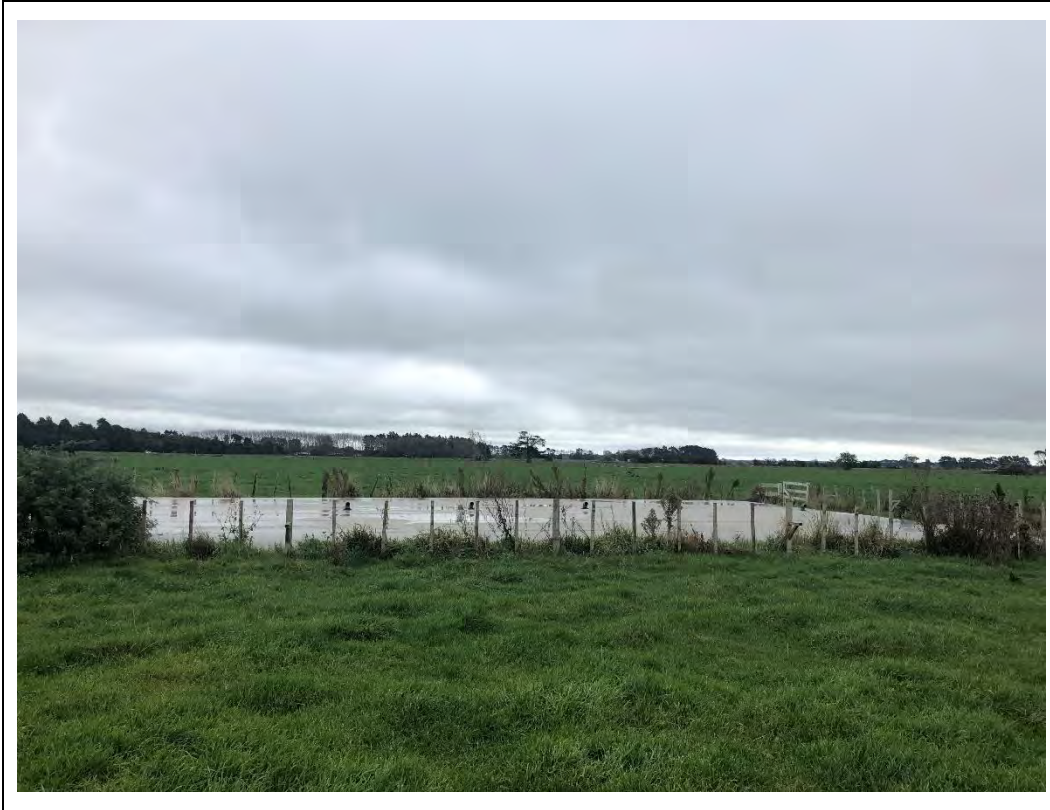
*Photograph 18 Appendix B.1: Effluent pond with cover north west of the milking shed.*

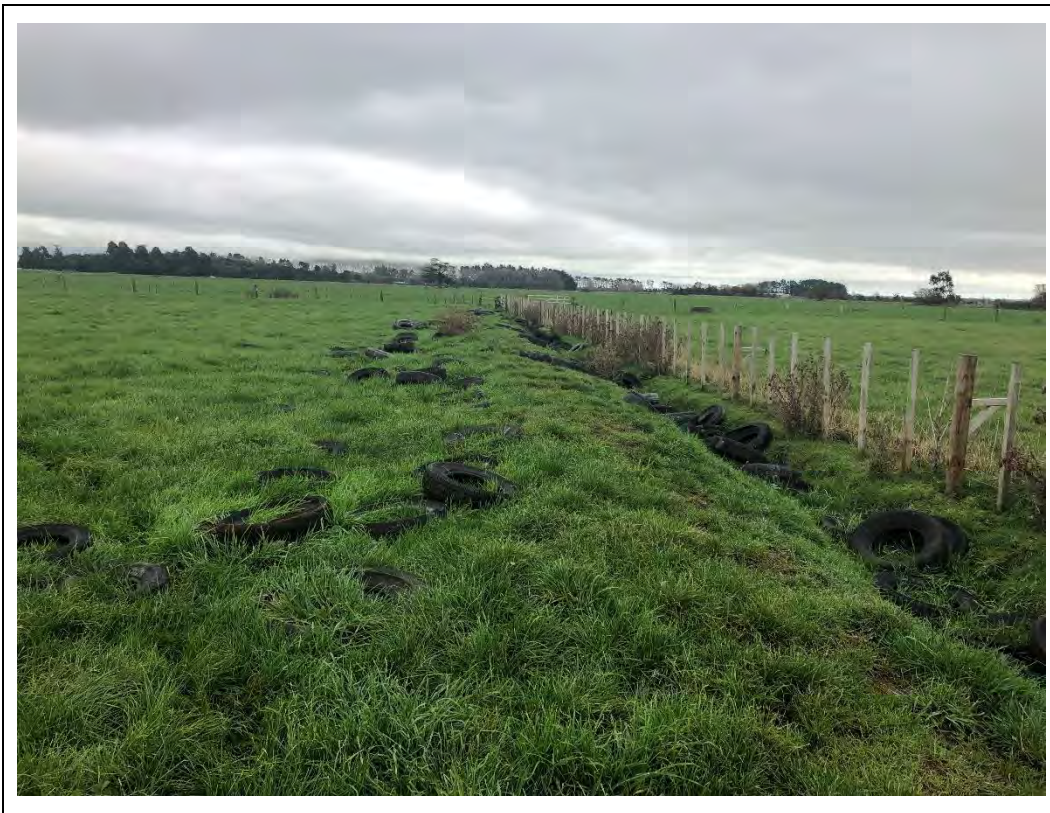
*Photograph 19 Appendix B.1: Tyres in and around drainage channel in a northern paddock.*

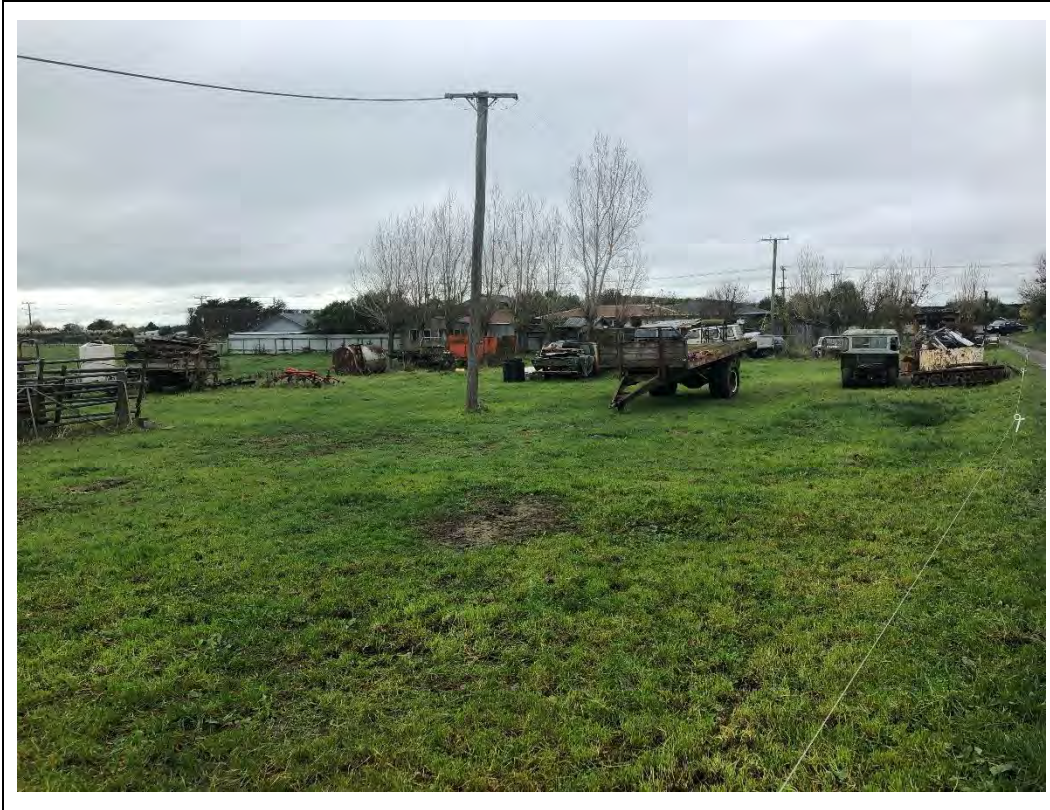
- Disused vehicles and equipment including an above-ground storage tank (AST) and vehicles were stored in the area to the north-east of the driveway. A small shed constructed of corrugated iron was also observed in this area (see photograph 20);

*Photograph 20 Appendix B.1: Disused vehicles, farming implements and an above ground storage tank stored in paddock north of accessway.*

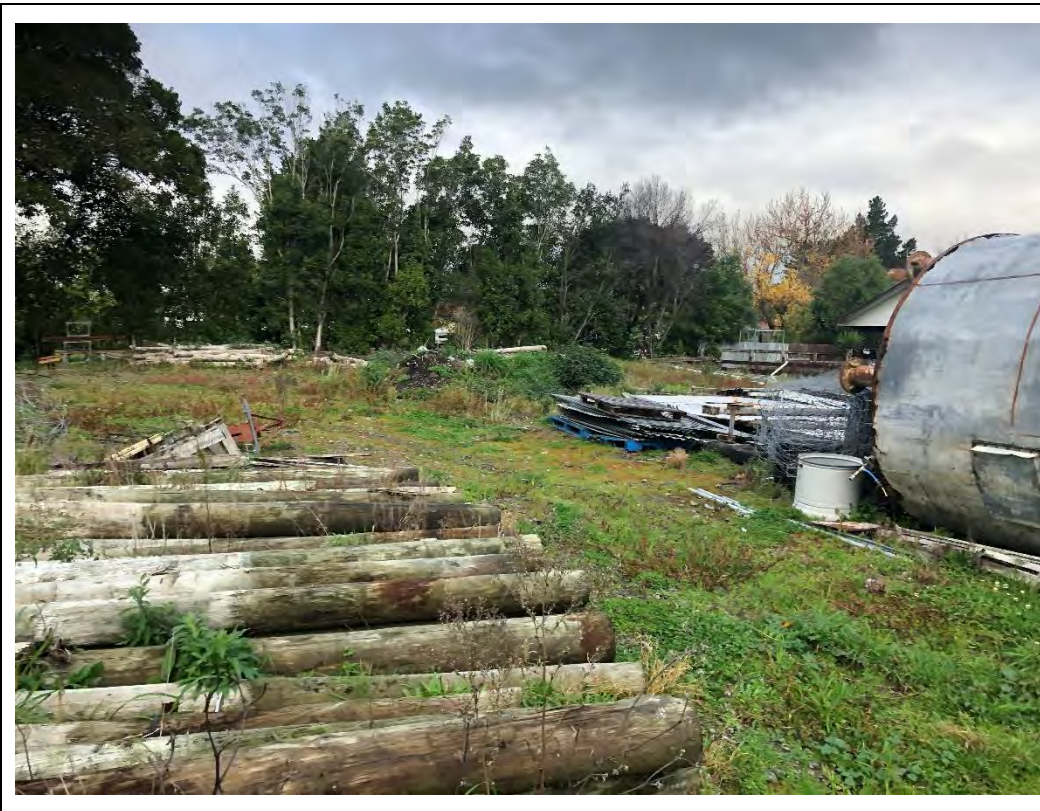
*Photograph 21 Appendix B.1: Equipment stored in area of former tunnel house including silo.*

- A plastic tunnel house was previously on the property to the rear of the house. The area is now used for the storage of equipment, including wooden poles, plastic, metal, wire, a tractor and a large tank (possibly a silo). A pile of soil and green waste was present in the centre of this area (see photographs 21 and 22);

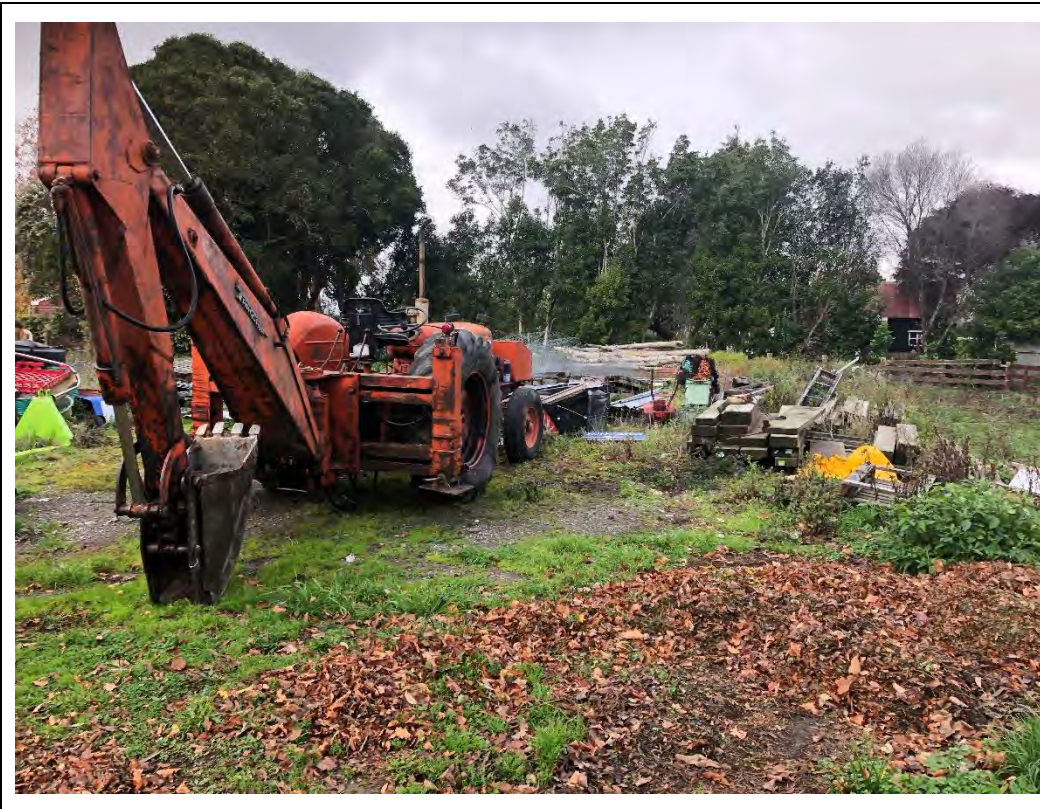
*Photograph 22 Appendix B.1: Equipment stored in area of former tunnel house.*

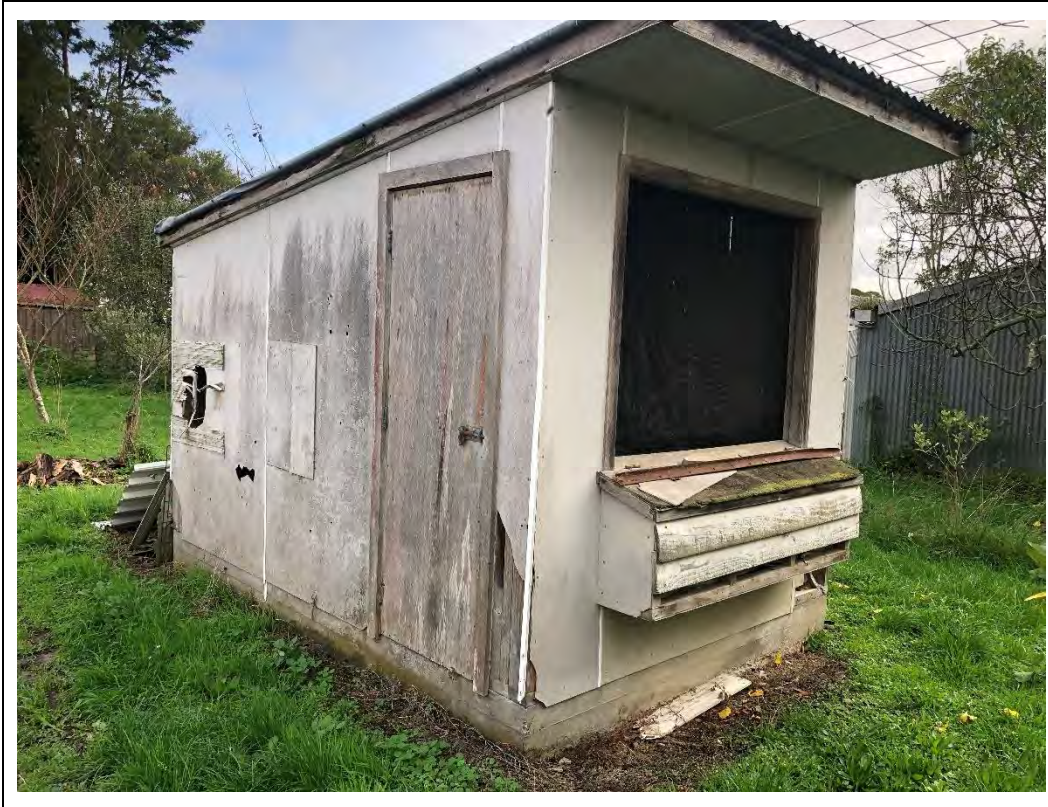
*Photograph 23 Appendix B.1: Small shed constructed of fibreboard to the north of the house.*

- A small shed is present to the north of the house. The shed is constructed of fibreboard cladding and soffits which could potentially contain asbestos. Broken areas and holes were observed in the cladding panels and large fragments were present on the ground surrounding the building. A large fragment was seen on the top of a box attached beneath the window (see photographs 23 and 24);

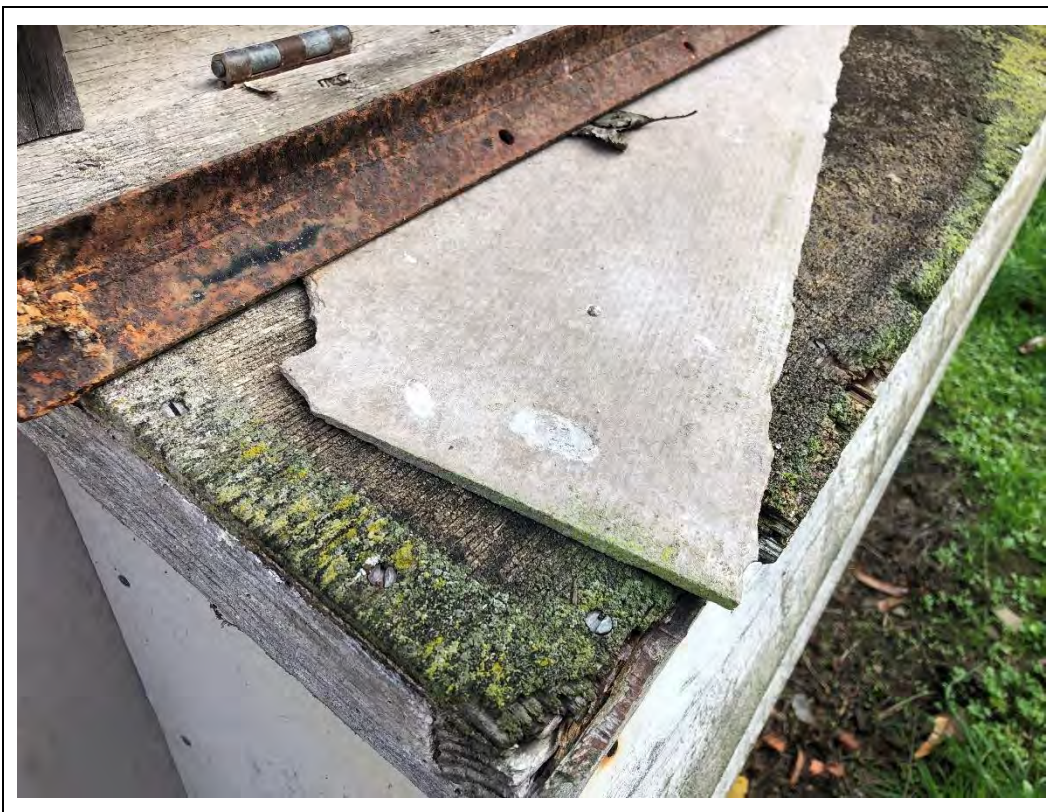
*Photograph 24 Appendix B.1: Fragment of fibreboard on the top of a box attached to the shed.*

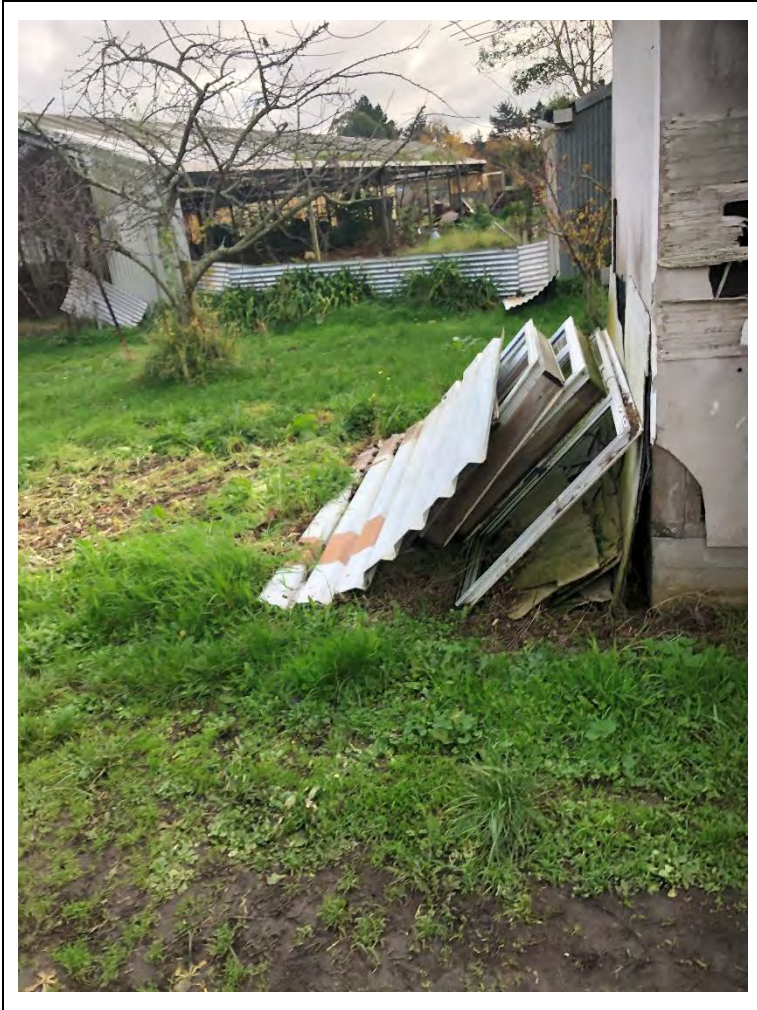
*Photograph 25 Appendix B.1: Building material stored to the rear of the small shed.*

- Building materials, including windows, metal sheeting and pieces of fibre cement cladding sheets were seen to be stored against the west of the shed (see photograph 25); and

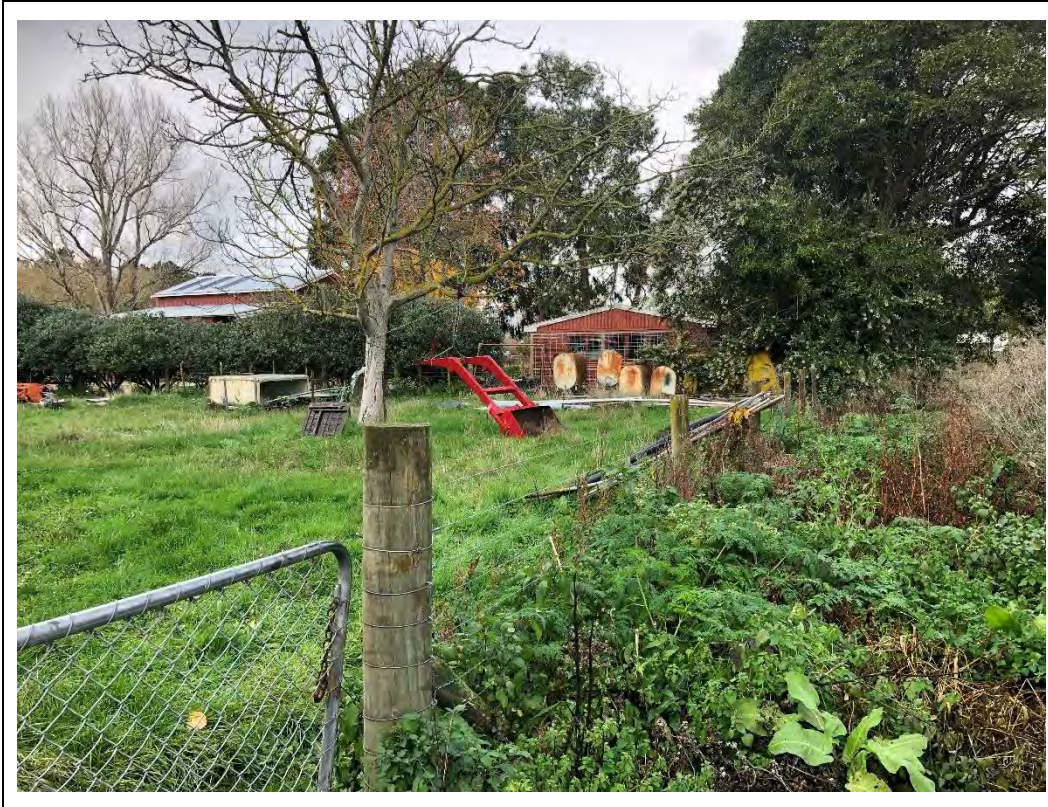
*Photograph 26 Appendix B.1: Disused aboveground storage tanks on south eastern boundary of property.*

- Four aboveground storage tanks containing diesel that were used for heating of the glasshouses on 44 Cloverlea Road, were observed along the south-east boundary, in the paddock beyond the area previously containing the tunnel house. The area also contained other pieces of equipment that appeared to be disused (see photograph 26).

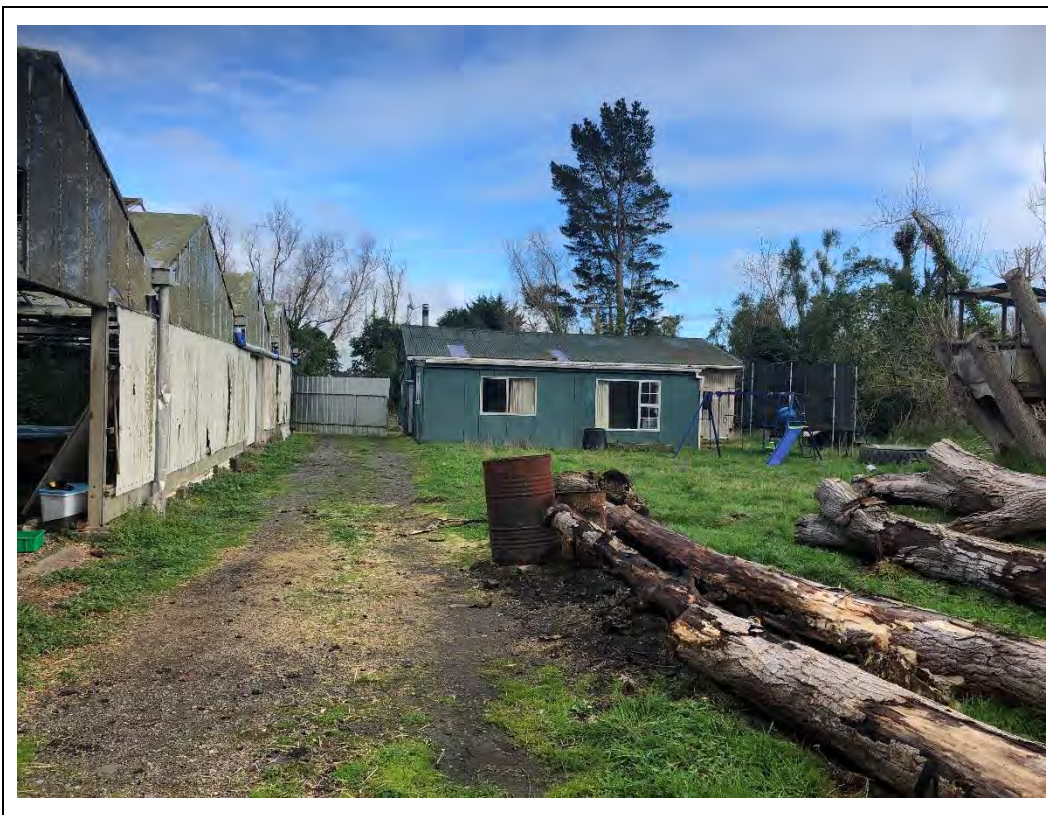
- Metal drums where burning appears to have been undertaken was seen behind the office building in line with the glasshouse (see photograph 27);
  - A large glasshouse was present, constructed of corrugated metal sheeting, corrugated plastic sheeting and a concrete foundation. The plastic sheets ('clearlite') on the roof of the building are in a deteriorating condition and a number of sheets are broken and appear to be collapsing into the building. The building is currently used for storage of equipment (see photograph 28);

*Photograph 27 Appendix B.1: Rear of office/retail building showing board and batten style cladding.*

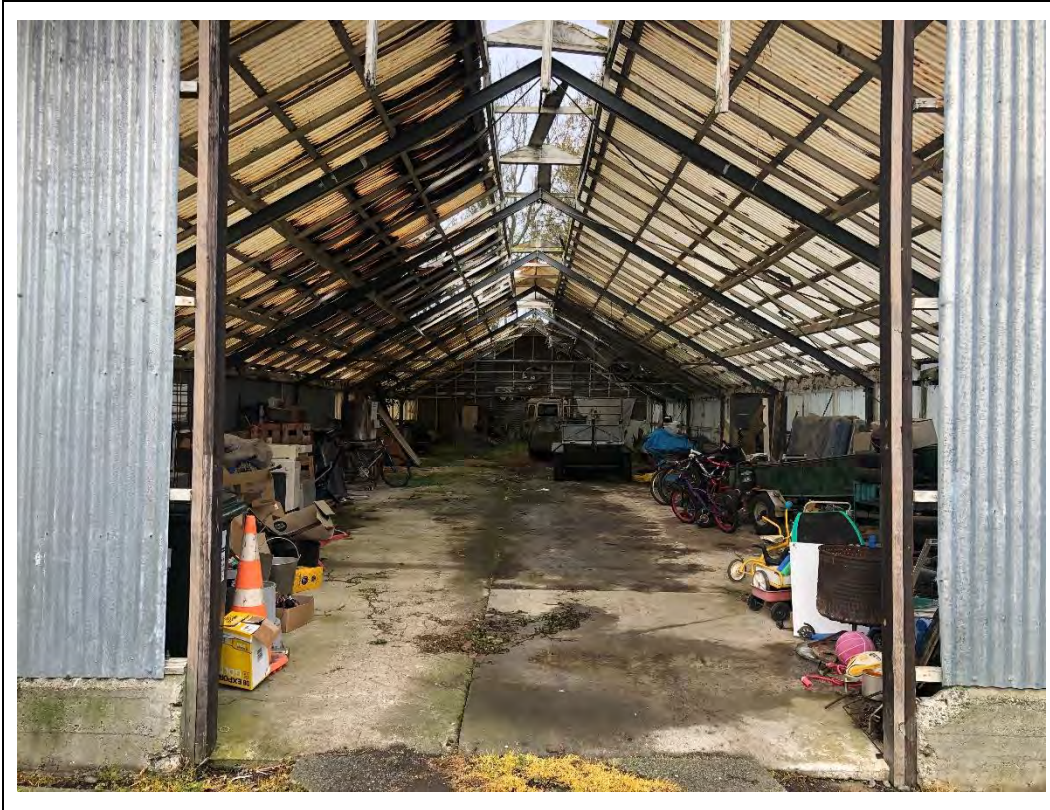
*Photograph 28 Appendix B.1: Large glasshouse with concrete foundation now used for storage.*

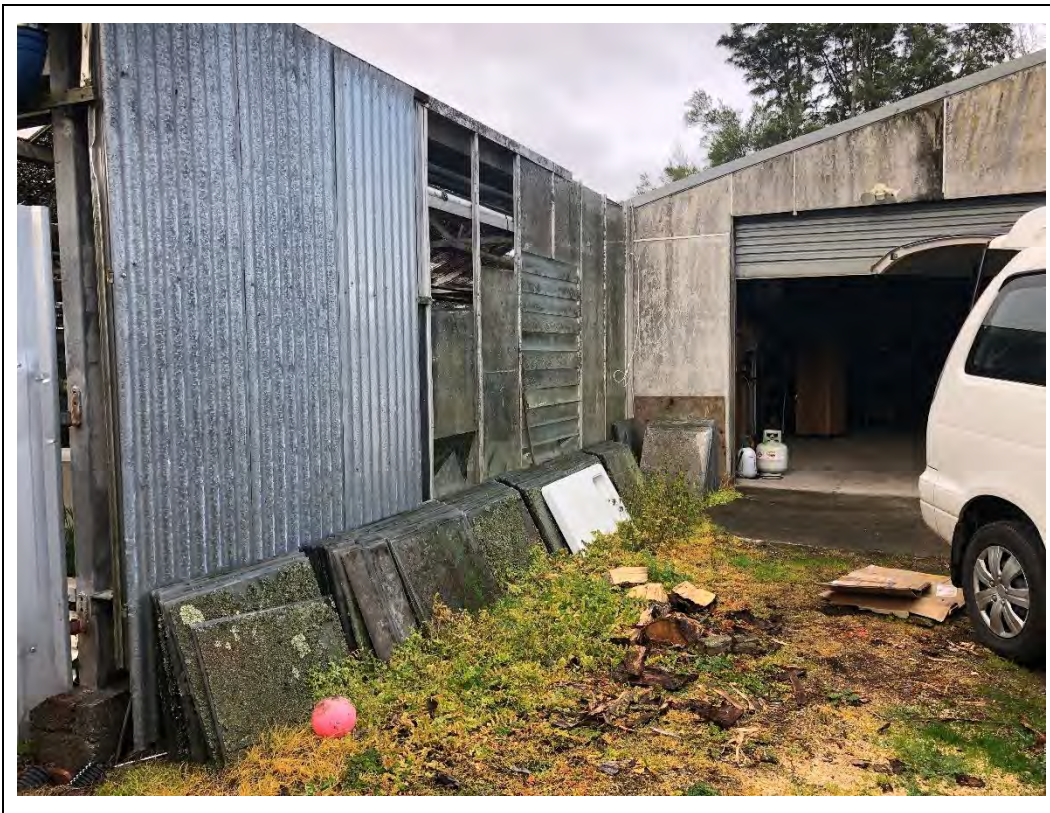
- A store building adjoins the southern wall of the large glasshouse above. Fibre cement cladding, potentially containing asbestos, was observed on the north-facing external wall. The cladding was unpainted and weathered, and cracking and chipping were also evident on the panels. The building is used for storage and contains appliances including fridges and freezers (see photographs 29 and 30);

*Photograph 29 Appendix B.1: Store building adjoining the southern wall of the large glasshouse.*

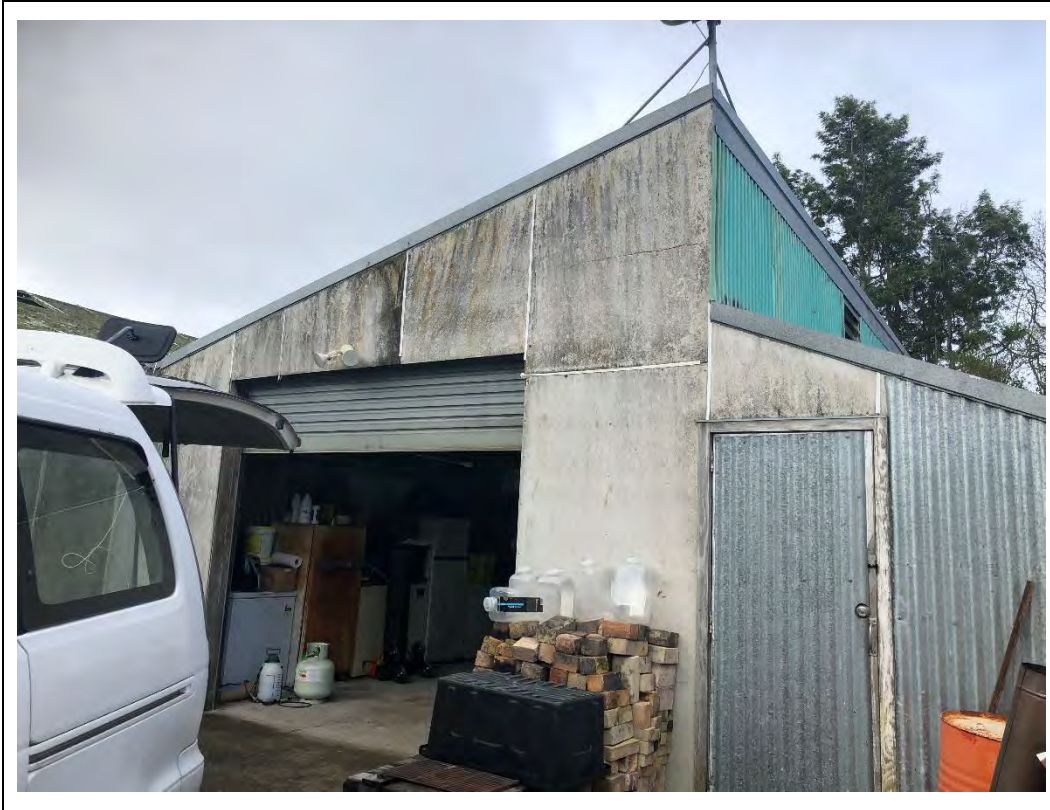
*Photograph 30 Appendix B.1: Exposed fibreboard cladding on north-facing external wall of store building.*

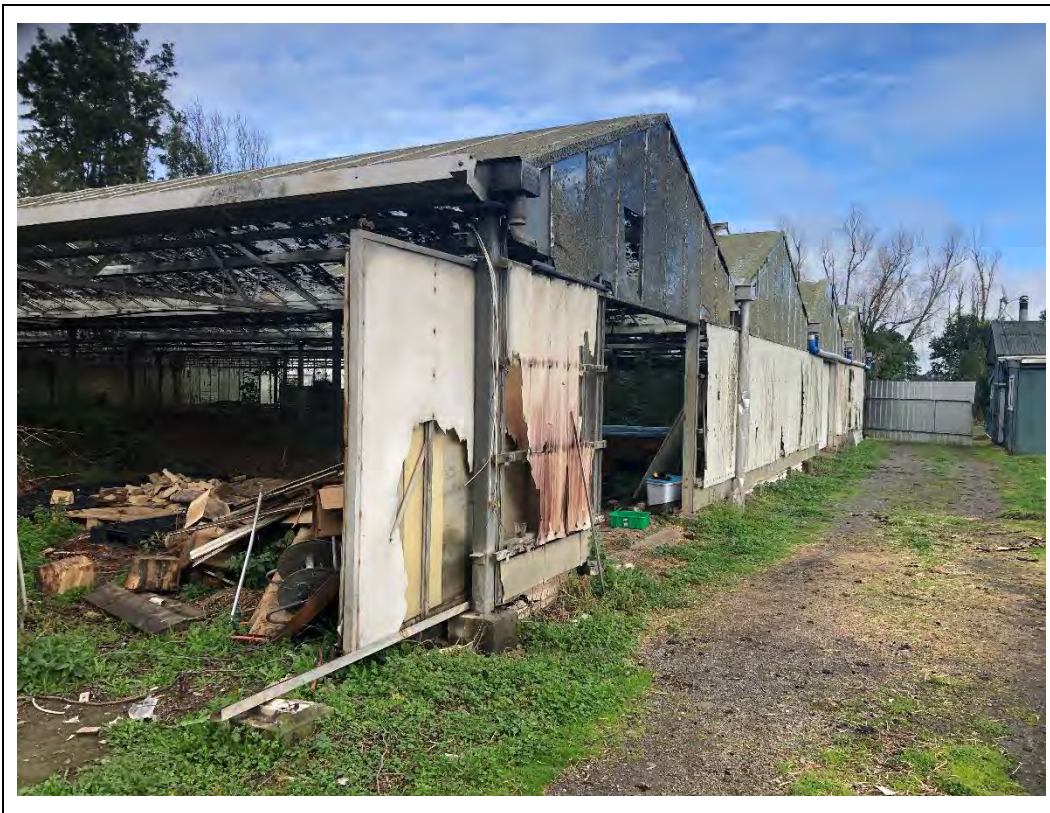
- Large, commercial-scale, glasshouses are present to the rear of the store building, the glasshouses were reportedly constructed in the mid to late 1980s. The glasshouses are constructed of steel framing, corrugated plastic sheeting and glass panels. The glasshouses are in a disused and deteriorating condition, and one of the sections of the glasshouse has been removed (see photograph 31); and

*Photograph 31 Appendix B.1: Southern portion of disused and deteriorating commercial glasshouses.*

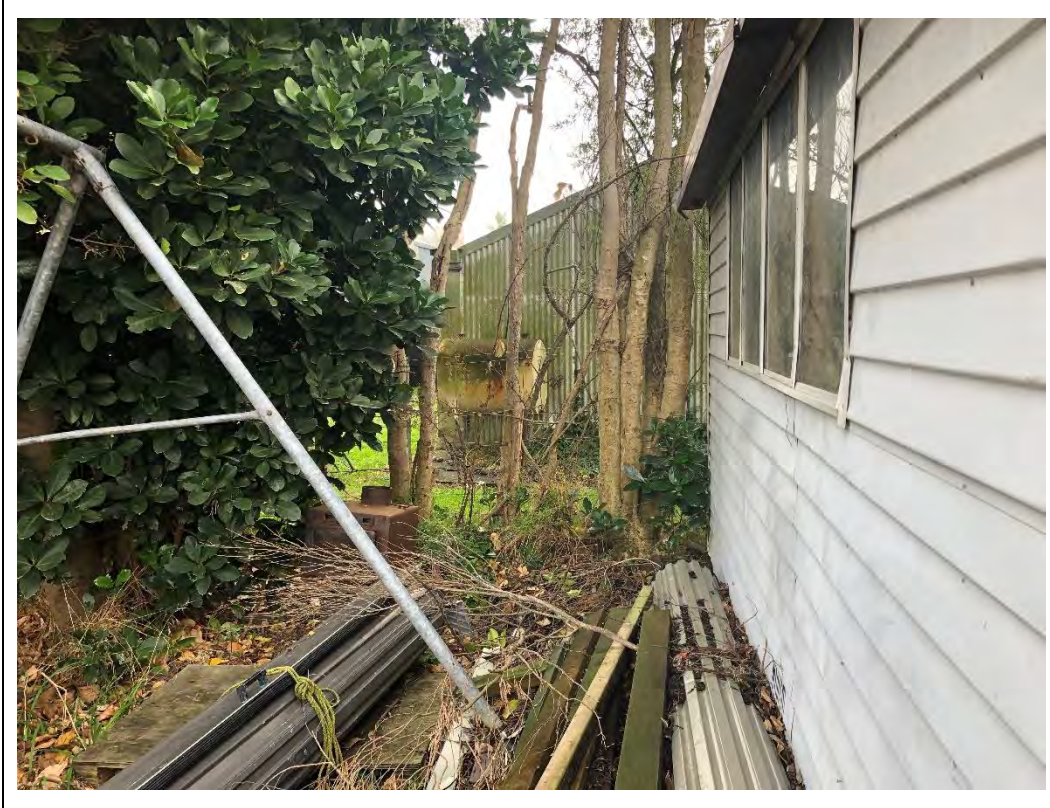
*Photograph 32 Appendix B.1: Above ground storage tank adjacent to the the rear of the southern-most glass house, as seen from 40 Cloverlea Road.*

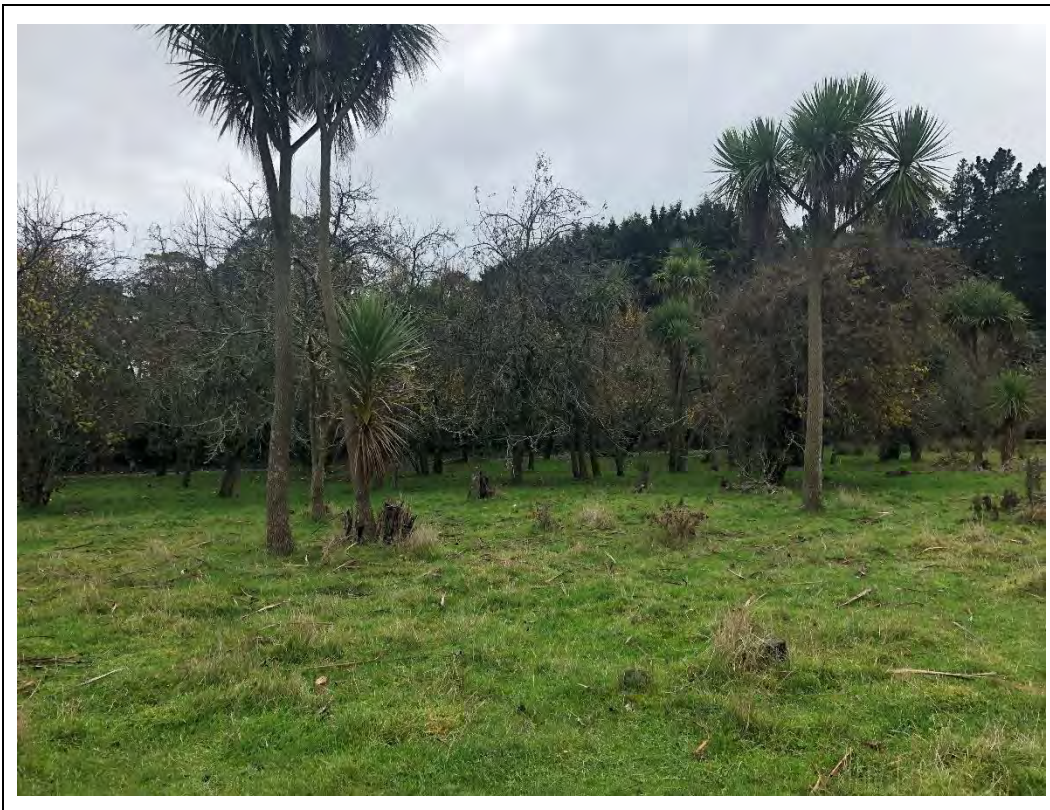
*Photograph 33 Appendix B.1: Remaining fruit trees from former orchard at 58 Cloverlea Road.*

- This property was previously a portion of the former apple orchard that once comprised a number of properties in north-east area off Cloverlea Road. The majority of the fruit trees, except for remaining rows on the northern portion of the property, have been cleared from the property (see photograph 33); and
- Various sheds (including what appears to be a refrigerated building), shipping containers, a bus, intermediate bulk containers, wooden bins containing wire, plastic and metal drums and water tanks were seen on the southern portion of the property (see photograph 34 and 35).

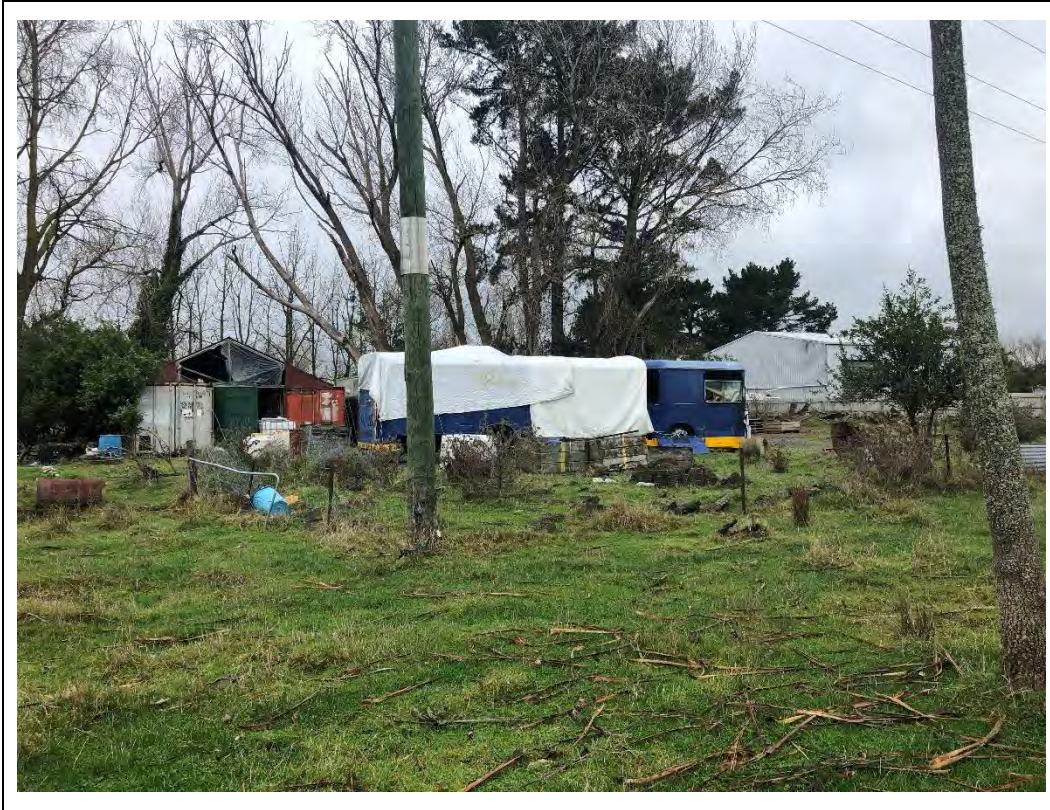
*Photograph 34 Appendix B.1: Example of equipment observed on southern portion of the property.*

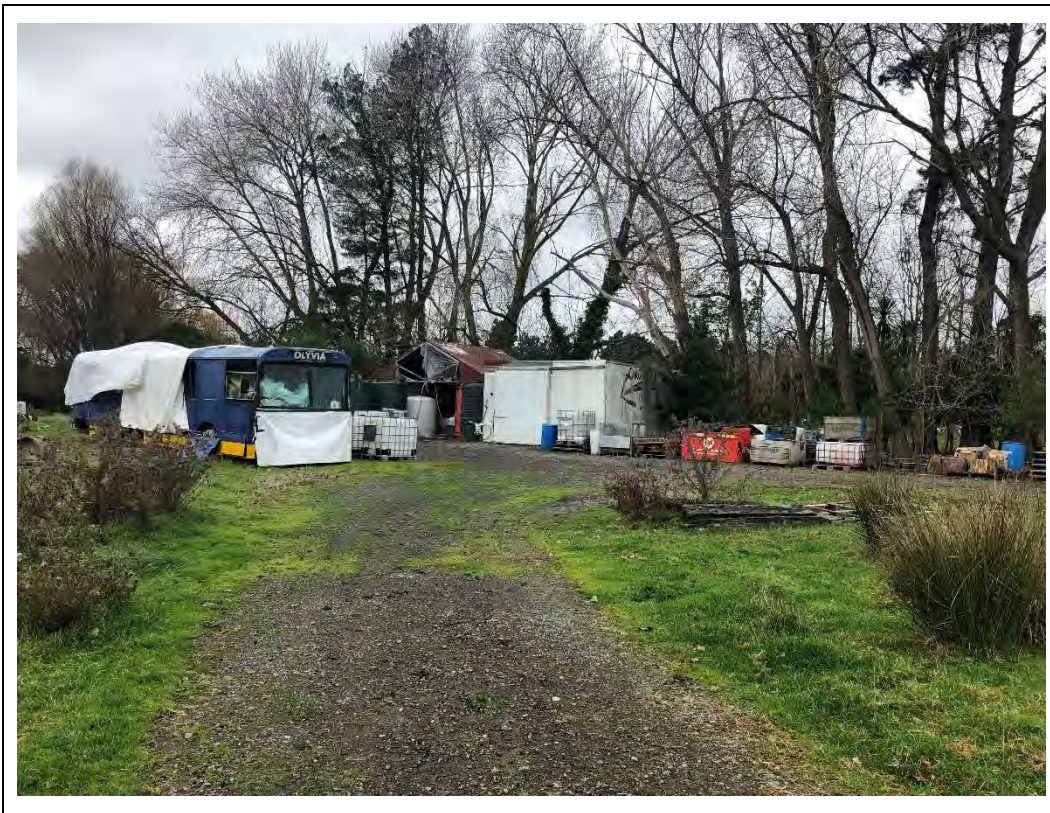
*Photograph 35 Appendix B.1: Refrigerated building and sheds seen on southern portion of property.*

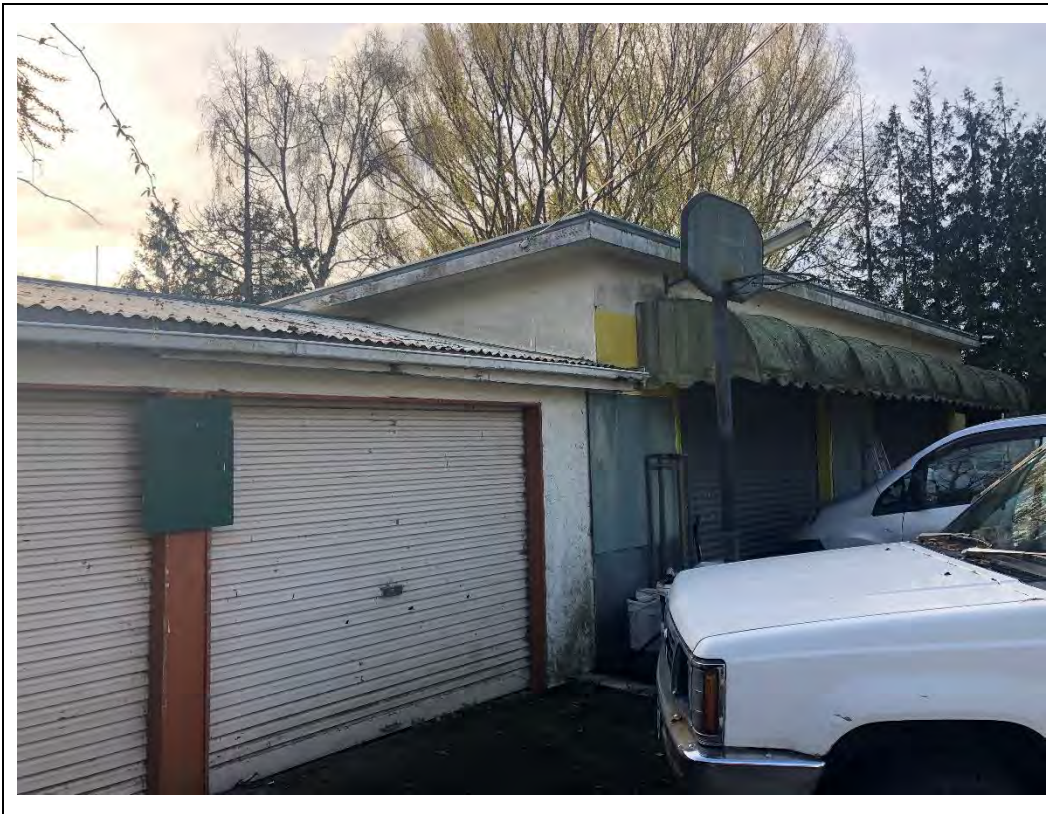
- Fibre board and stucco paint were observed on the southern external walls of the former packing shed and attached garage. Fibreboard was also observed on the soffits of the packing building (see photograph 36);

*Photograph 36 Appendix B.1: Front of store/packing building constructed of fibreboard and stucco paint.*

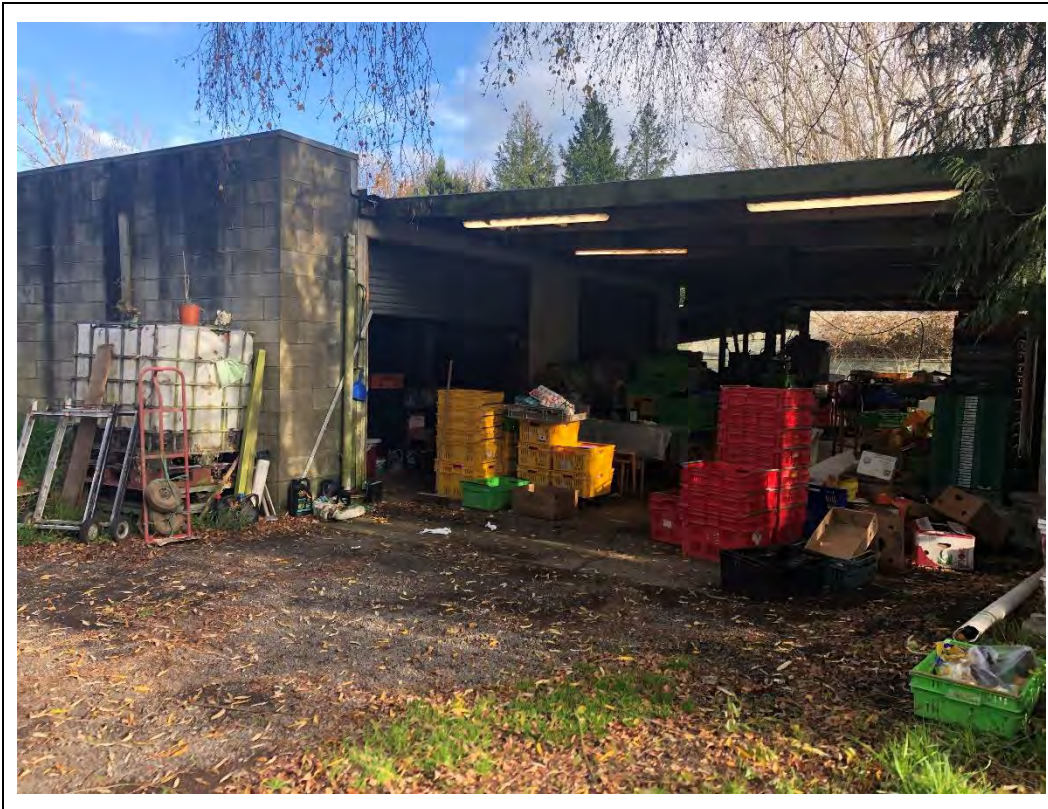
- Equipment and other items, including a number of retail containers of oil (small volumes) were observed adjacent to and within the northern portion of the store building (see photograph 37);

*Photograph 37 Appendix B.1: Rear of store/packing building containing items including containers of oil.*

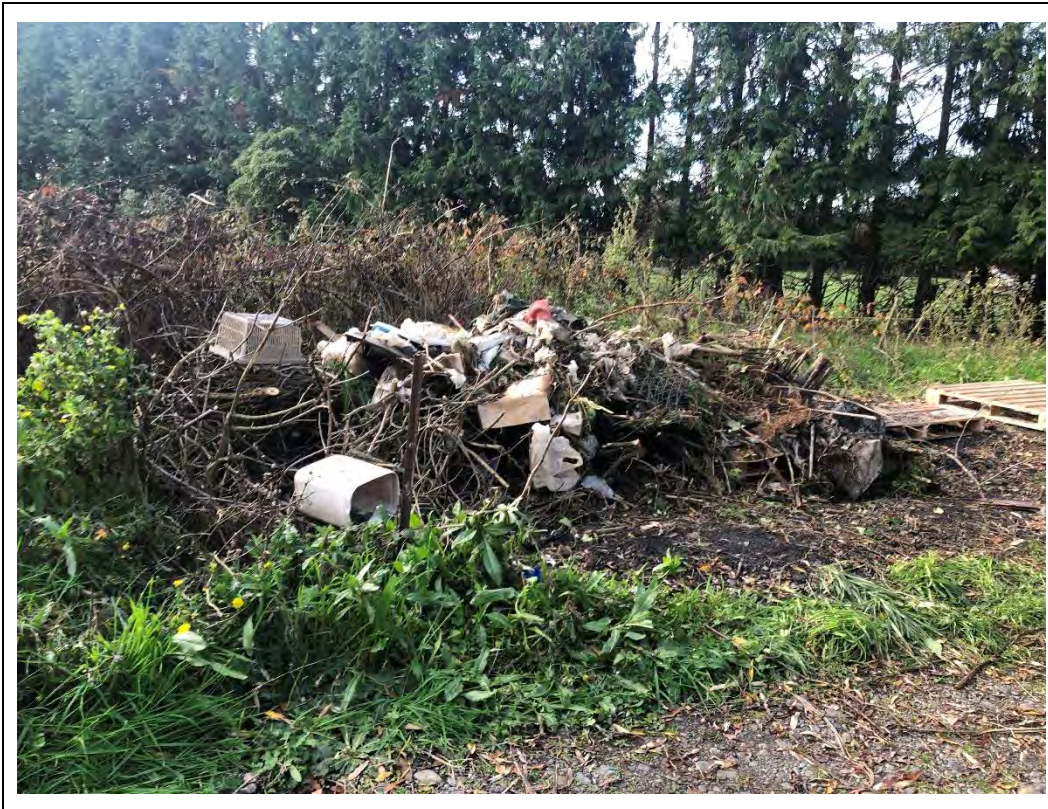
- Produce is no longer grown on site. The property owner explained that instead they purchase produce from offsite growers and on sell it;
- A pile of rubbish including wire, cardboard, green waste, wooden pallets, and plastic was observed across the driveway from the storage building. Areas of the rubbish pile appears to have been burnt (see photograph 38);

*Photograph 38 Appendix B.1: Rubbish pile across the driveway from the northern portion of the store building.*

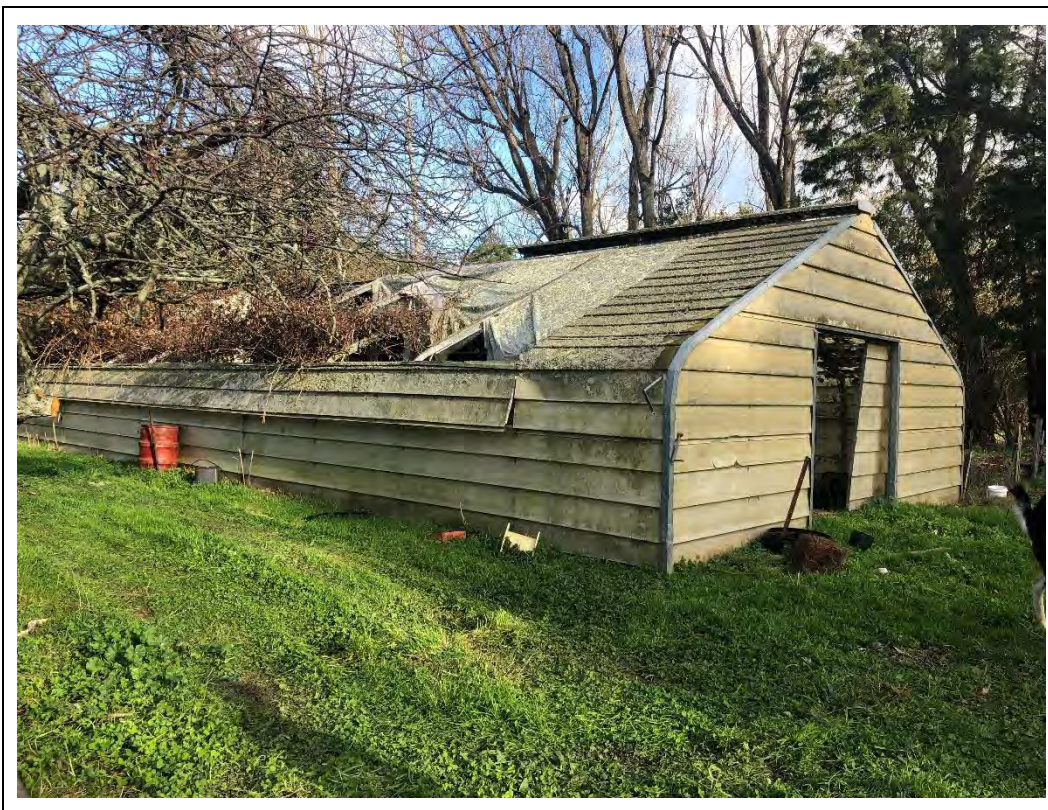
- Water tanks and a refrigerated shipping container were observed near to the storage building;
- A disused tunnel house constructed of fibreglass and metal framing was observed to be in a deteriorating condition. A portion of the roof has been replaced with plastic sheeting which, in areas, has collapsed into the structure under the weight of falling branches and debris from trees above. The tunnel house has no flooring, and the ground surface consists of grass and bare soil. Plastic wrap and disused items including fruit crates and a plastic drum were observed within and adjacent to the structure (see photograph 39);

*Photograph 39 Appendix B.1: Disused tunnel house to the west of the store building.*

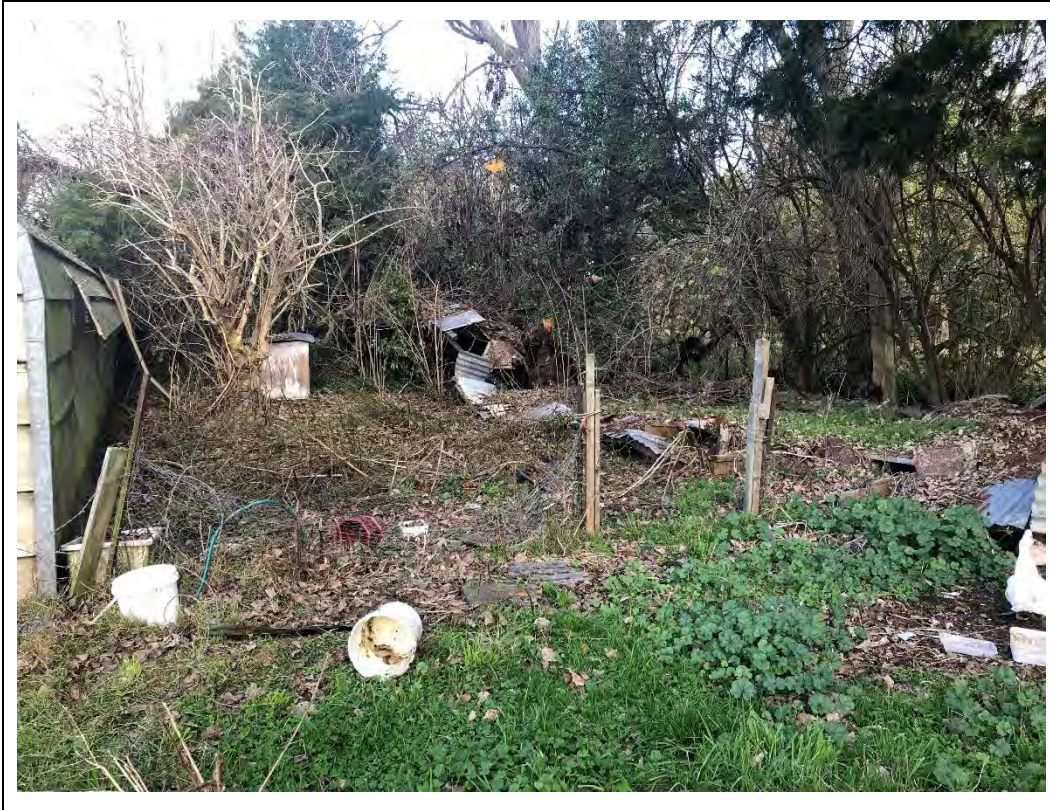
*Photograph 40 Appendix B.1: Area to the west of tunnel house with deteriorating structures.*

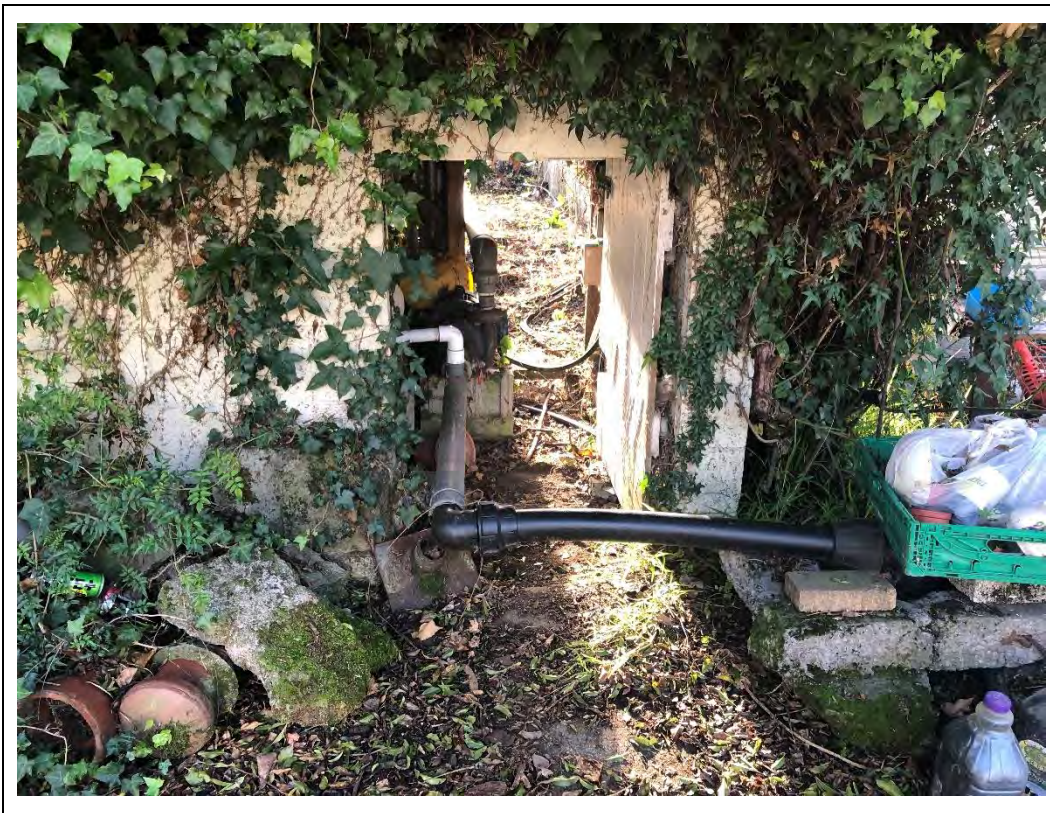
- Irrigation has been removed from the former growing areas and the associated pipework is stored beneath the shelter hedge adjacent to the railway;
- Additional water tanks and a small bore shed, which is overgrown with vegetation, are present to the west of the front portion of the store building. Litter in the form of cans and plastic bottles was observed in front of the bore shed (see photograph 41); and

*Photograph 41 Appendix B.1: Bore shed to the west of the store building, litter present at front of shed.*
