+ Preliminary Site Investigation

Kākātangiata Structure Plan and District Plan Change

Prepared for  
Palmerston North City Council

Prepared by  
Tonkin & Taylor Ltd

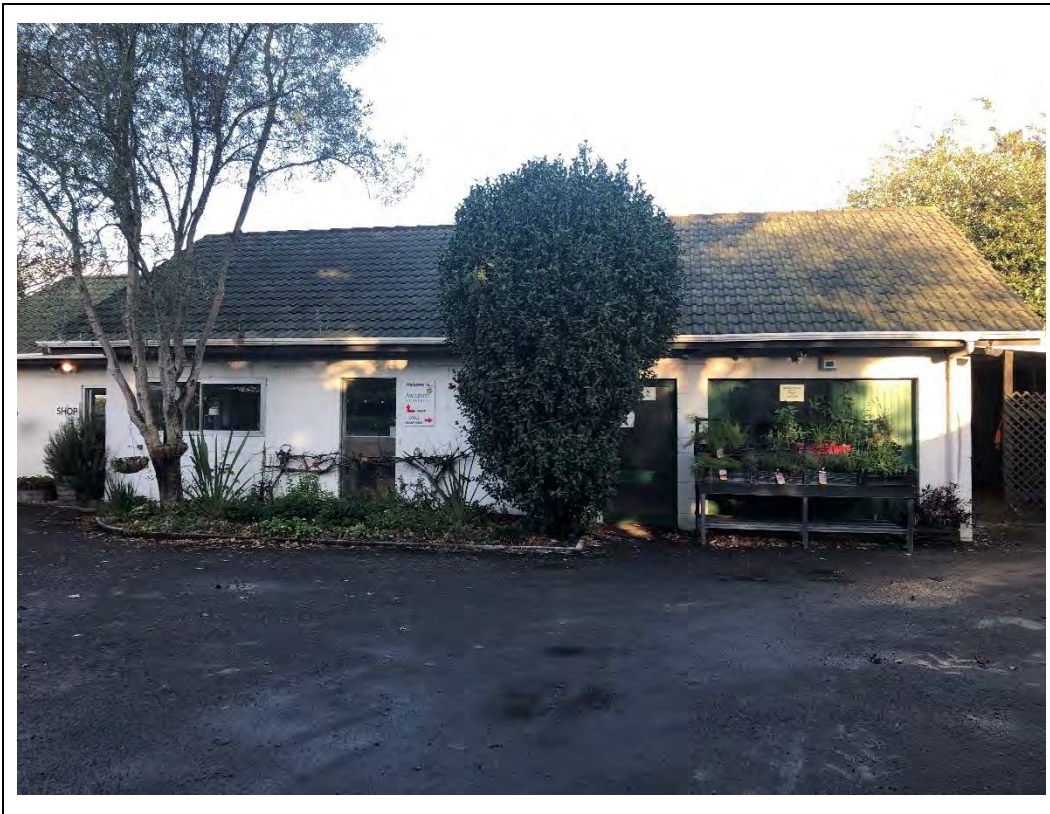
*Photograph 42 Appendix B.1: Retail store building present to the south of the carparking area.*

- The retail building is present to the south of the carparking area and is constructed of concrete cinderblocks with what appears to be decramastic or bitumastic coated roof tiles (see photograph 42);

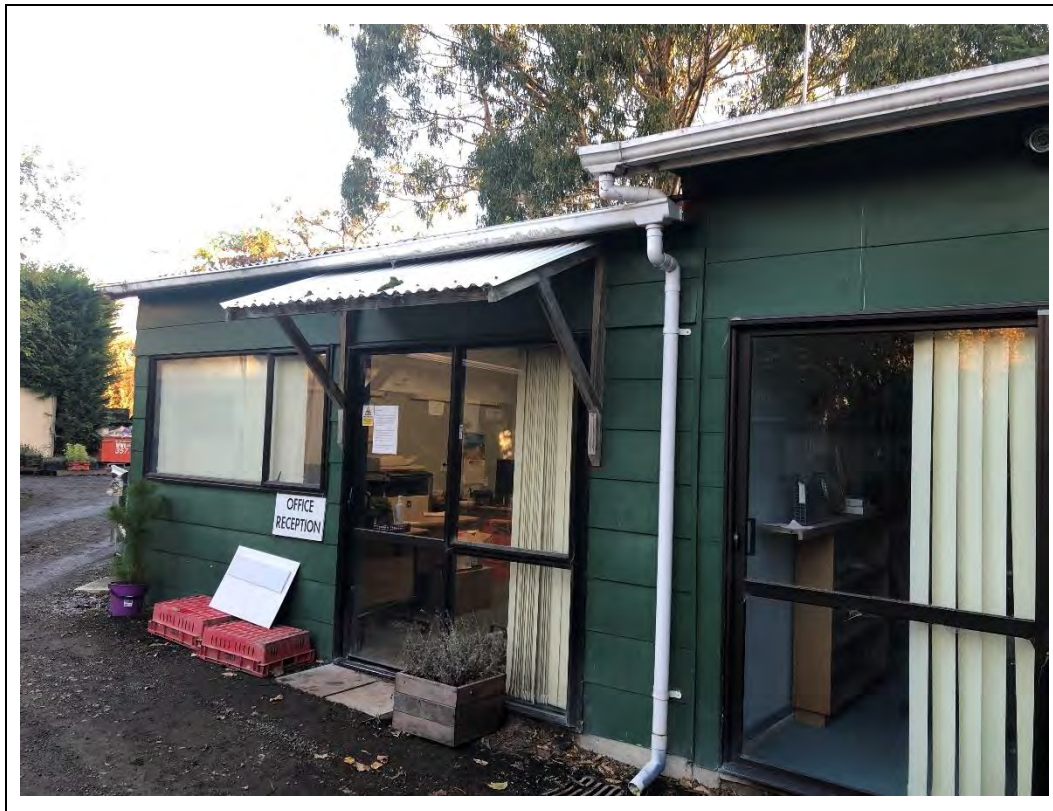
*Photograph 43 Appendix B.1: Office/reception building constructed of fibreboard cladding.*

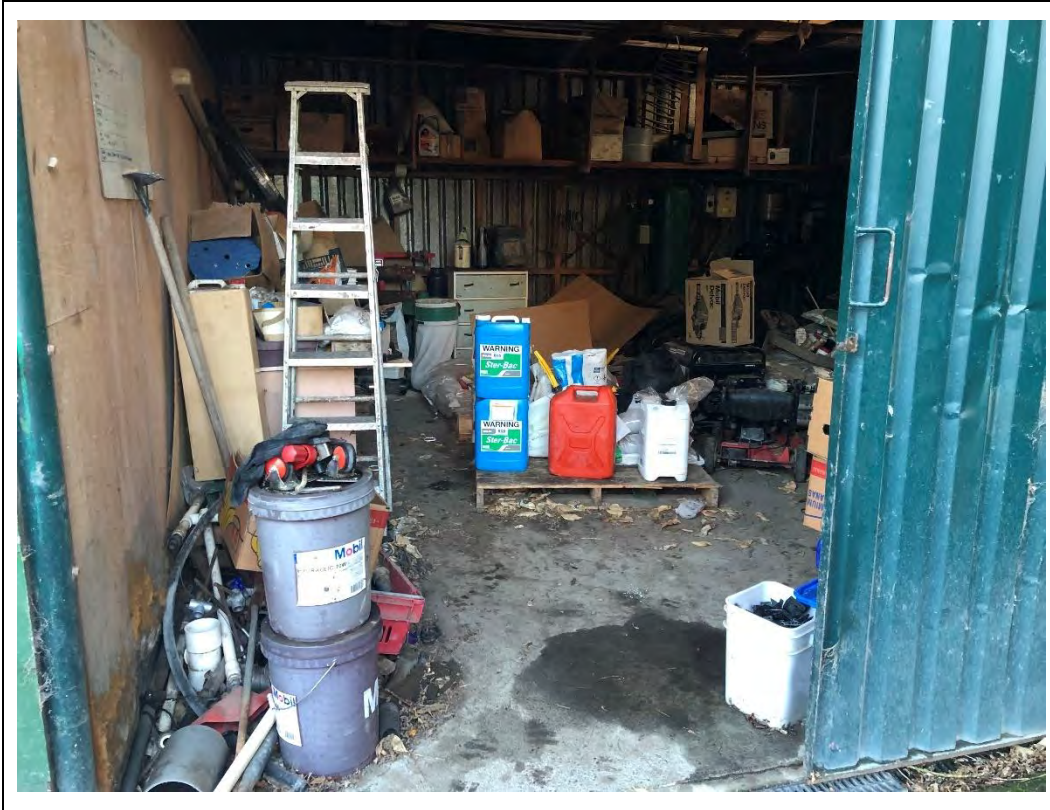
- A building used for storage adjoins the northern side of the reception/office building, the building contained buckets of branded hydraulic fluid, jerry cans likely containing fuel, cleaning products and equipment. Staining was evident on the concrete floor of the building (see photograph 44);

*Photograph 44 Appendix B.1: Store building adjoining the reception/office building.*

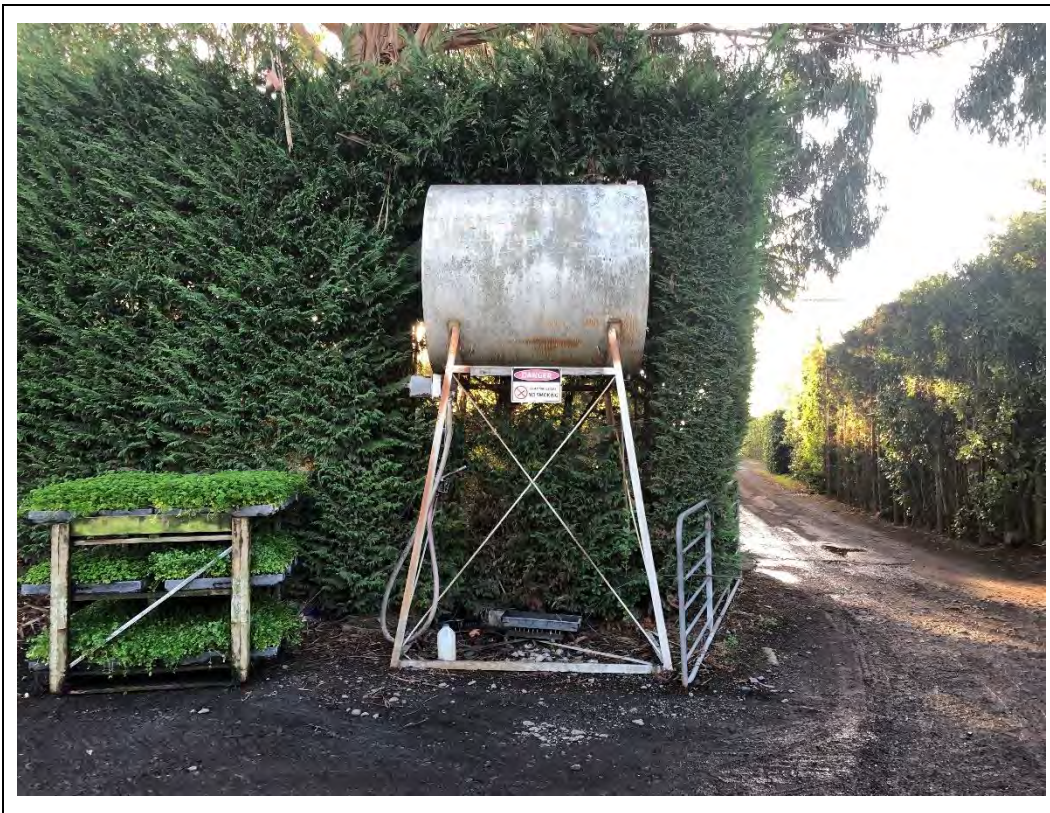
- Diesel is stored in an above ground tank with refuelling facilities in another carparking area to the west of the office and retail buildings, immediately adjacent to the site boundary. No hydrocarbon odours were detected, nor staining evident surrounding the tank during the site walkover. However, the soil beneath the tank was damp due to prior rainfall and therefore some staining may be present but not seen during the walkover (see photograph 45);

*Photograph 45 Appendix B.1: Aboveground storage tank containing diesel to the west of the office building.*

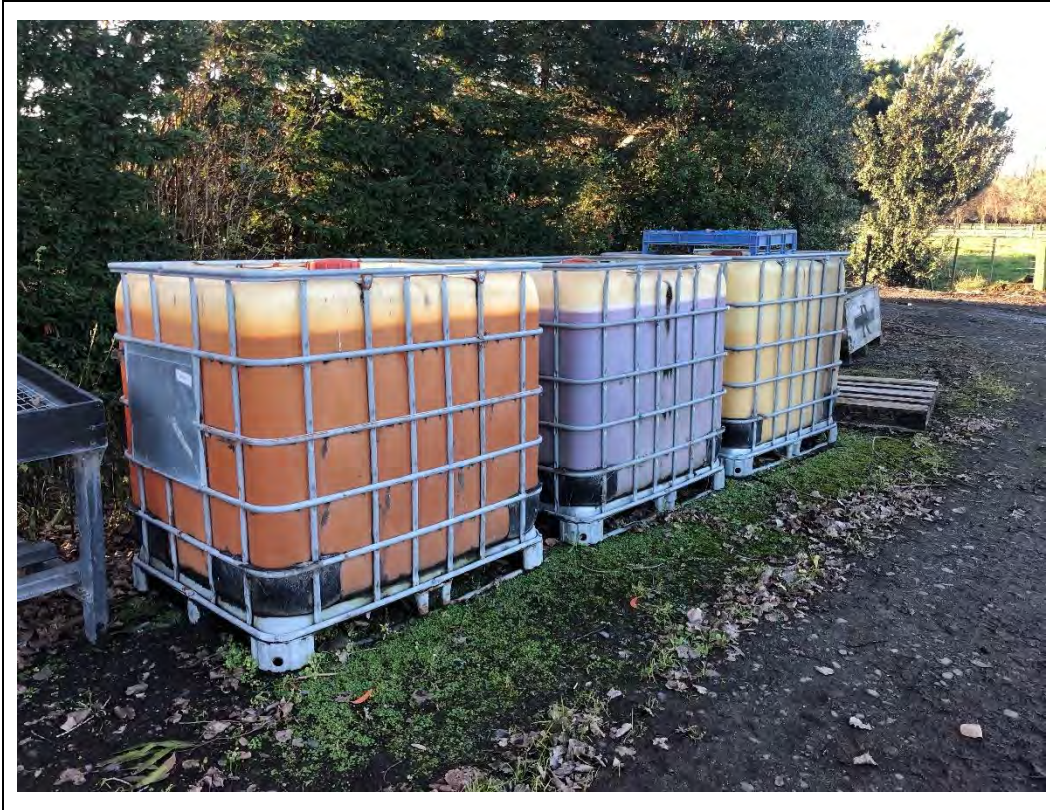
*Photograph 46 Appendix B.1: Intermediate bulk containers containing coloured solutions.*

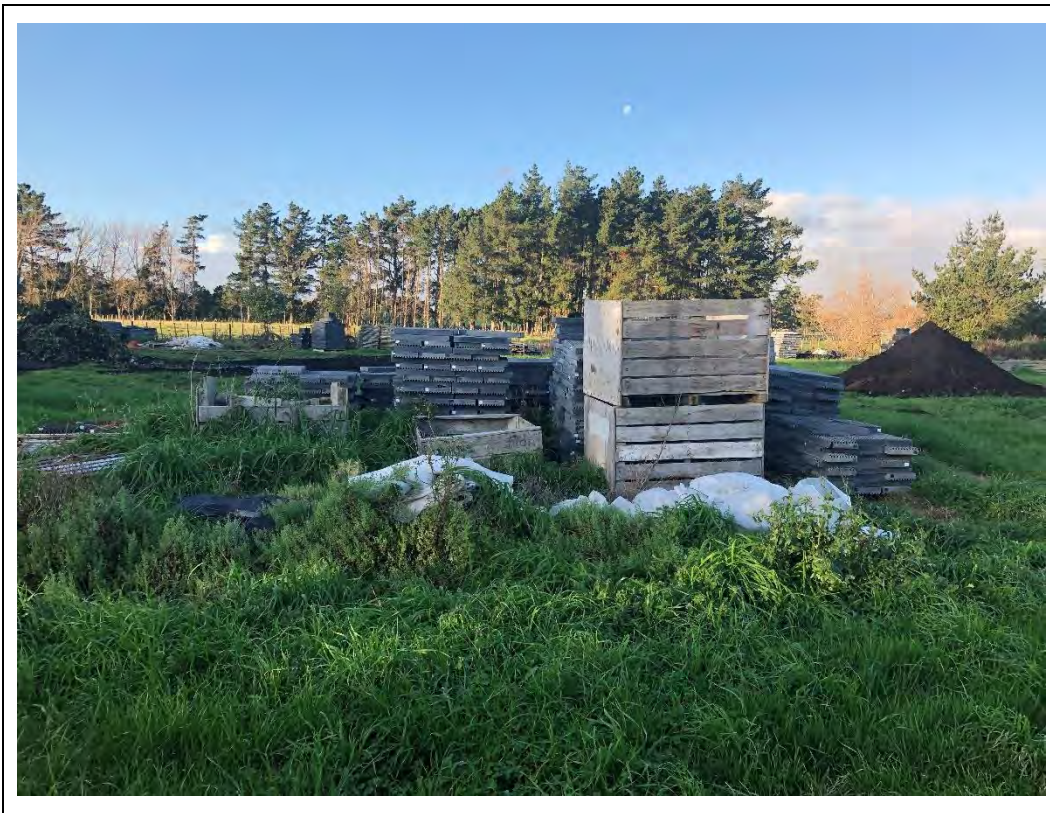
- Discarded items, including wooden bins, plastic wrap and pallets, drums, metal bars used for supporting the plastic wrap for rows, vegetation, soil, tyres, and wooden pallets were observed in the eastern and southern portions of the site (see photographs 47 and 48).

*Photograph 47 Appendix B.1: An example of discarded items on eastern portion of property.*

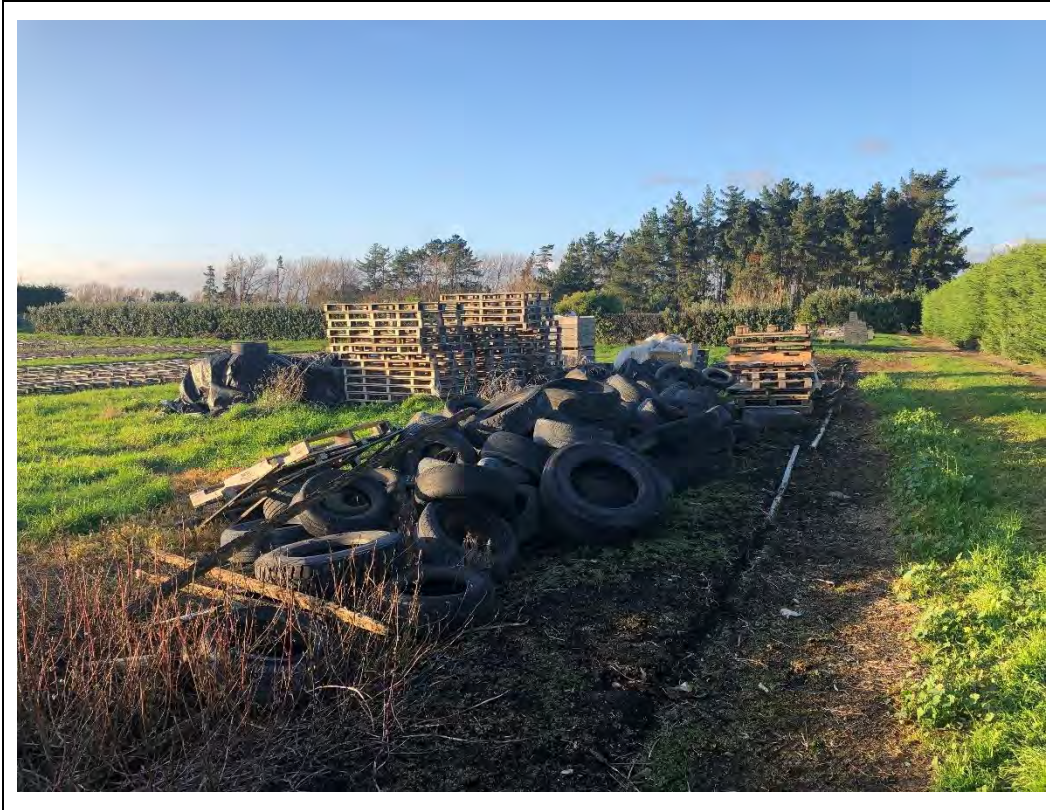
*Photograph 48 Appendix B.1: An example of discarded items towards the eastern portion of property.*

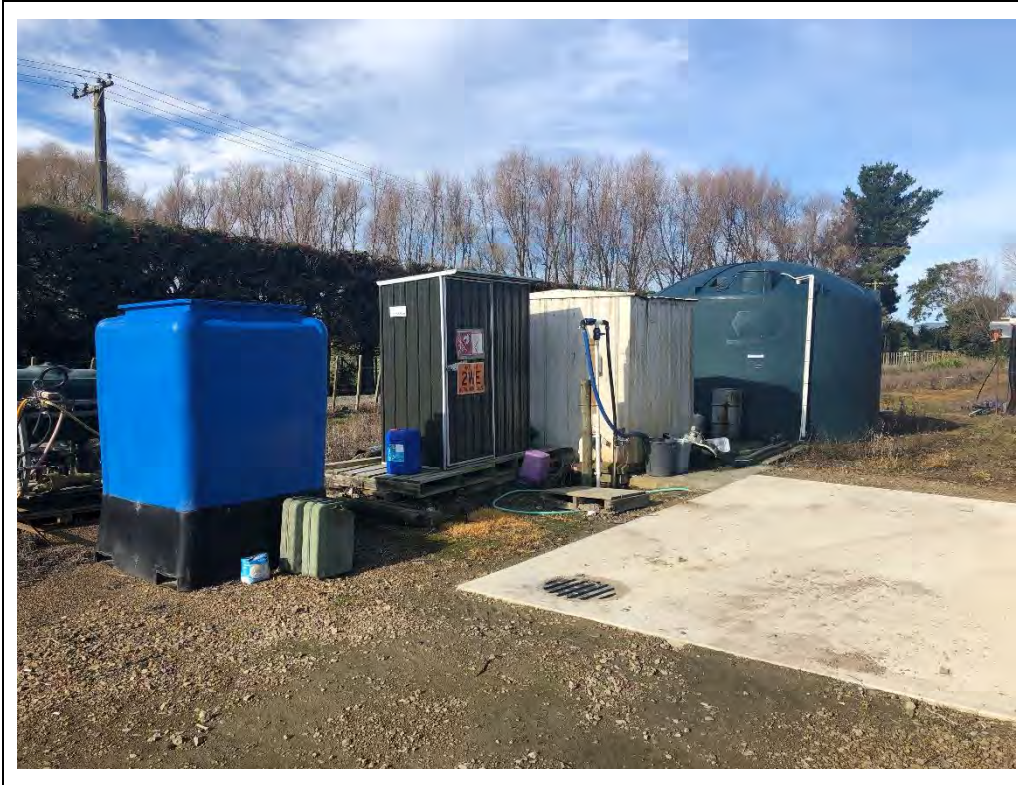
- The property owners have owned the property for the past five years and have reportedly used the property as an organic market garden. Prior to the property owners owning the site it was used to grow flowers and berries. Sprays are reportedly no longer used on site;
- The site is predominantly unpaved and mostly bare soil with some gravelled and concreted areas;
- A concrete pad with drainage is present adjacent to the hazardous substance store on the eastern boundary of the property. The hazardous substance store is a small metal shed set on wooden pallets and is labelled with signage indicating flammable liquids, ecotoxic substances and agrichemicals. A large blue plastic container is present to the north of the store, and metal jerry cans were seen next to the container (see photograph 49);

*Photograph 49 Appendix B.1: Hazardous substance store, pump shed and water tank.*

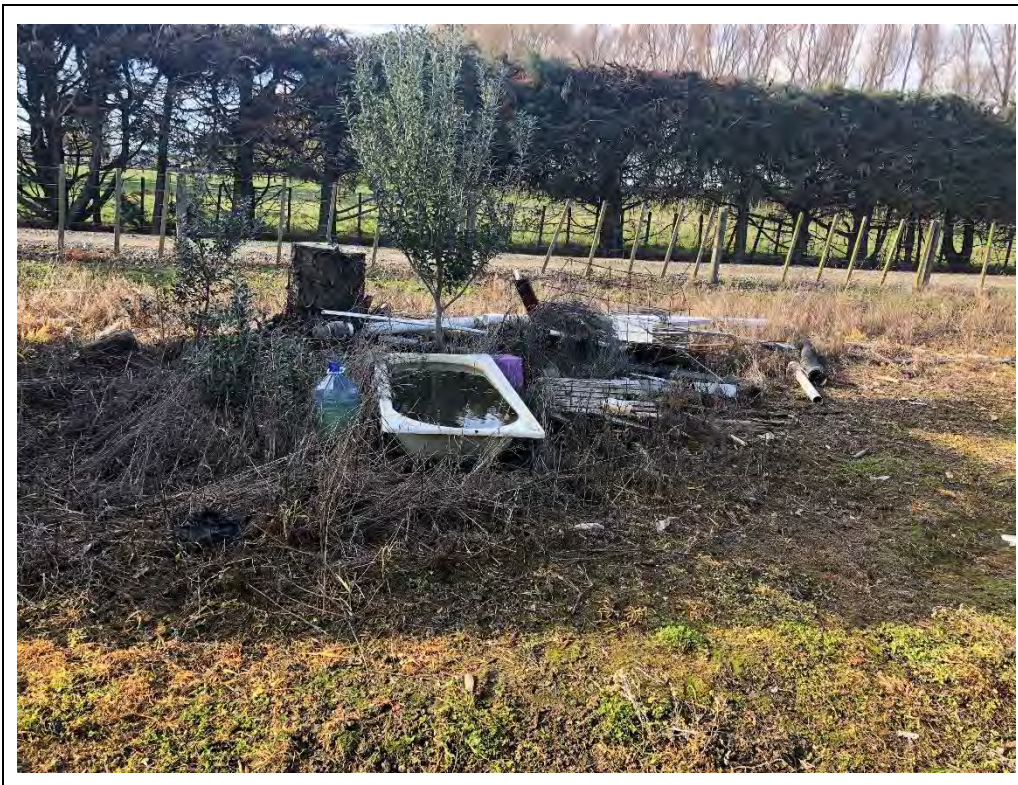
*Photograph 50 Appendix B.1: Discarded items immediately south of water tank.*

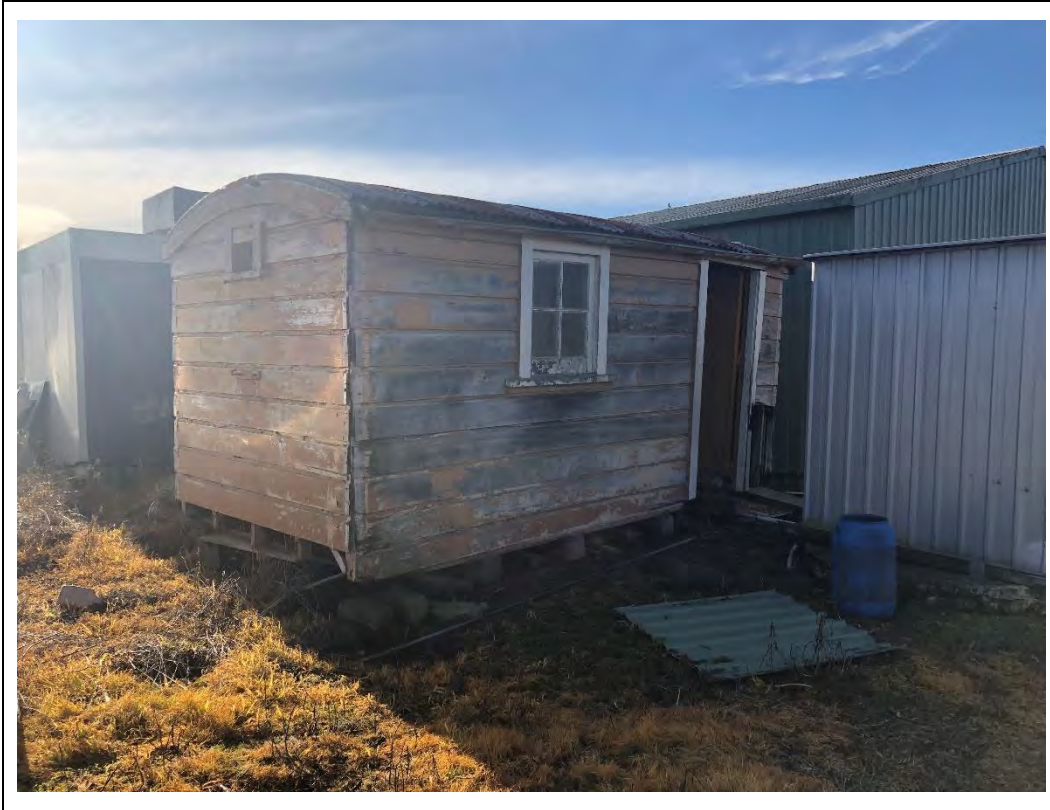
*Photograph 51 Appendix B.1: Small timber building with flaking paint to the west of the main building.*

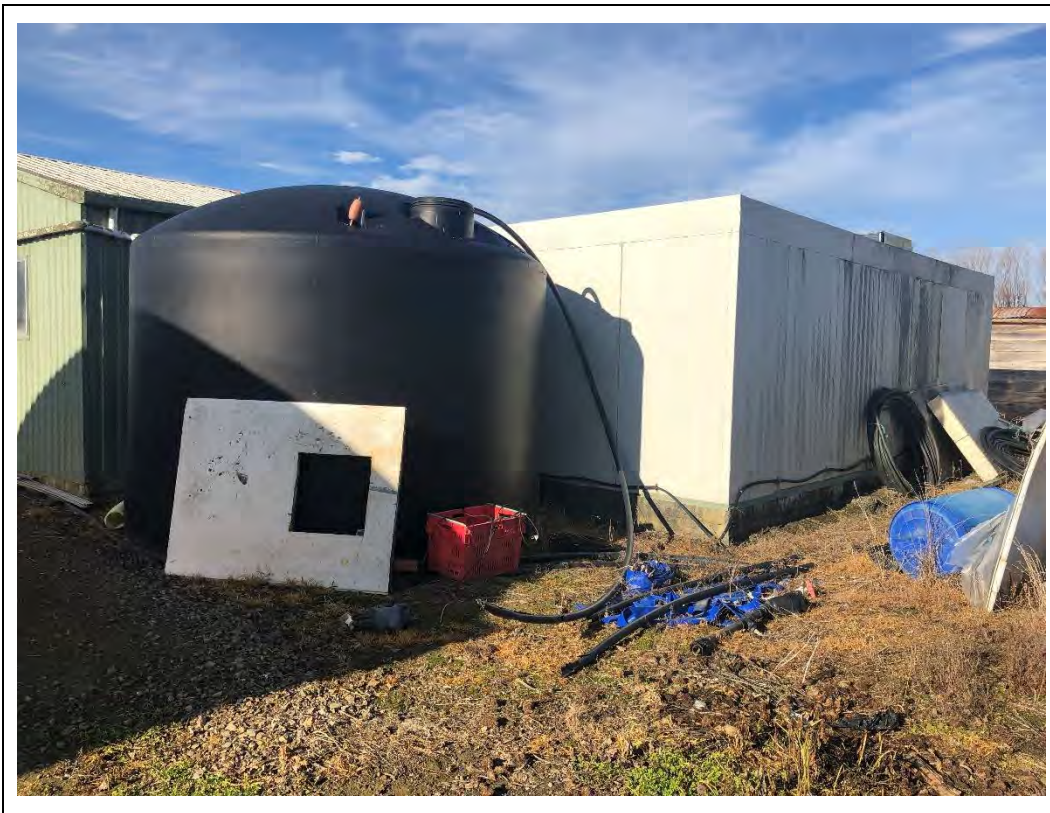
*Photograph 52 Appendix B.1: Water tank and refrigerated building to the west of the main building.*

- There is a small timber building in the area immediately west of the main building. Flaking paint was seen on the building. A refrigerated building and a water tank are also in the area to the west of the main building (see photographs 51 and 52);

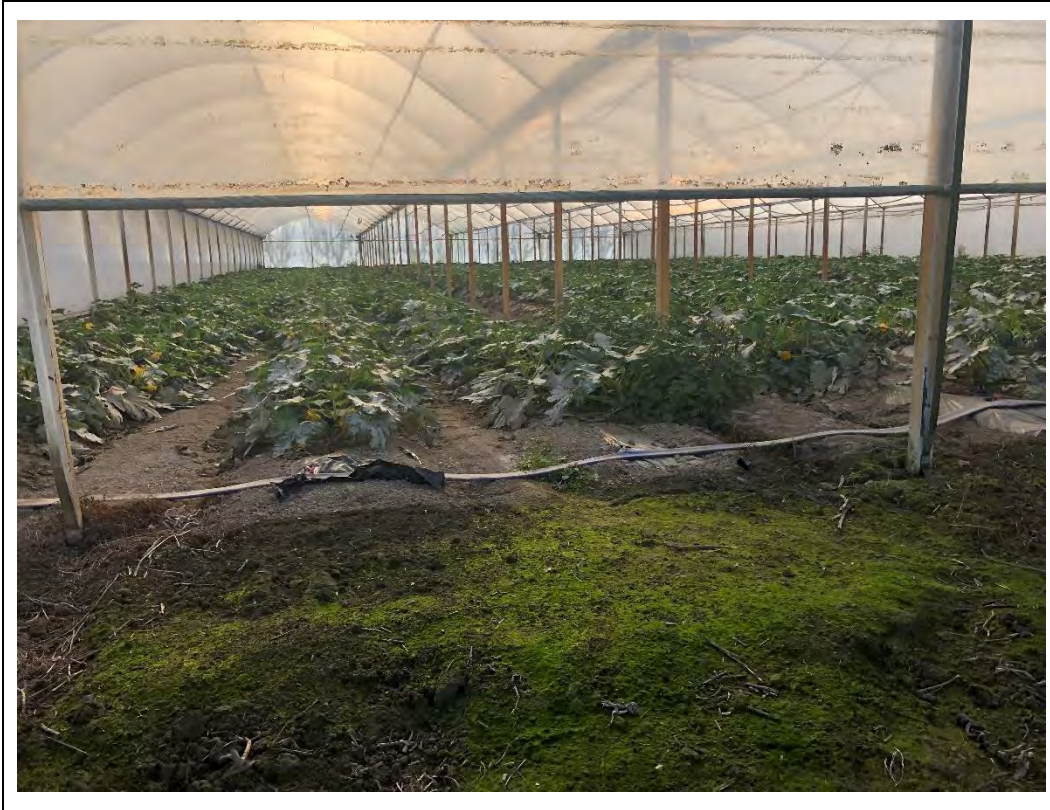
*Photograph 53 Appendix B.1: Example of planting in tunnel houses on northern portion of property.*

- Plastic tunnel houses, constructed of steel framing and plastic sheeting, occupy the majority of the eastern half of the property. The tunnel houses on the northern portion of the property are mostly in use and plants are both grown in the ground and in raised planting beds (see photograph 53);

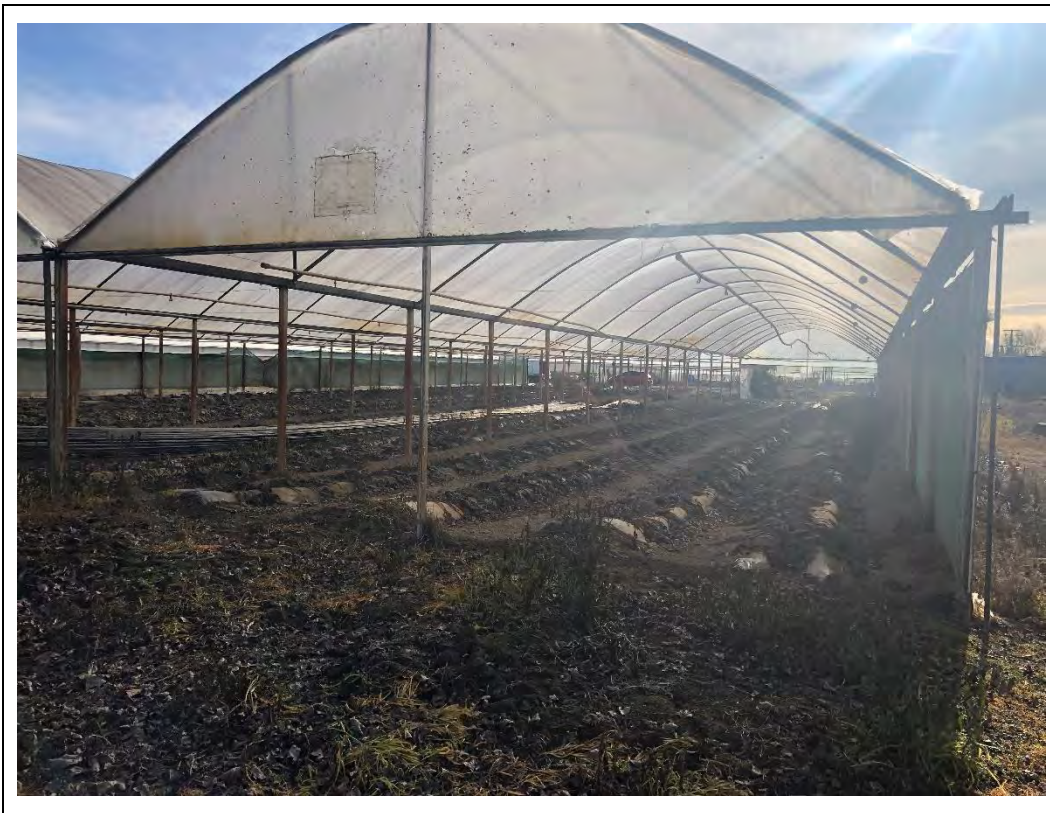
*Photograph 54 Appendix B.1: Example of tunnel houses on southern portion of property.*

- The tunnel houses on the southern portion of the property did not contain growing produce at the time of the walkover. However, it appeared that works to remove dead vegetation and prepare the soil for planting were in progress (see photograph 54);

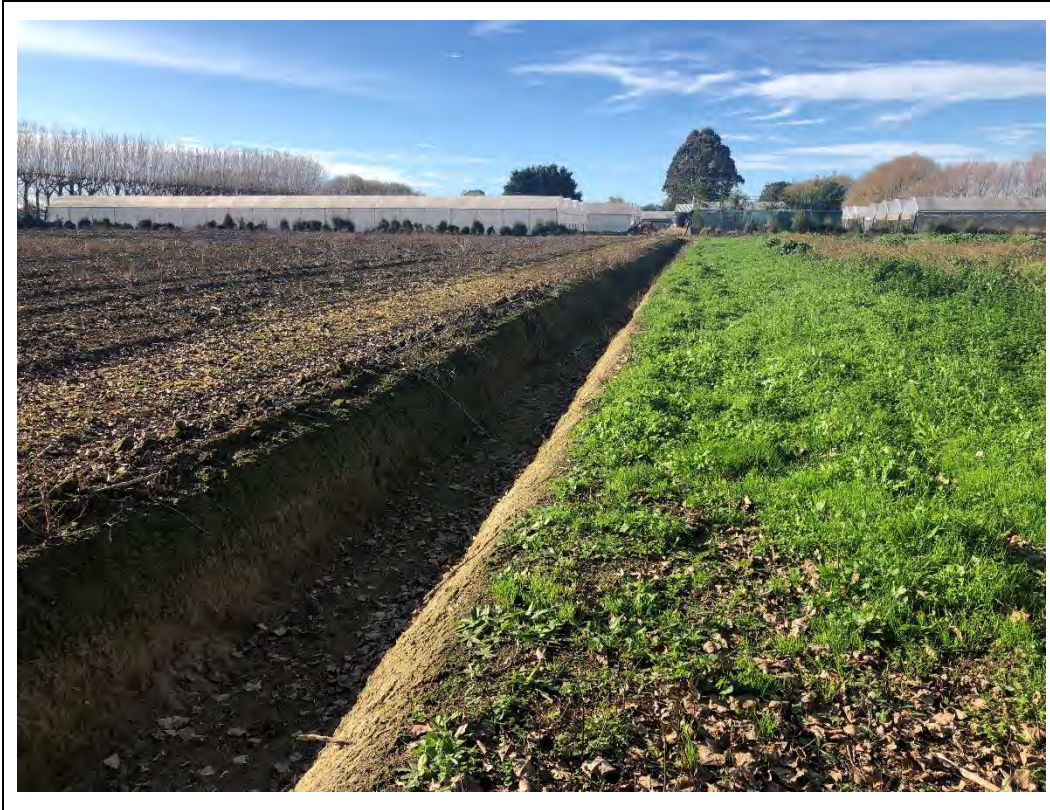
- Plastic sheeting, produce crates, plastic buckets, and disused equipment including a water pump were observed in the eastern most tunnel house;
- Drainage channels approximately 1 m wide and 1 m deep were seen along the southern and western boundaries and also transecting the centre of the western portion of the property. Plastic piping was seen running adjacent to and within some areas of the channels (see photograph 55); and

*Photograph 55 Appendix B.1: Drainage channel running west to east through the centre of the property.*

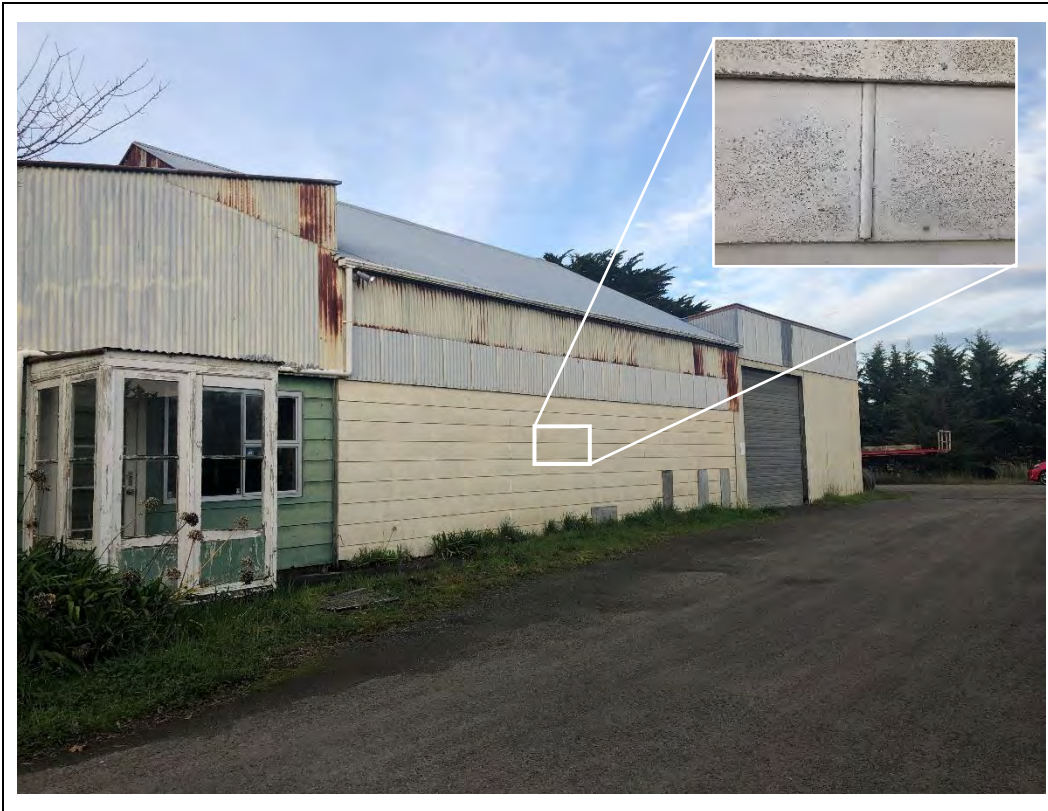
- The majority of the property is unpaved, except for an area west of the workshop building, which is asphalted. Some cracking in some low areas was evident. Ponding was evident on the gravel accessway (see photograph 56);

- The workshop building is constructed of a combination of corrugated iron and fibreboard. The building has a corrugated iron roof and concrete foundation (see photograph 56);

*Photograph 56 Appendix B.1: Eastern portion of the workshop building showing paving and cladding.*

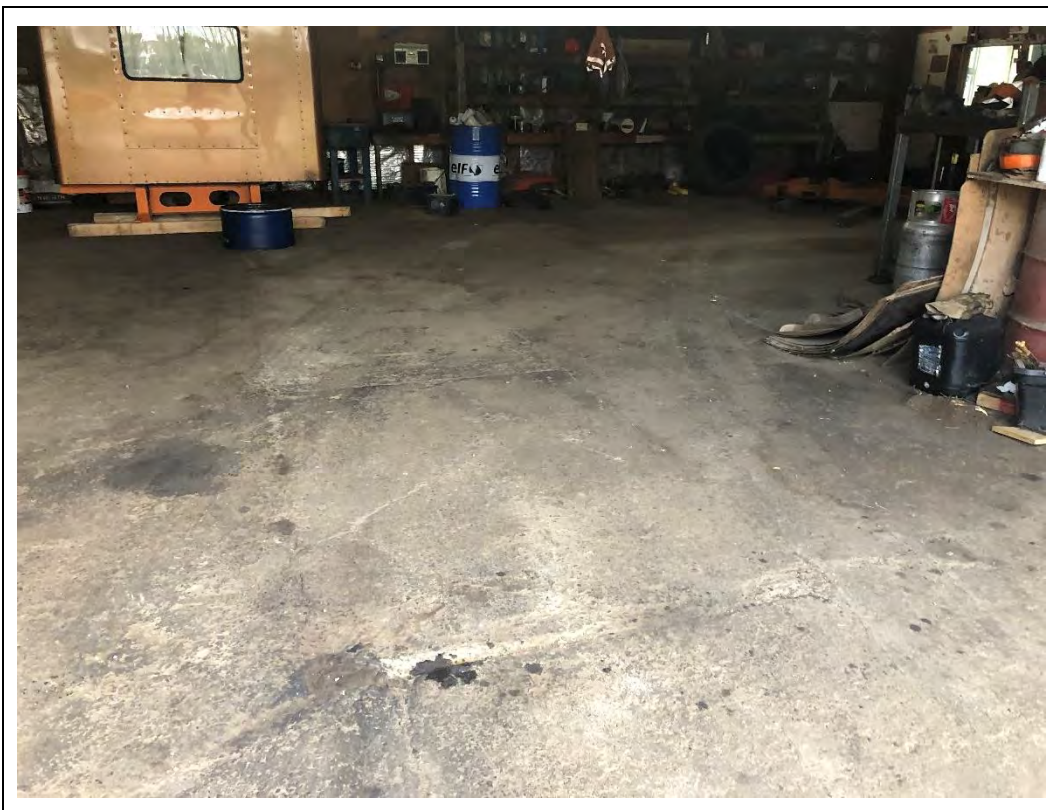
- Vehicle maintenance is undertaken within the workshop building and hydrocarbon staining was evident on the concrete floor in the maintenance area. A rectangular area that has been cut is present within the workshop near the eastern doorway (see photograph 57);

*Photograph 57 Appendix B.1: Within workshop building looking towards shelving on eastern wall. Cut rectangular area within concrete floor. Hydrocarbon staining evident.*

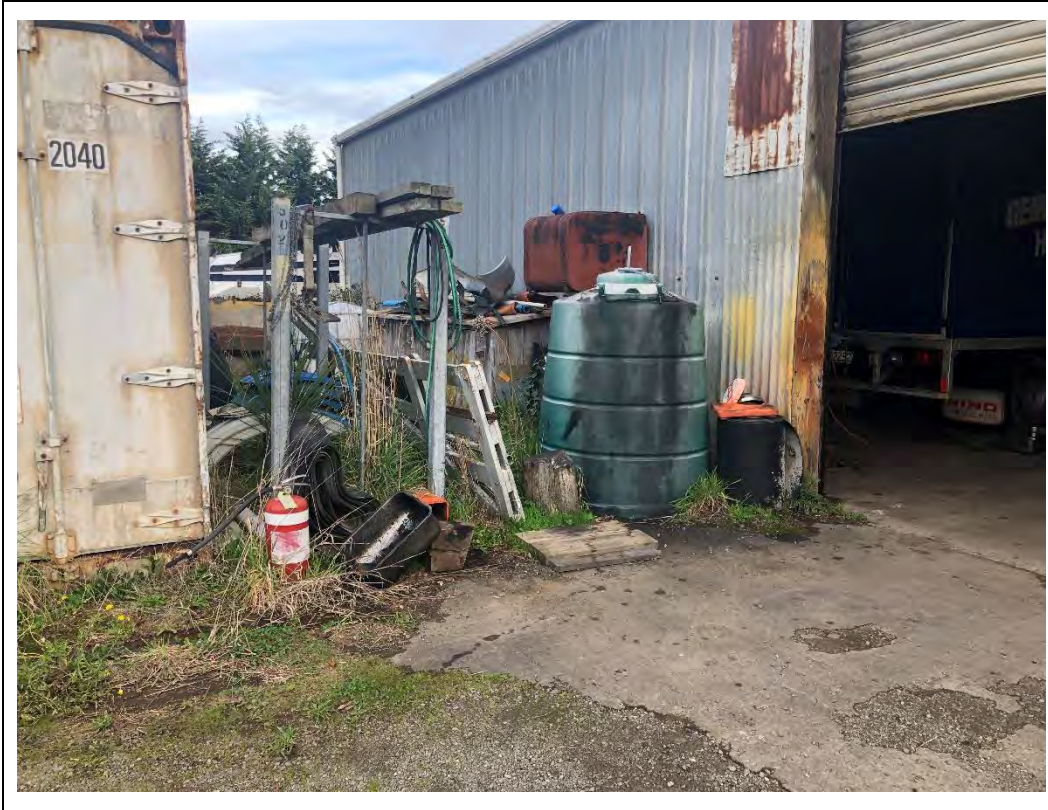
- A waste oil tank is outside the eastern doorway, and staining is evident on the tank and in the surrounding, partially paved, area. The area also contains a disused small storage tank, timber, a fire extinguisher and assorted vehicle parts including a large rubber belt, mudguards and a front bumper (see photograph 58);

*Photograph 58 Appendix B.1: Waste oil tank and small storage tank outside doorway to west of workshop.*

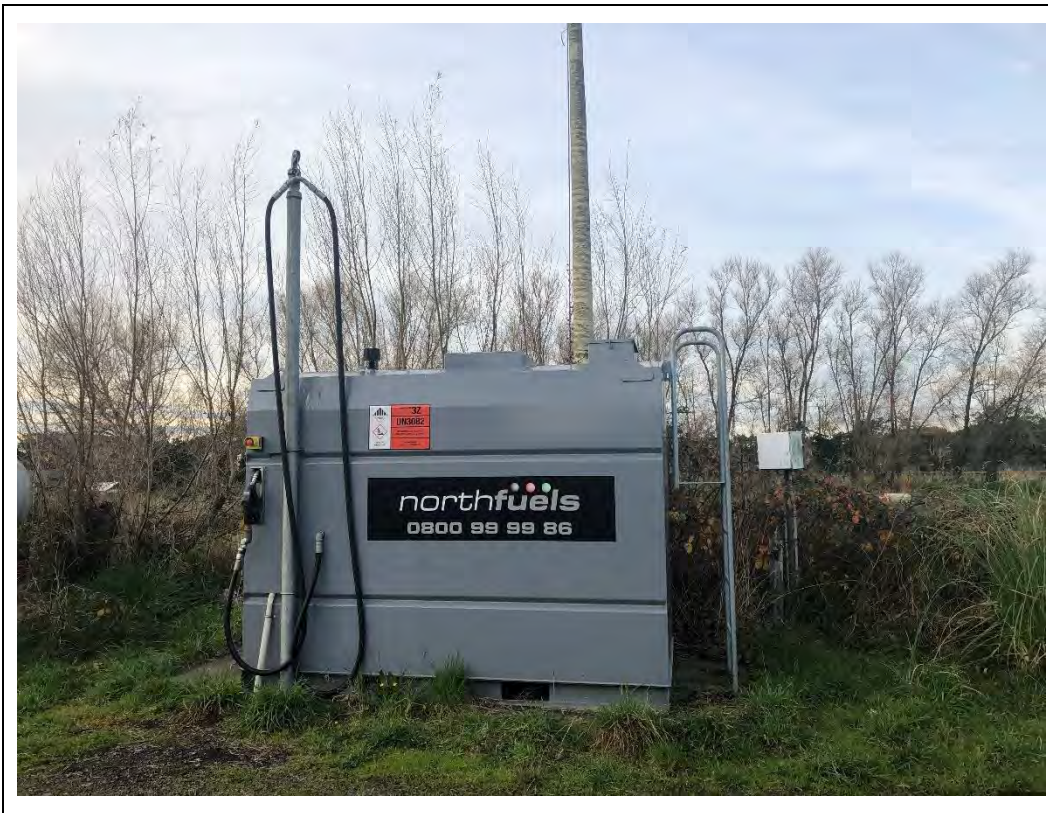
*Photograph 59 Appendix B.1: Aboveground storage tank on western portion of the property.*

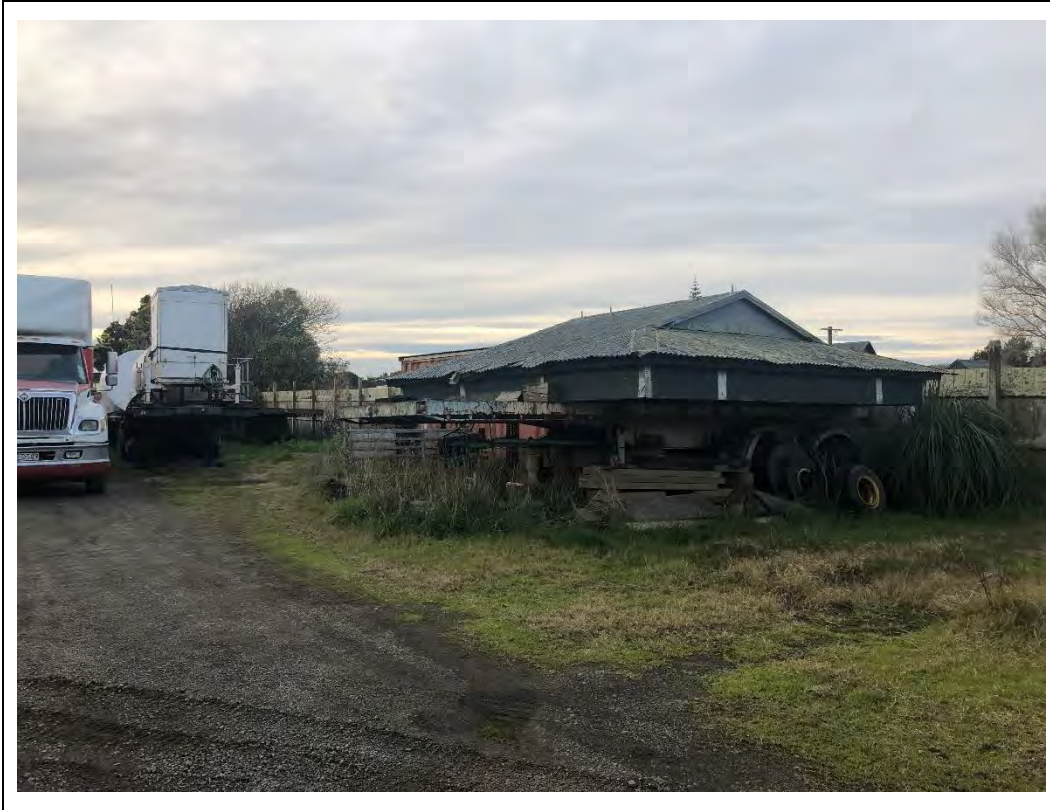
*Photograph 60 Appendix B.1: Trucks and trailers stored on north of property, storage tanks and roof on trailers.*

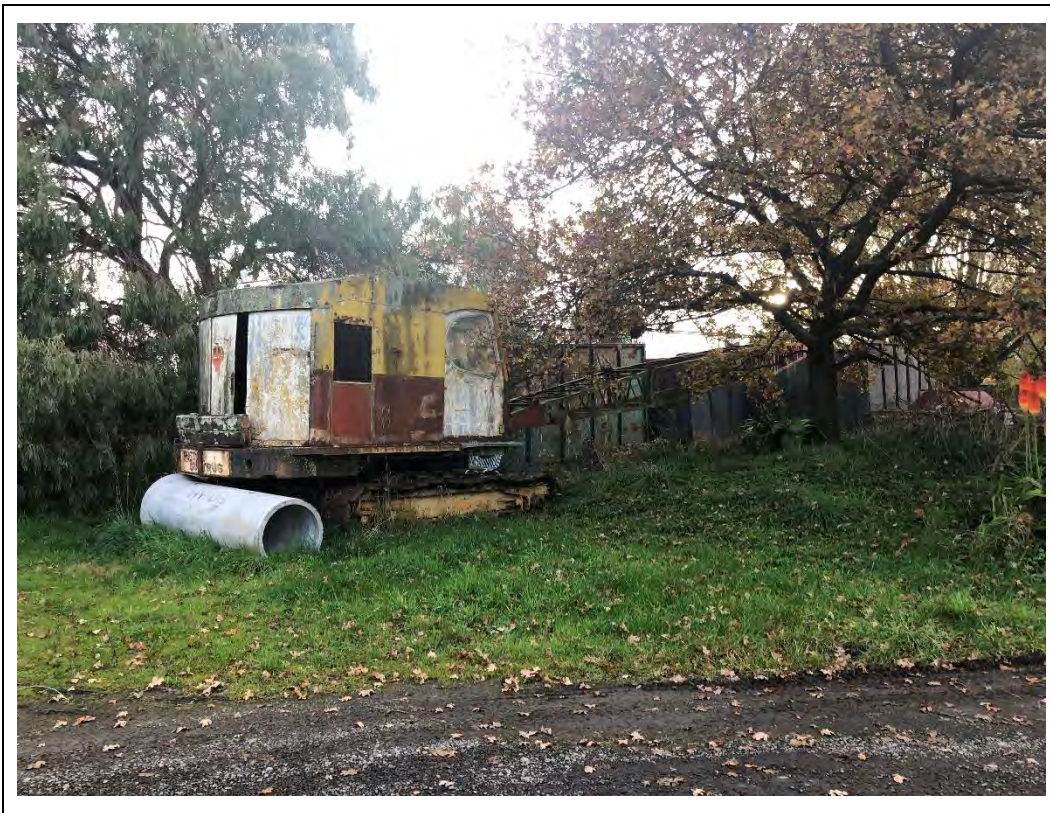
*Photograph 61 Appendix B.1: Disused crane and metal containers on northeastern portion of property. 'Lean-to' building beyond left of image.*

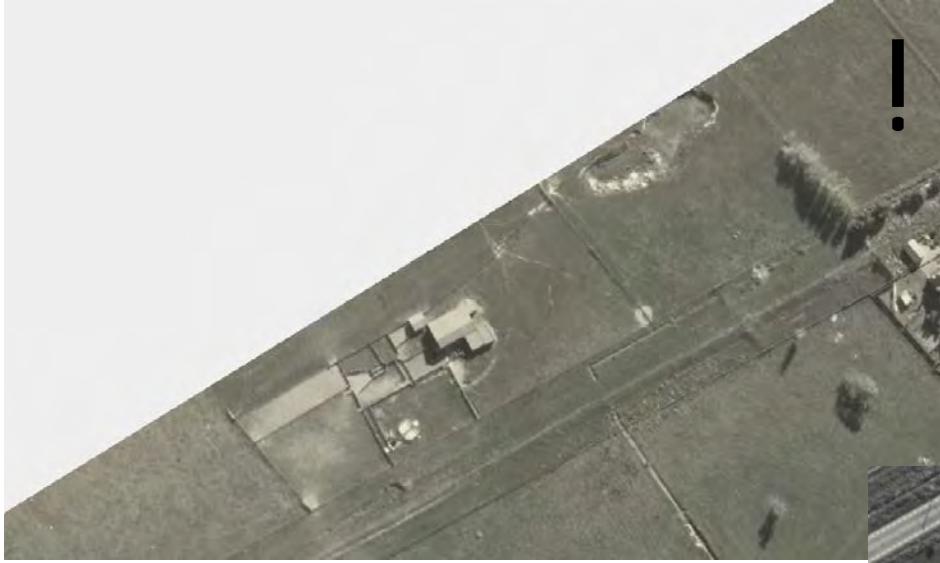
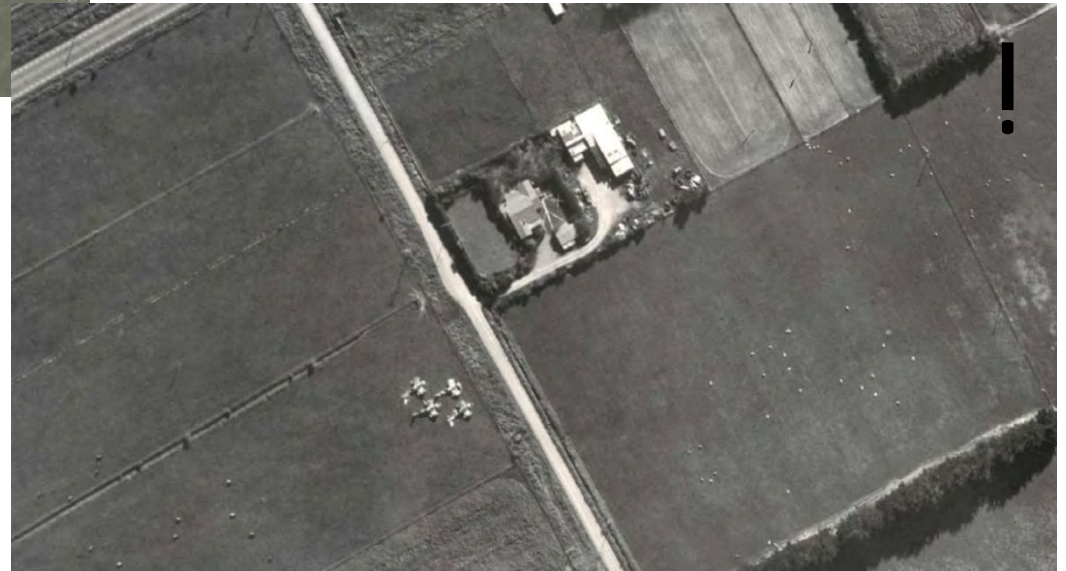
*Figure Appendix E.3: Selected images of sheep dip in Manderson area and workshop on Shirriffs Road. Sourced from PNCC Local Maps, 1956 layer.*

The presence or location of the possible sheep dip at 233 No 1 Line Longburn (SH56 portion of property) referred to, and identified on Figure 5, within the 2011 investigation has not been confirmed during the historical information review during this current investigation.
