Re: Characterisation of Waterways Present within the Kakatangiata Master Plan Area

The Palmerston North City Council have engaged Forbes Ecology Limited to undertake a high-level characterisation of waterways present within the Kakatangiata Master Plan Area.

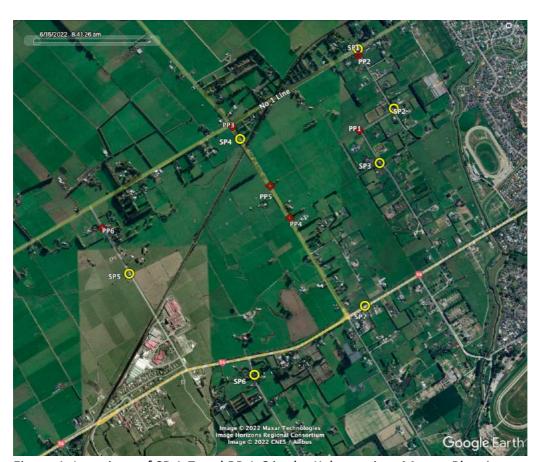
Figure 1. Locations of SP 1-7 and PP 1-6 in the Kakatangiata Master Plan Area.

The locations of SP 1-7 and PP 1-6 are shown in Figure 1.

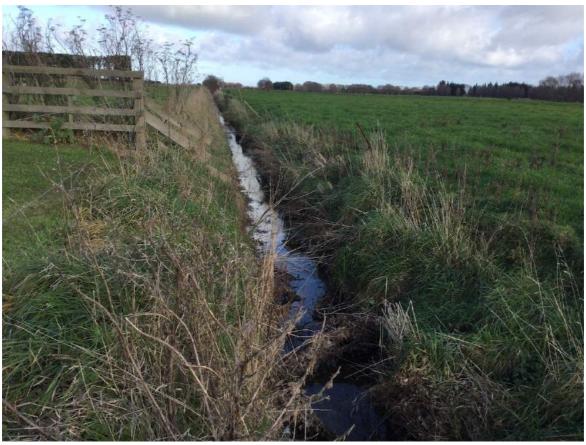
,
Site	Hydroclass
SP1	Permanent or intermittent
SP2	Permanent or intermittent
SP3	Permanent or intermittent
SP4	Permanent
SP5	Permanent or intermittent
SP6	Permanent
SP7	Permanent or intermittent
PP1	Permanent or intermittent
PP2	Ephemeral
PP3	Permanent or intermittent
PP4	Ephemeral
PP5	Permanent
PP6	Permanent

Compared with the survey results from SP 1-7, the six photopoint assessment sites show a similar nature and range in waterway character. The exceptions being PP2 and 4 which were both of ephemeral hydroclass.
