Whiskey Creek Plan Change, Palmerston North

Stormwater Management Plan for Flygers Investment Group Limited

Mitch Hydro Limited | April 2021

Date: 15 April 2021 Ref: 2017.03 Status: Issue 2

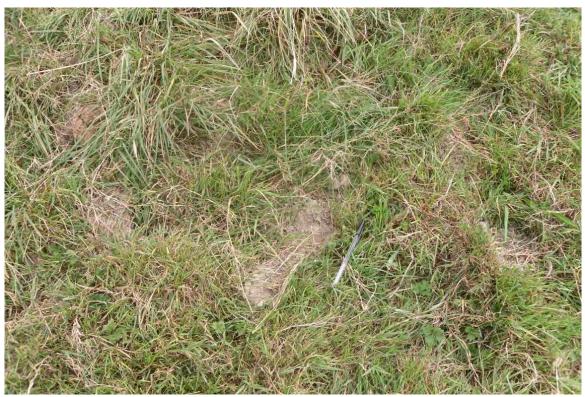
Figure 1: General condition of pasture (March 2018)

The site is located in the lower Whiskey Creek catchment. The site is currently being used for pastoral farming, with cattle herds observed in the paddocks. The ground surface is generally in good condition (Figure 1) with some erosion and pitting observed on the banks and slopes adjacent to the large, remnant open channels.

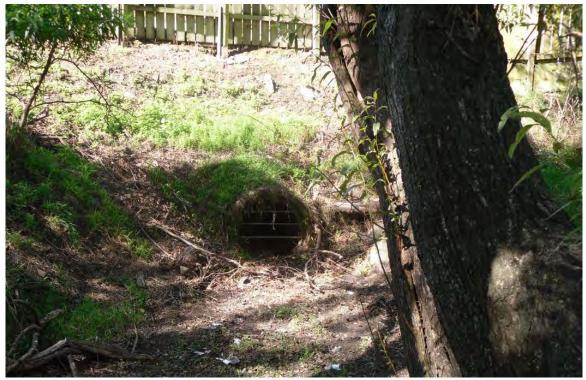
Figure 2: PNCC 900mm dia. stormwater connection adjacent to No. 91 Benmore Avenue

The area drains roughly east to west until it is intercepted by the remnant Whiskey Creek open channels draining to the south, which culminate at the floodway stop-bank adjacent to No. 91 Benmore Avenue, where the PNCC 900mm diameter stormwater main commences (Figure 2).

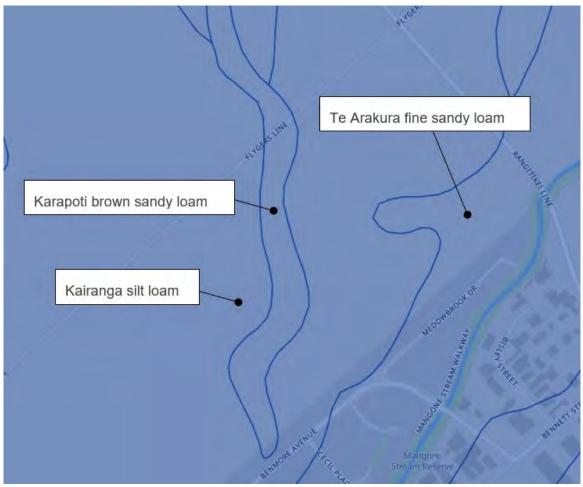
The surficial soils of the proposed site (Figure 3) are mostly Kairanga silt loam, with a small area of Te Arakura fine sandy loam, and the coarser Karapoti sandy loam (gravelly phase) in the Whiskey Creek remnant stream channel. These soils are typically poorly draining.

Figure 3: Surficial Soils

Applying the United States Soil Conservation Service (SCS) rainfall-runoff method, the surficial soils are categorised as 'poorly draining' Class C. During significant rainfalls events, the soils are high yielding in terms of runoff.

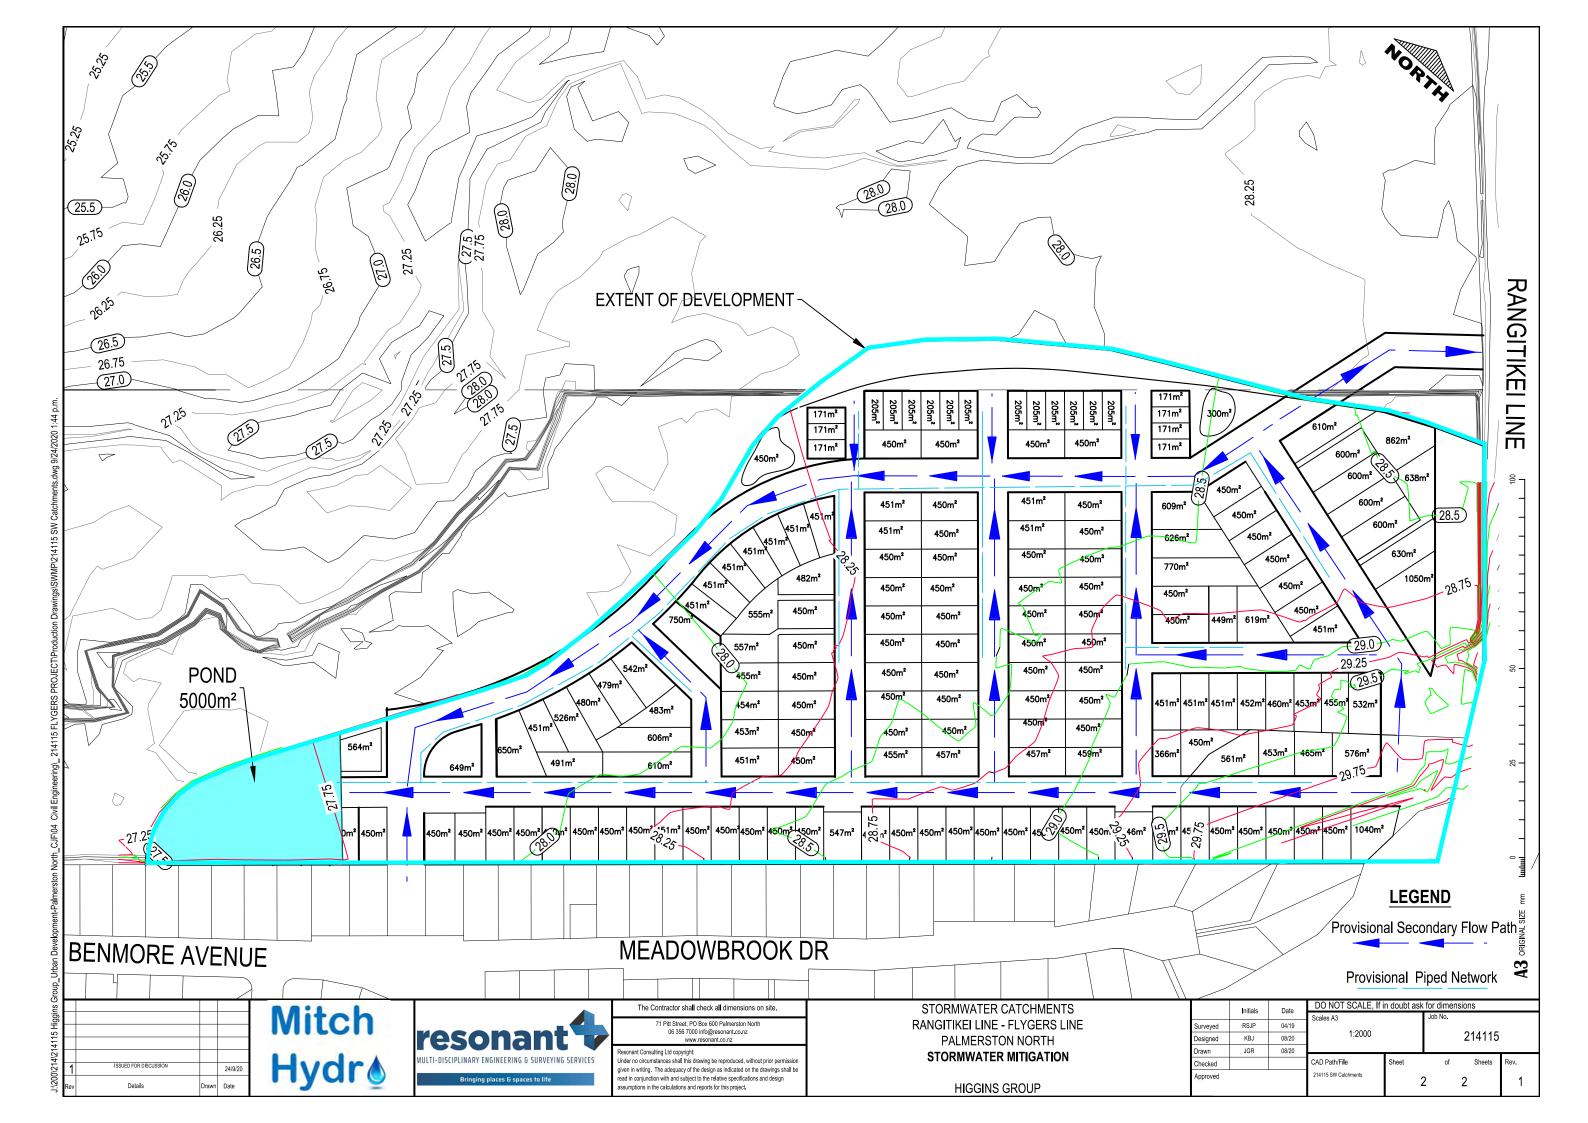
Appendix B Fully Developed Layout

The fully developed (Resonant) layout is included in Appendix B. There are some minor differences between the modelled layout in Appendix B and the McIndoe Urban 'Indicative Masterplan' layout (refer Figure 5 below).

The indicative layout (Appendix B) includes approximately 170 lots ranging in size from 171m² to 1050m². The predominant lot size is at or about 450m², which also coincides as the average lot size. The following assumptions² with regard to site coverage have been applied in the stormwater modelling:

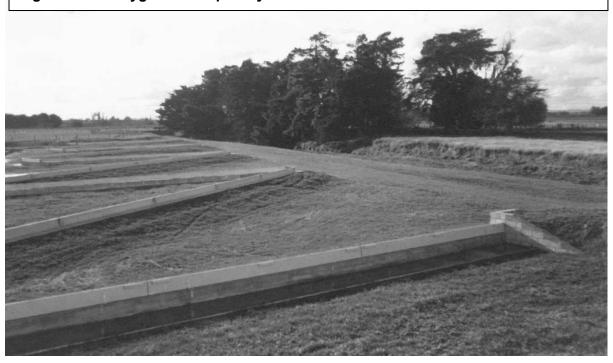
The spillway consists of a concrete sill 262 metres long, and zig-zag shaped in plan view (to minimize land occupied by overflows). Figure 10.3.1 below shows the spillway viewed from the downstream end. It carries 45 horizontally hinged gates of varying length, and 320 millimetres high. They are shaped so that rising water holds the gate shut by acting as a counterweight until it reaches the top of the gate, when the horizontal water pressure exerted on the vertical section of the gate becomes sufficient to tip it over. The design is found on Drawing 2496, Sheets 1 to 10.

Figure 10.3.1 Flygers Line spillway from downstream end
