Dust Monitoring Report

Hirock *Linton Quarry*

Y0135 • 1 June 2023 • Issue 1

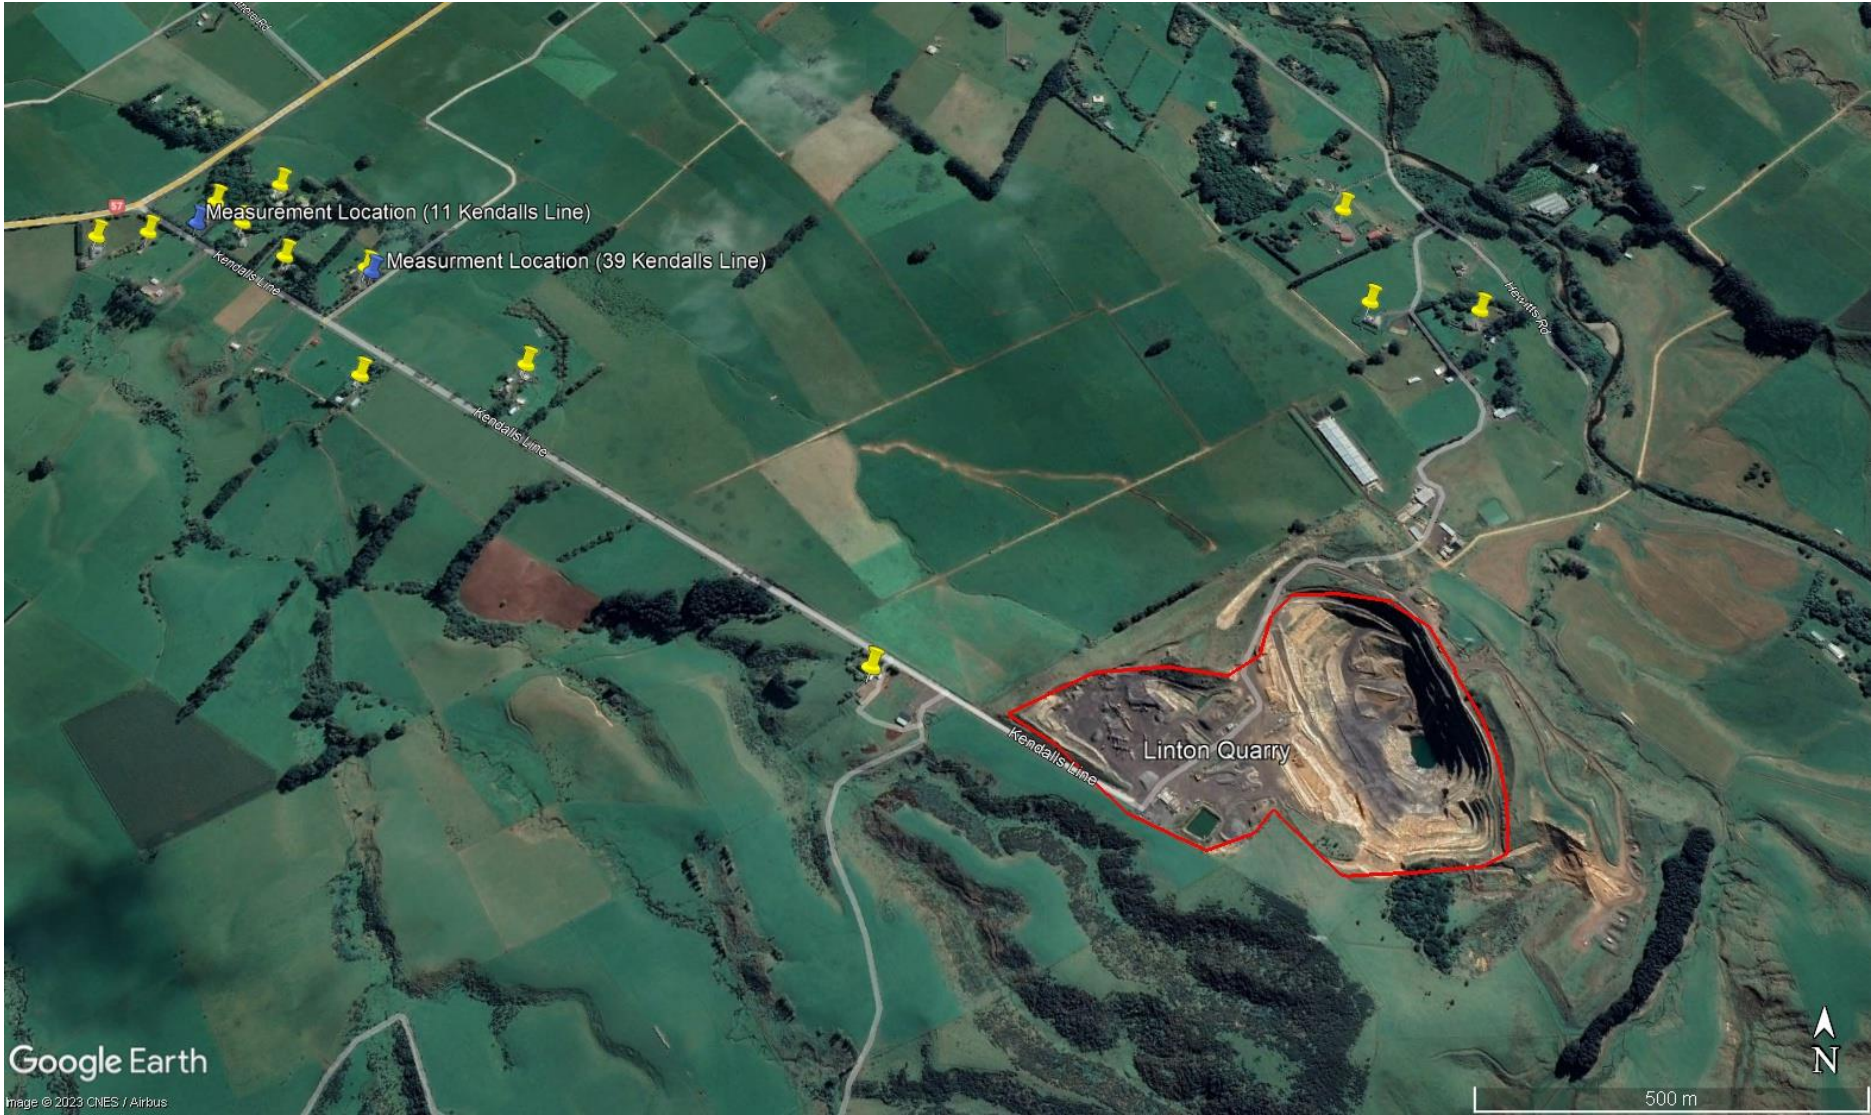
Figure 1 Satellite image of Linton Quarry

Receivers to dust emissions are the rural residential houses on neighbouring properties and along Kendalls Line. The sensitive receivers are identified on the map below in Figure 1 Satellite image of Linton Quarry. The list of receivers northwest of the quarry along Kendall's Line are:

- 11 Kendalls Line
- 15 Kendalls Line
- 33 Kendalls Line
- 39 Kendalls Line
- 4 Kendalls Line
- 6 Kendalls Line
- 56 Kendalls Line
- 75 Kendalls Line
- 150 Kendalls Line

150 Kendalls Line is likely to be the worst effected by quarry operations and road traffic, due to the proximity to site.

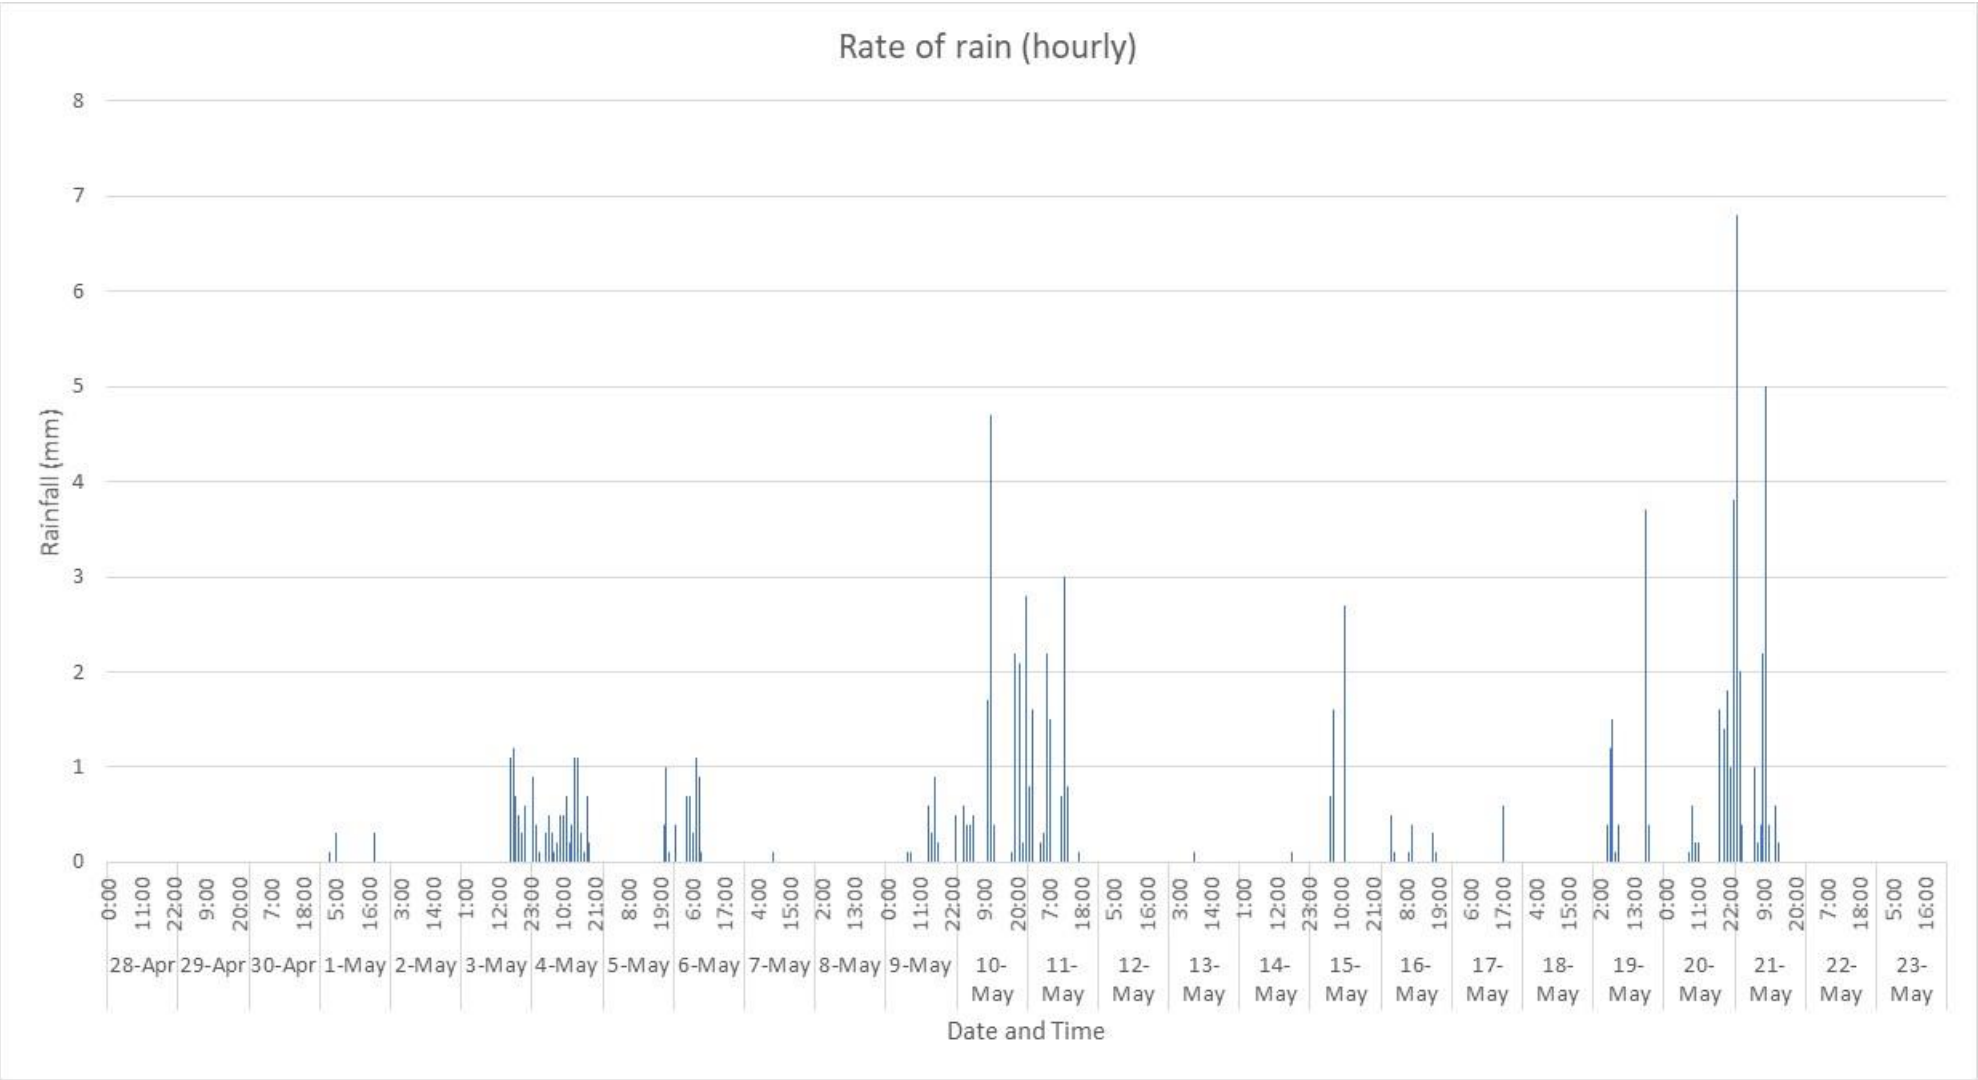
Graph 1 Hourly Rain

Graphs of a wind rose and hourly rain observations have been plotted.

Measurements from NIWA station 21963 (Palmerston North) was reviewed and wind speed and direction as well rain rate was graphed.

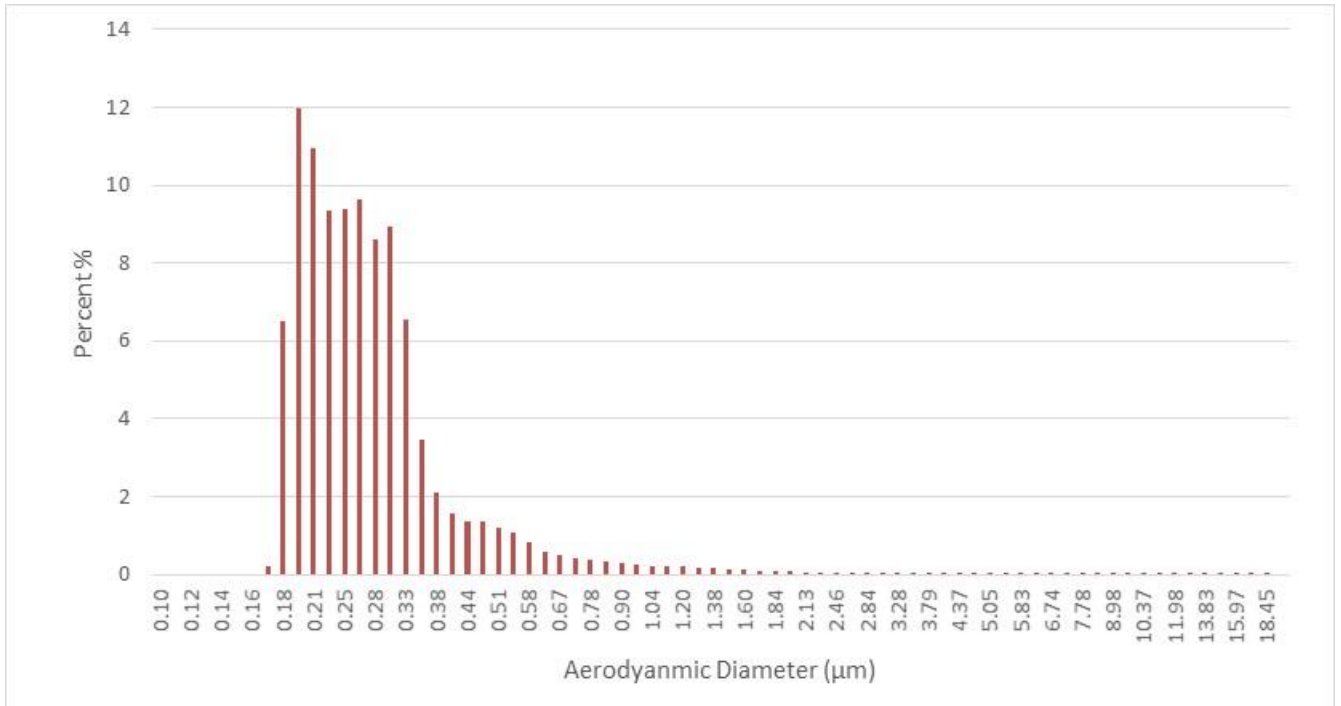
The dust found at the monitoring site is shown in the graph below. This graph shows the majority of the dust is less than 0.38 µm in size. The proportion of dust greater than 1µm is low.

A human eye can at best see dust particles of 40 µm or larger. Dust sizes measured at 39 Kendall’s line is not expected to be visible to the human eye.

Dust of the size particles measured at 39 Kendalls Line will not have sufficient mass to readily be readily deposited.

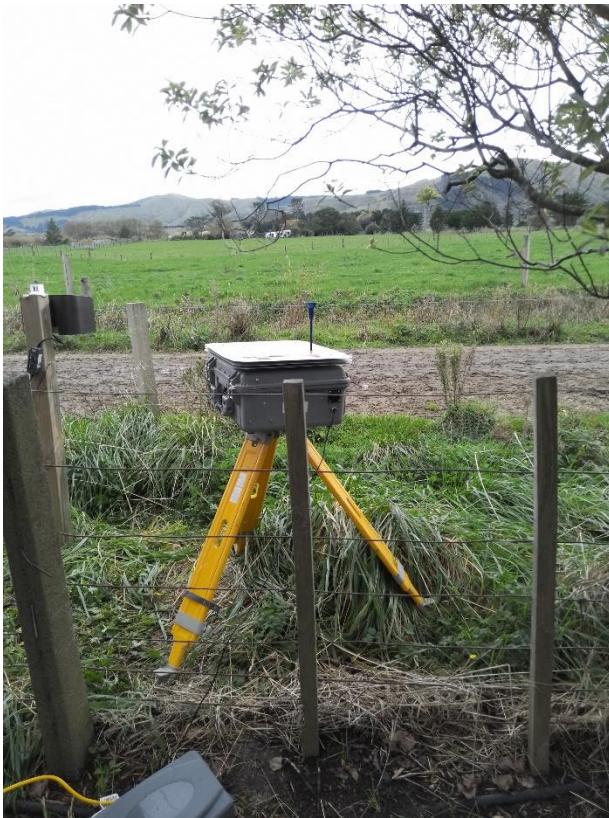
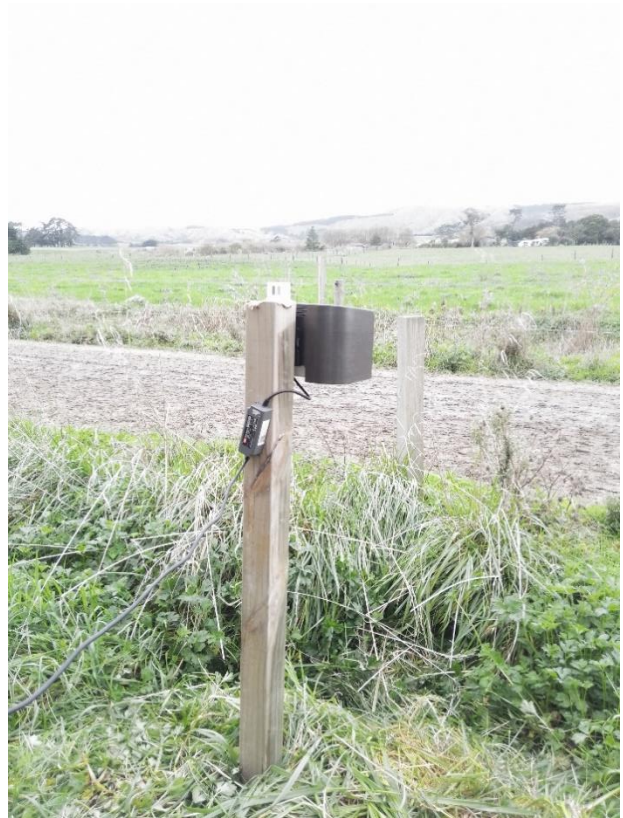
A Palas AQ guard¹ was setup beside the dusttrak monitor at 39 Kendalls Line to measure for PM1, PM2.5, PM4, PM10, PM_{Total} and particle size distribution. A meteorological station was also setup at 39 Kendalls Line, although data was not able to be recovered from it. A met station close to the analysers is considered to be more accurate than one locally. The data from a closely located met station will pick up any local weather effects.

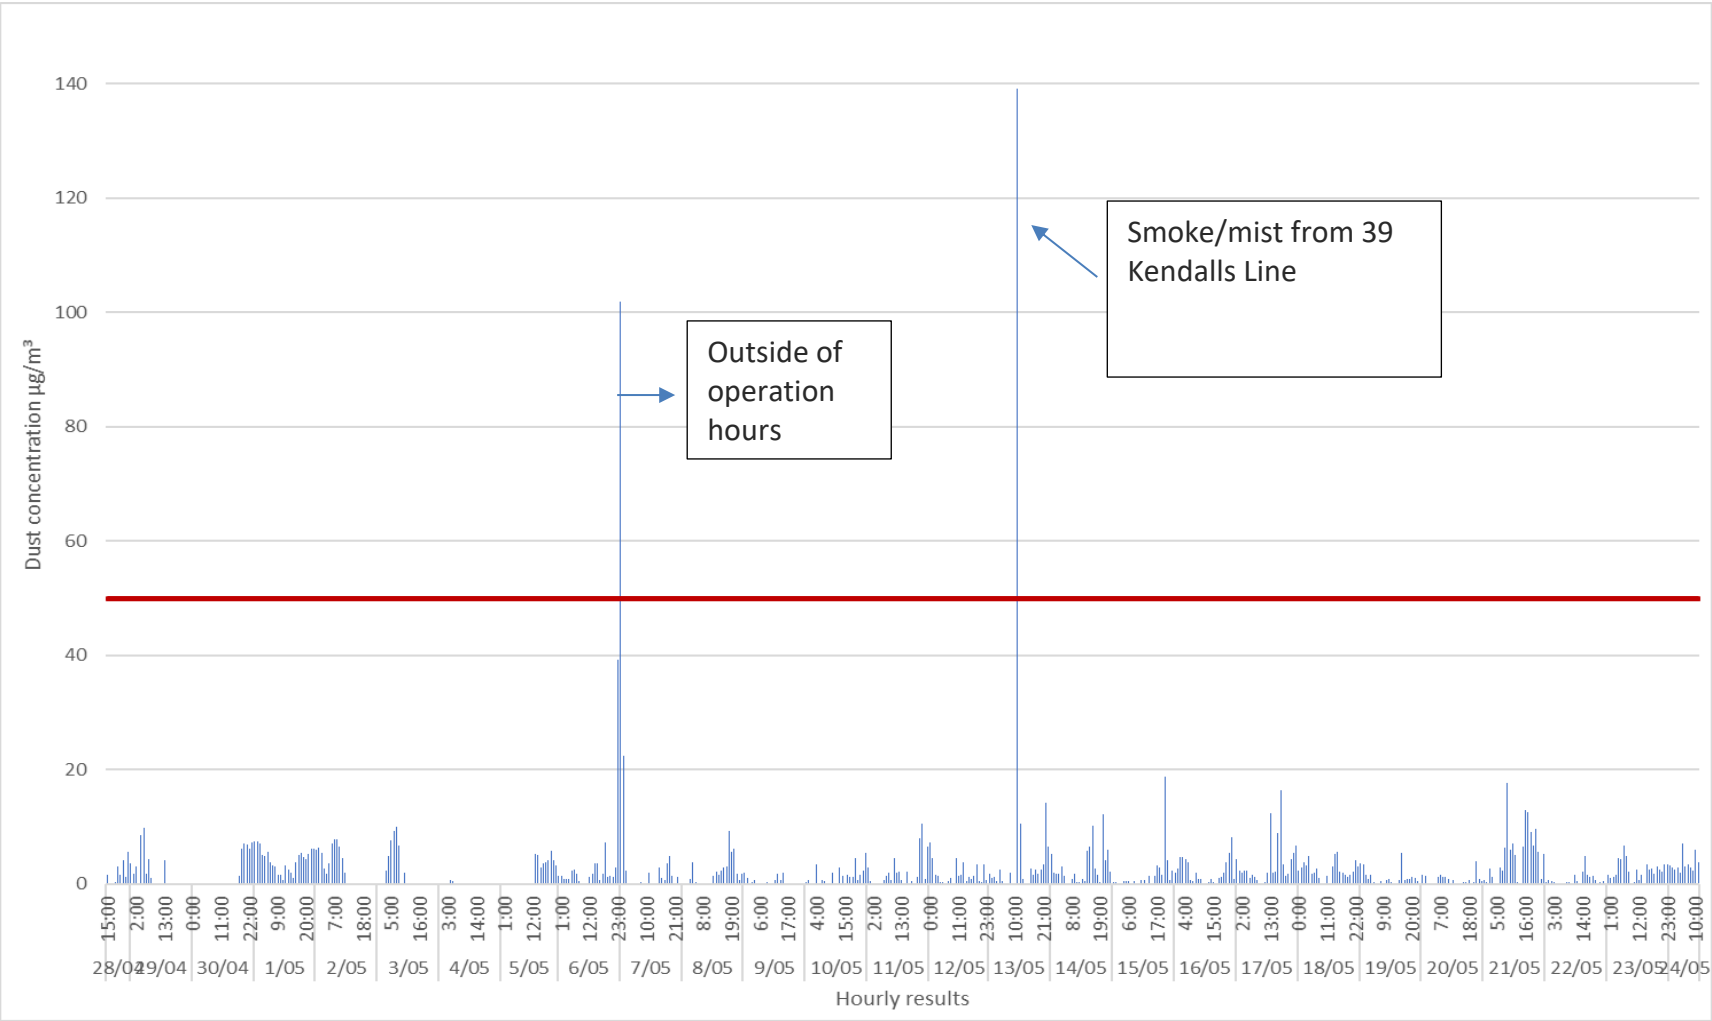
Graph 4 Hourly DustTrak data from 39 Kendalls Line

There were two outliers identified in the particulate monitoring. On May 13 there appeared to be large plumes of smoke/mist coming from the direction of 39 Kendalls Line observed from the time lapse monitoring.

Peaks during the 23rd of May happened outside of operational hours of the quarry and are therefore not associated with activities onsite.

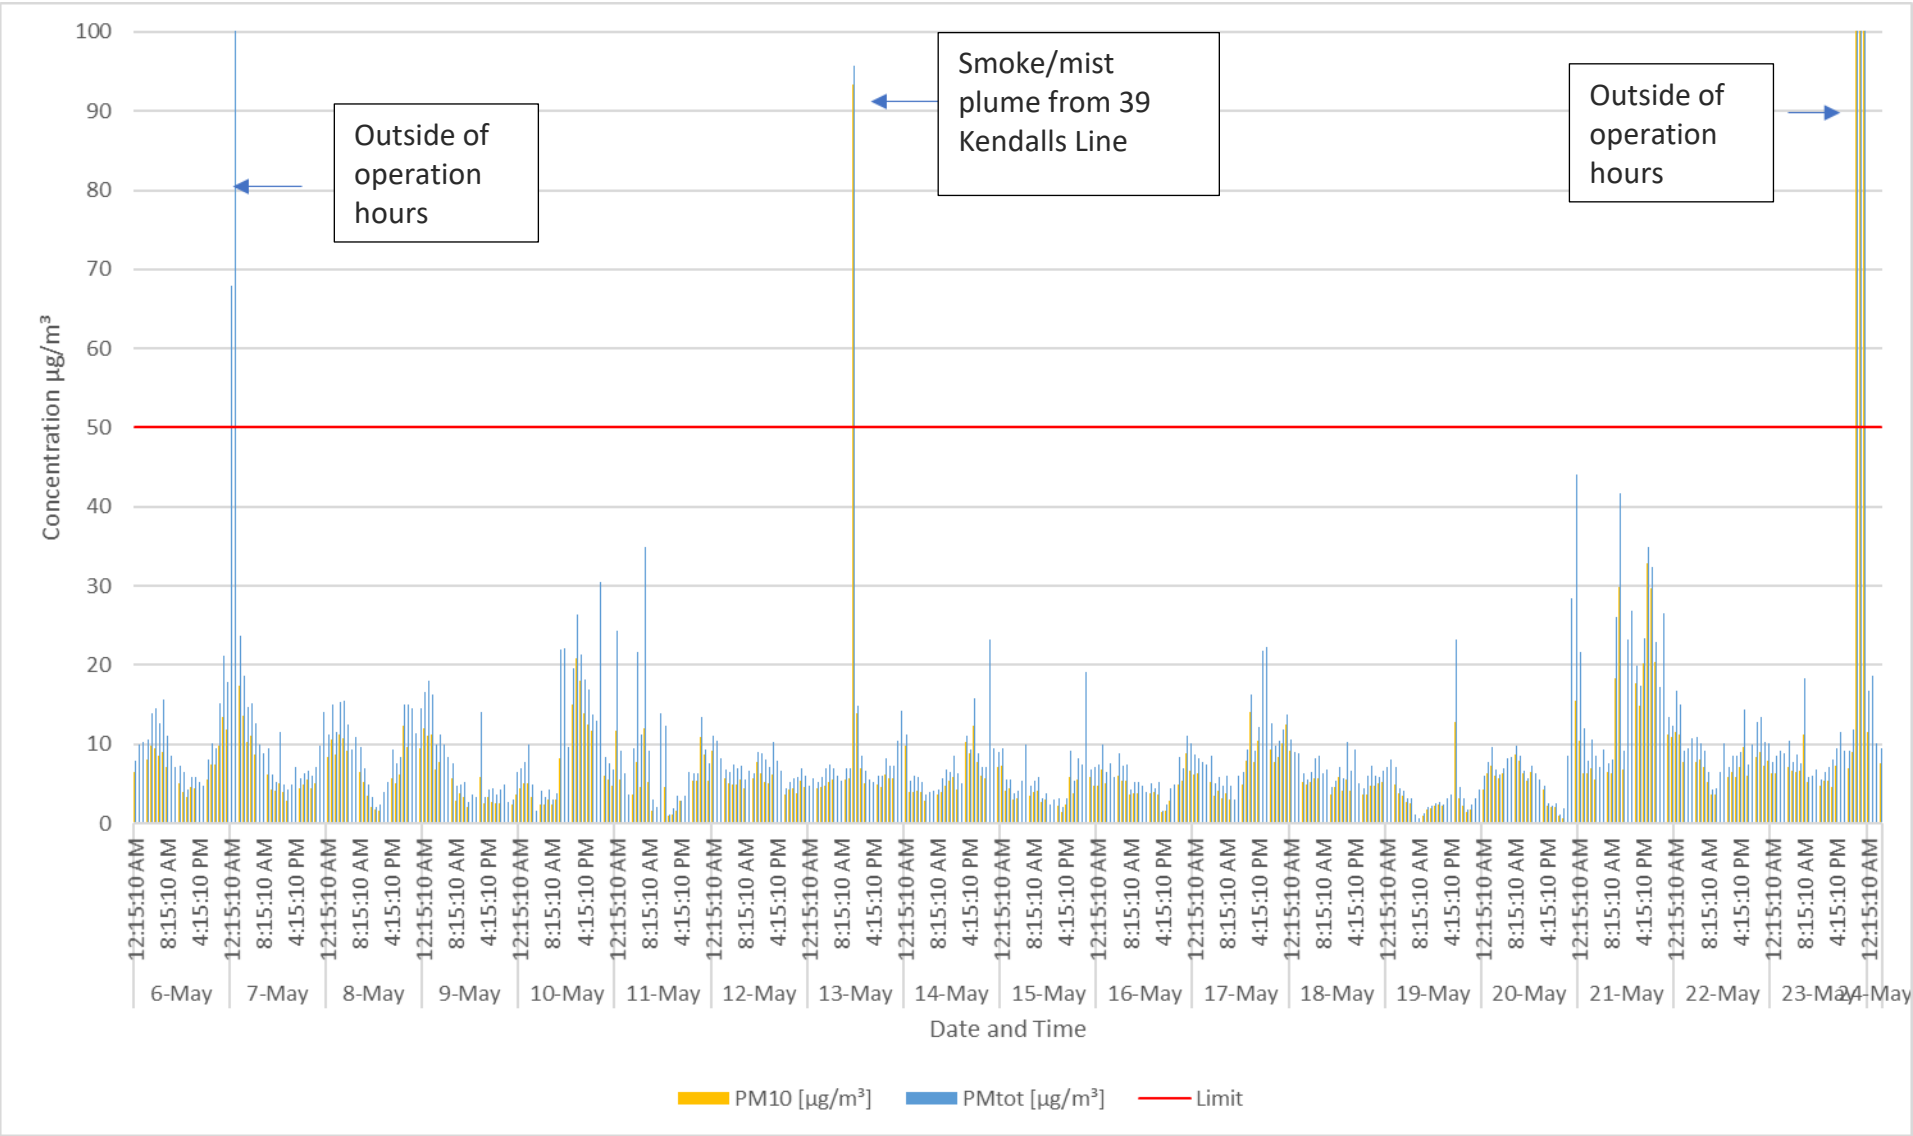
Graph 6 Hourly AQ Guard data from 39 Kendalls Line

The palace AQ guard was used to sample particulate from 39 Kendalls Line. Two parameters are displayed, particulate PM₁₀ and total particulate PM_{total}. The PM_{total} can be expected to capture particles up to 20 µm in size.

Due to the limitations of the DustTrak under low concentration the AQ guard is considered more representative of airborne concentrations (39 Kendalls Line) as it been compared with Environment Canterbury monitoring equipment.

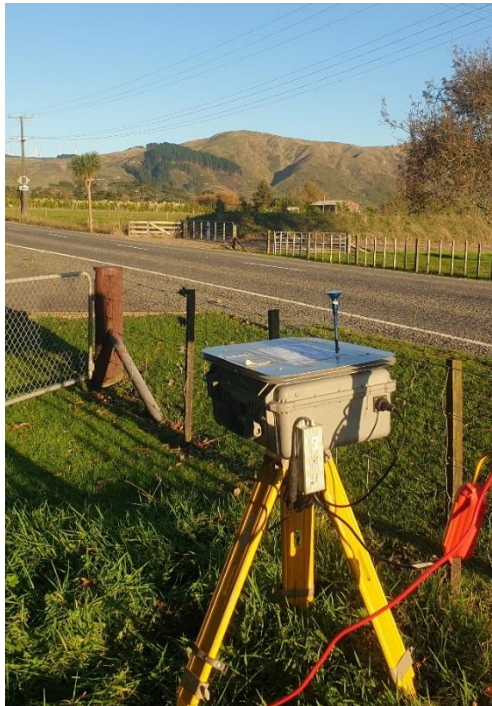
The DustTrak sampler was placed close to the road, in front of the two rural residential properties. Two graphs are provided, one is a one-hour averages, the other 24 hours averages. The 24-hour standard is $50 \mu\text{g}/\text{m}^3$, this is illustrated with a red line on the graph.

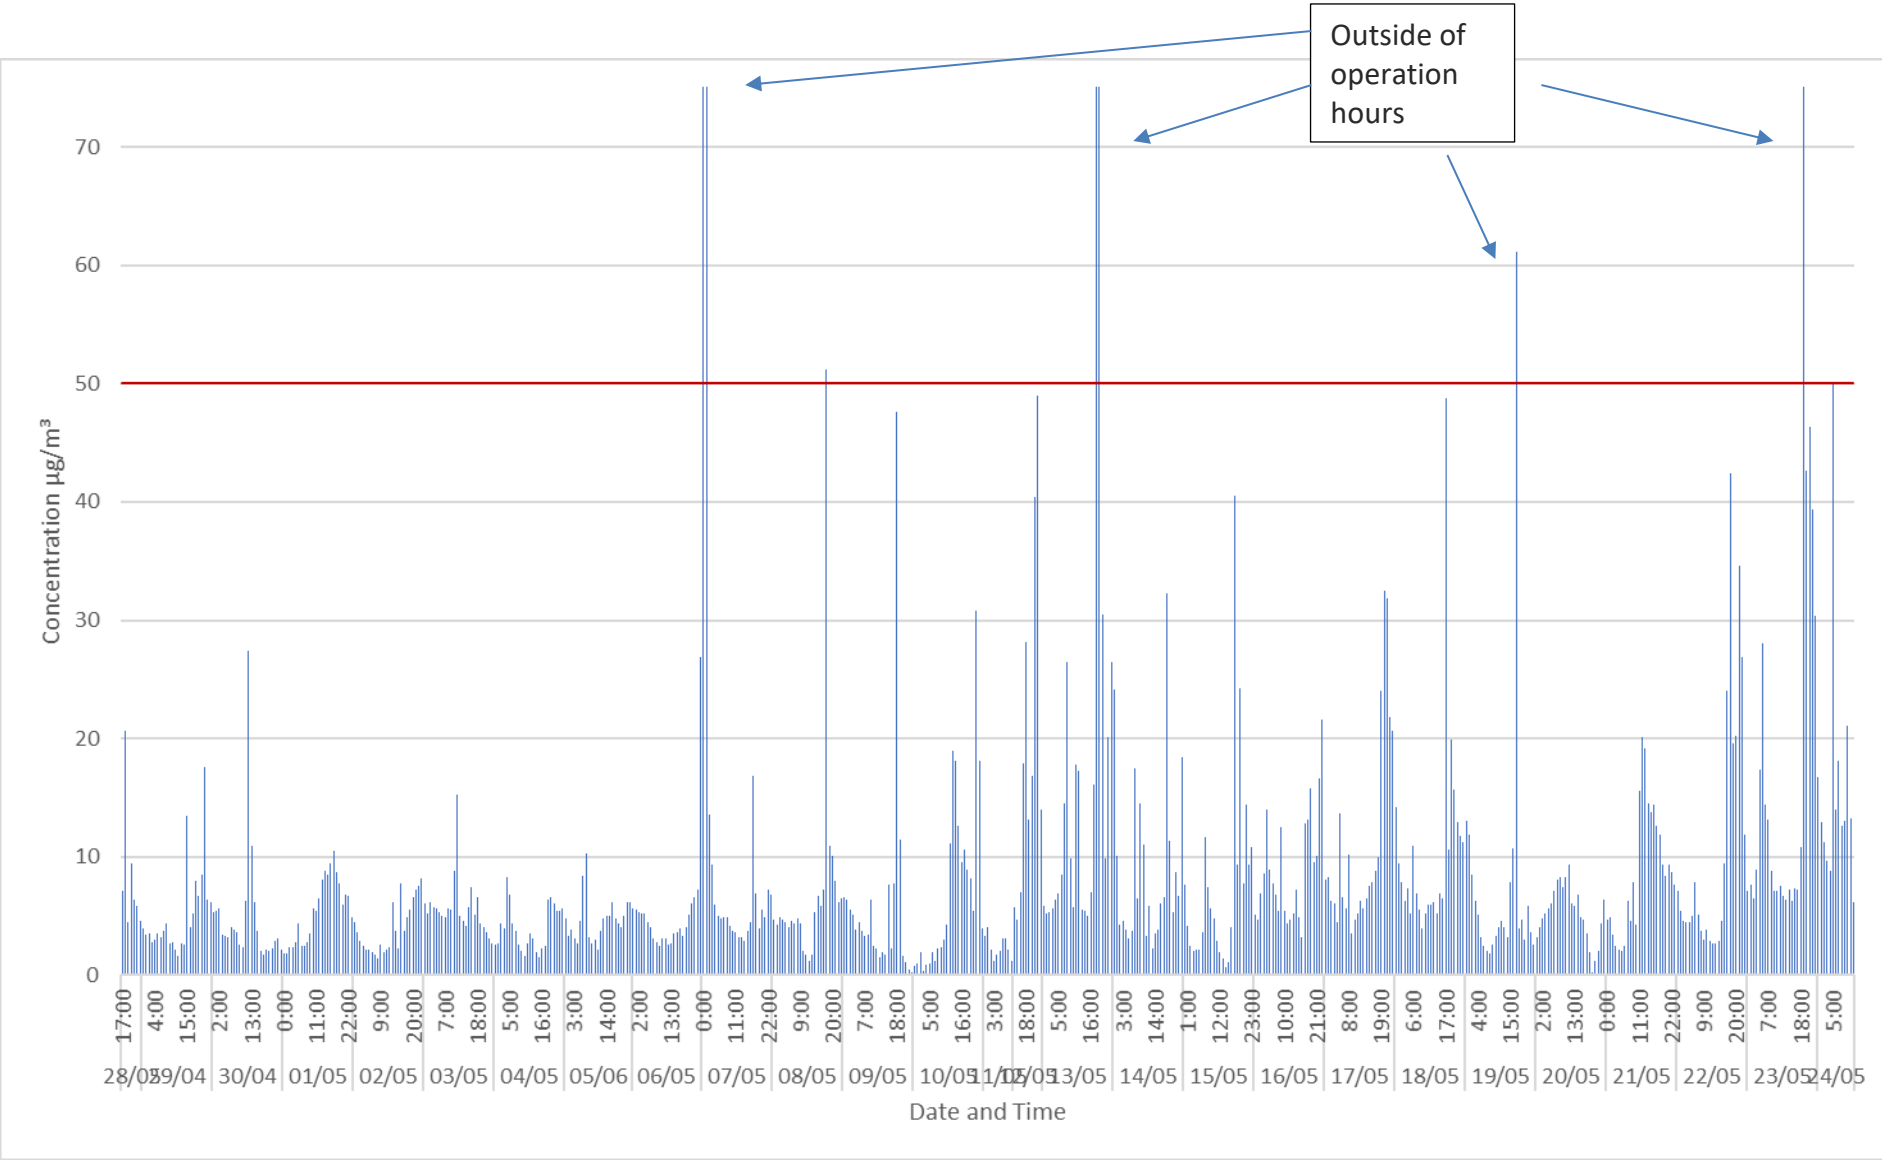
Graph 8 Hourly DustTrak data from 11 Kendalls Line

There are multiple peaks that are above $50 \mu\text{g}/\text{m}^3$ that are outside of Linton's active hours.

- The MFE guideline for PM10 for one hour is $150 \mu\text{g}/\text{m}^3$. This was exceeded in the monitoring at 11 Kendalls line at midnight (226) on 7 May.
