Job No: 85442.0300 12 May 2022

Palmerston North City Council 32 The Square Palmerston North 4410

Aokautere slope stability: considerations for consenting

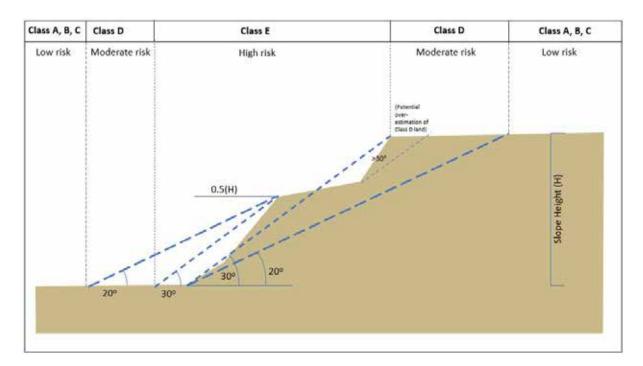
Figure 2.1: Schematic illustration of slope analysis methodology.

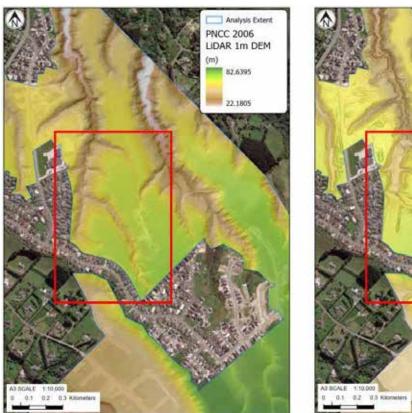
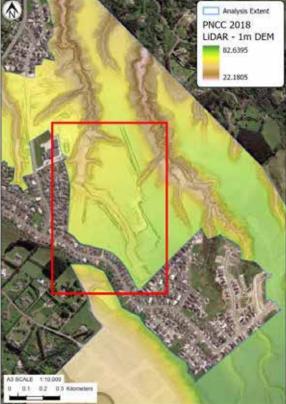
Figure 3.1: Digital elevation models: Left hand image shows 2006 topography, right hand image shows 2018 topography. The red boxes show the focus area.

We have carried out an exercise to identify areas likely to contain fill by subtracting the 2006 DEM from the 2018 DEM. Where the resulting values are negative, the land levels have been reduced by the resultant value by excavation and removal of land, and where the resulting values are positive,

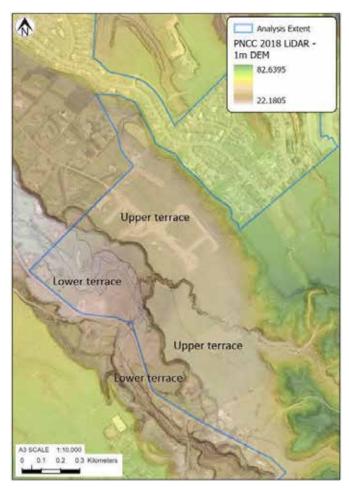
Figure 4.1: Topography of the Turitea Stream valley.

On the basis that there is no geotechnical information or groundwater data for this area, both the upper and lower terrace areas should be classified as **Liquefaction Category is Undetermined** in accordance with the MBIE/MfE Guidance (2017)¹⁰ at this time. Any development in these areas should assess the potential for liquefaction, following the framework laid out in the MBIE/MfE (2017) guidance.
