Palmerston North City Council

Notable Tree Survey March and April 2011

Address	Caccia Birch, 130 Te Awe Awe Street	
Tree name	Beech (<i>Nothofagus hybridus</i>) [more likely to be <i>N. solandri</i>]	
Location of the tree on the site	In the rose garden overlooking the lagoon	
Owner's name	Caccia Birch Trust	
Date of STEM Assessment	30 March 2011	Inspected by John Wakeling

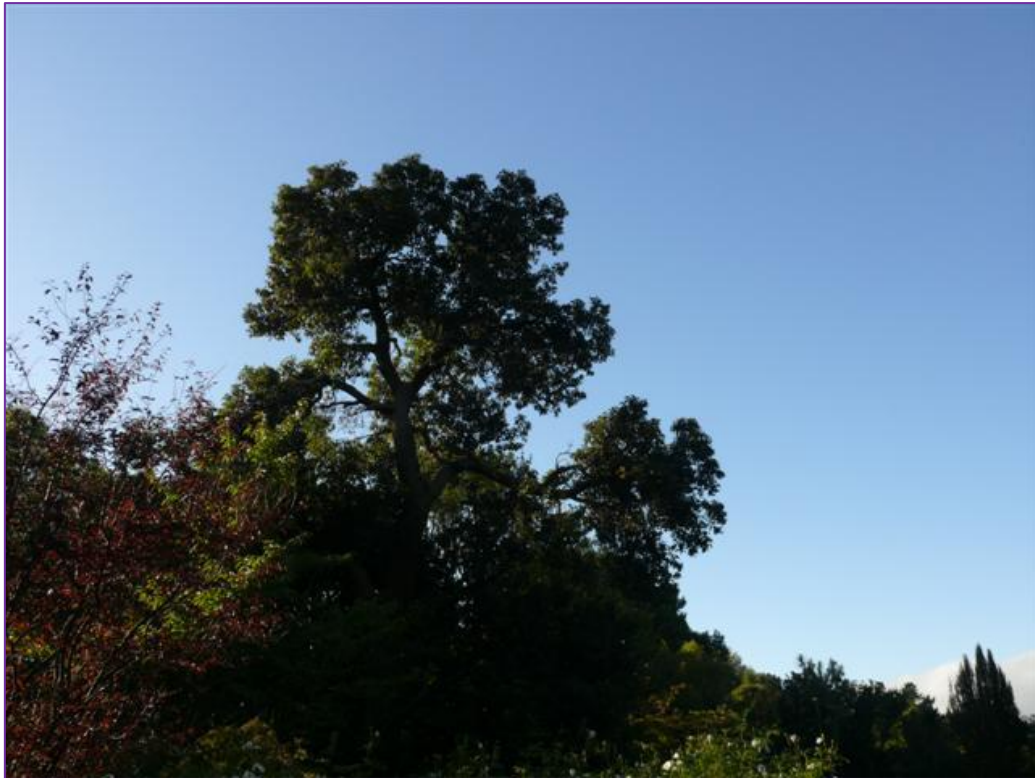
Comments	The species is noted for the brilliance of its mid-summer blossoms (about a month later). The downside is the great weight of the seed pods they produce; these are persistent and can cause breakage of quite large branches.

Figure 3, the crown

Category	Priority	Recommended Action	Timing (from April 2011)	Actioned	Completed
Amenity					
Health	routine	Remove end weight caused by seed cases	5 yearly		
Safety					
Overhanging b'dry

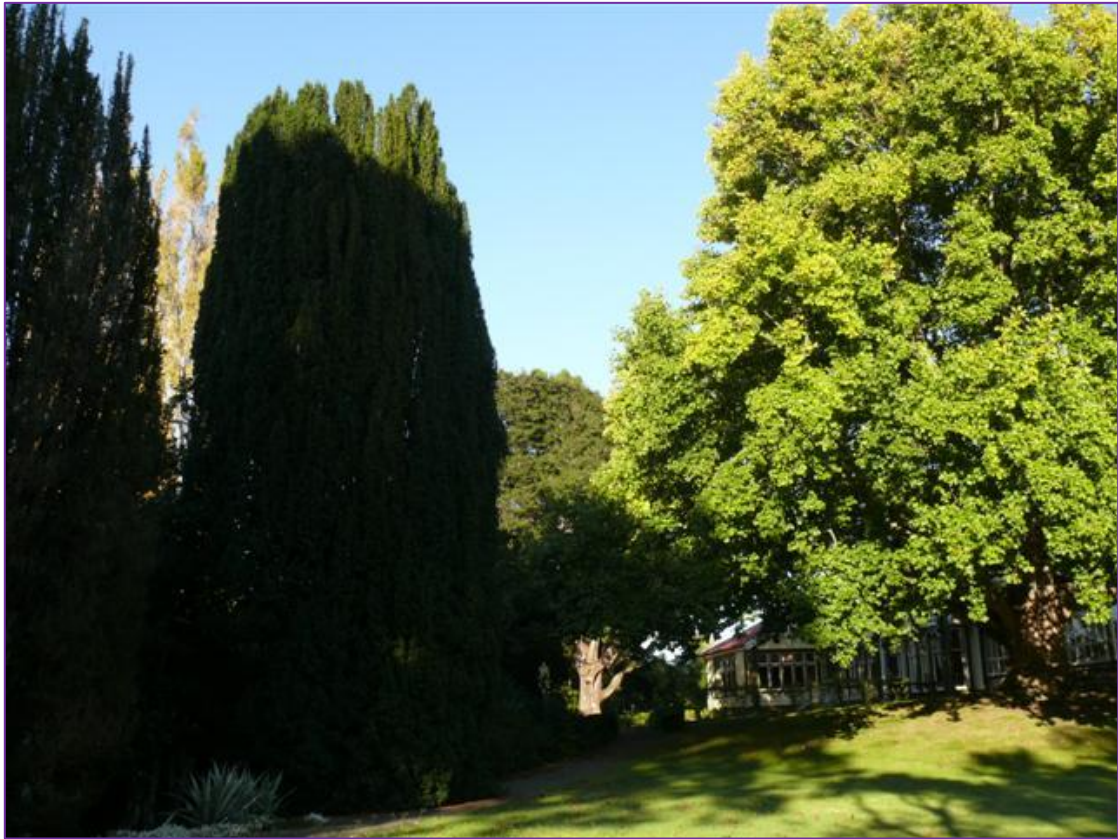
Figure 1, not a good photo of the protected Irish yew,

I have seen a similar occurrence in the UK, where, as a last resort, the owners cut the tree hard back to a naked stump of about 1.5m high. Residual reserves managed to start off a flush of new growth, which continued to grow well. I recommend this course of action for this tree. We have little to lose, if, after a year's waiting, nothing has happened, the stump can be removed.

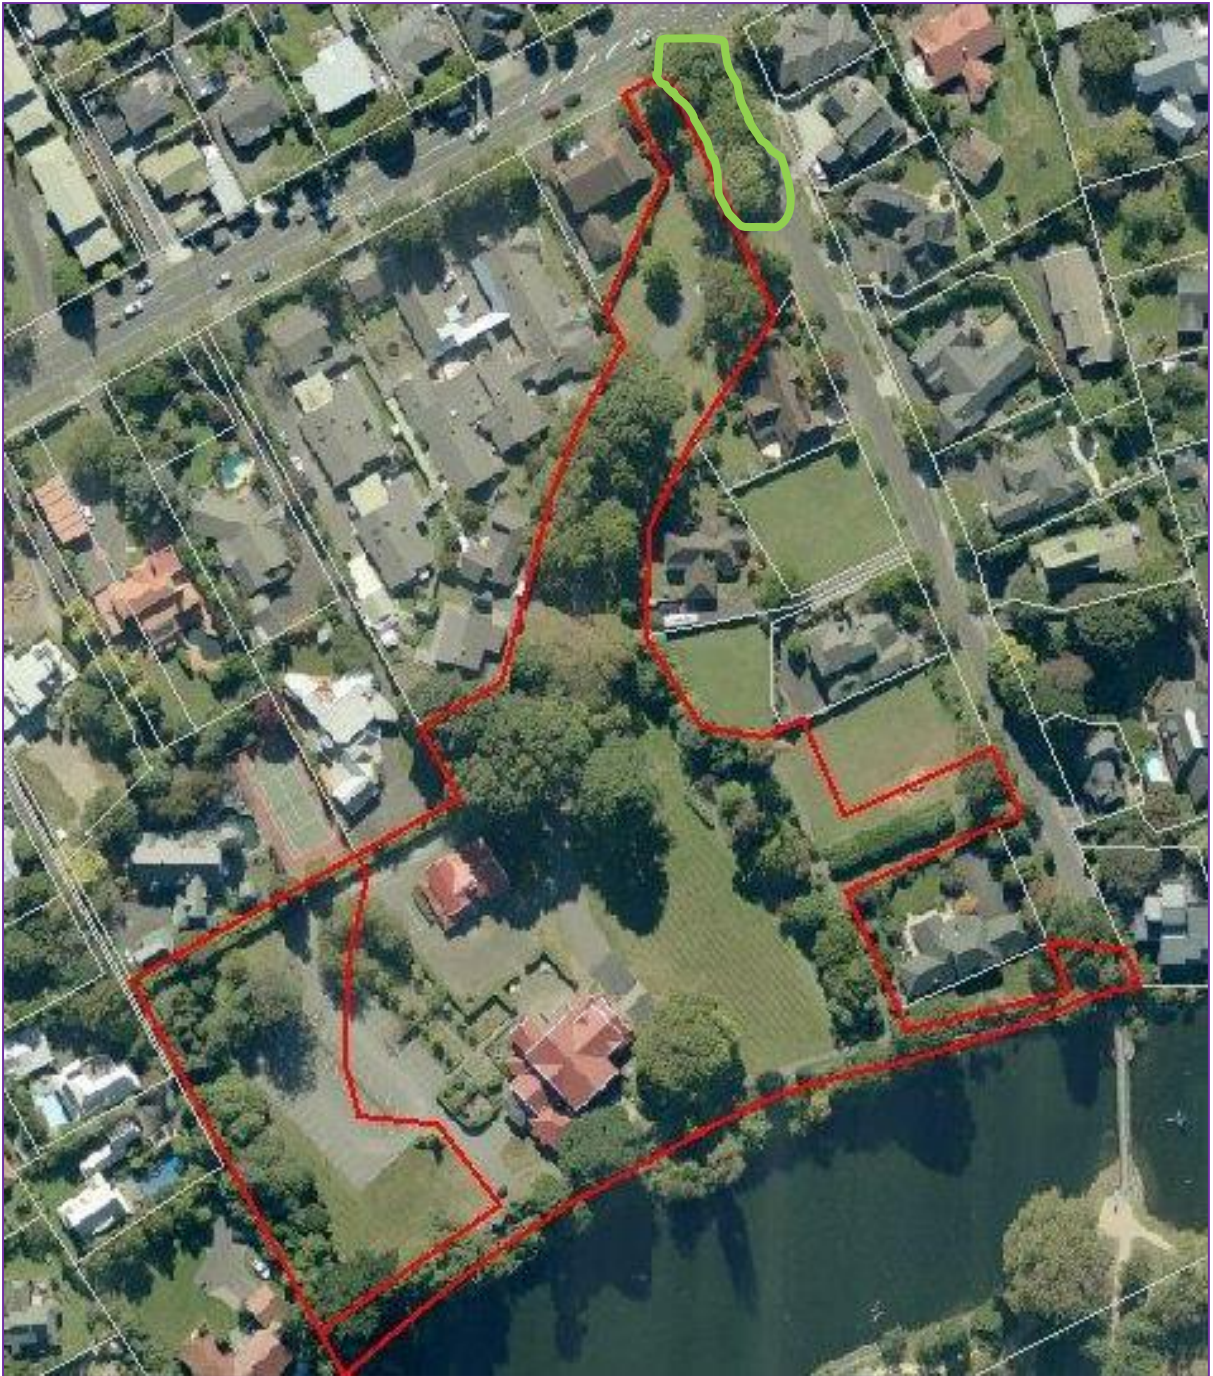
Figure 1. group of thre elm and one oak
