LATERAL SPREADING ASSESSMENT

Rangitikei Line & Flygers Line, Palmerston North

Document Number: J00367AA

Prepared For: Flygers Investment Group Limited

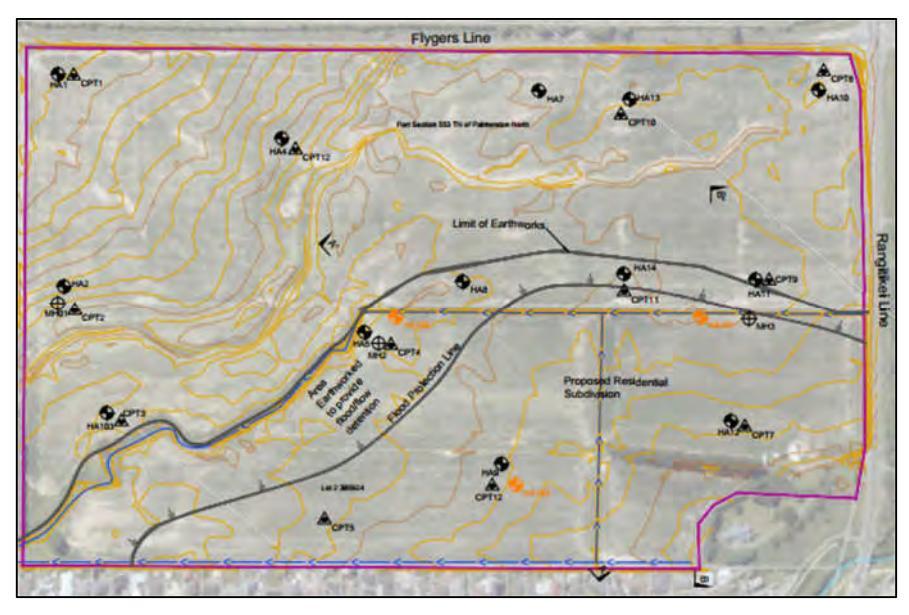
Figure 4, TGE test locations shown as orange icons

The location of the Riley boreholes (black icons) and the TGE hand augers (orange icons) and the location of developed cross sections are shown in Figure 4 extracted from the Test Location Plan attached in Appendix B.

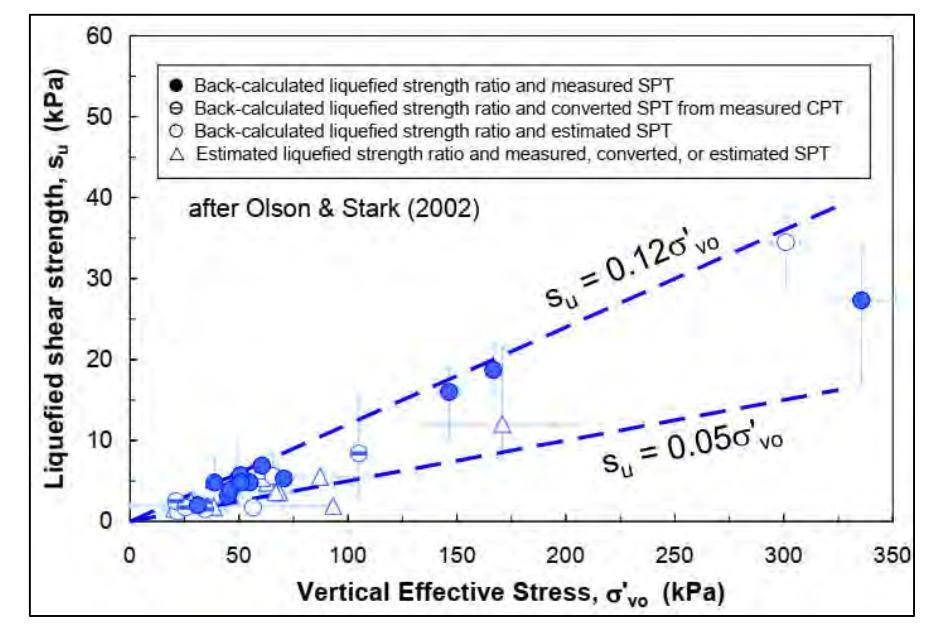
Figure 6. Liquefied strength ratio from back-analysed flow failures.

We have analysed the risk of lateral spread after the ULS event using the slope stability package Slope/w. We have assumed that the upper layer of Holocene alluvial sediments, beneath a 1 m deep groundwater level, liquefies. Olson and Stark (2002) proposed a liquefied strength ratio s_u/σ'_{vo} ranging from 0.05 to 0.12 (Figure 6) with an average of 0.09. For analysis we have conservatively adopted a ratio of $s_u/\sigma'_{vo} = 0.075$.

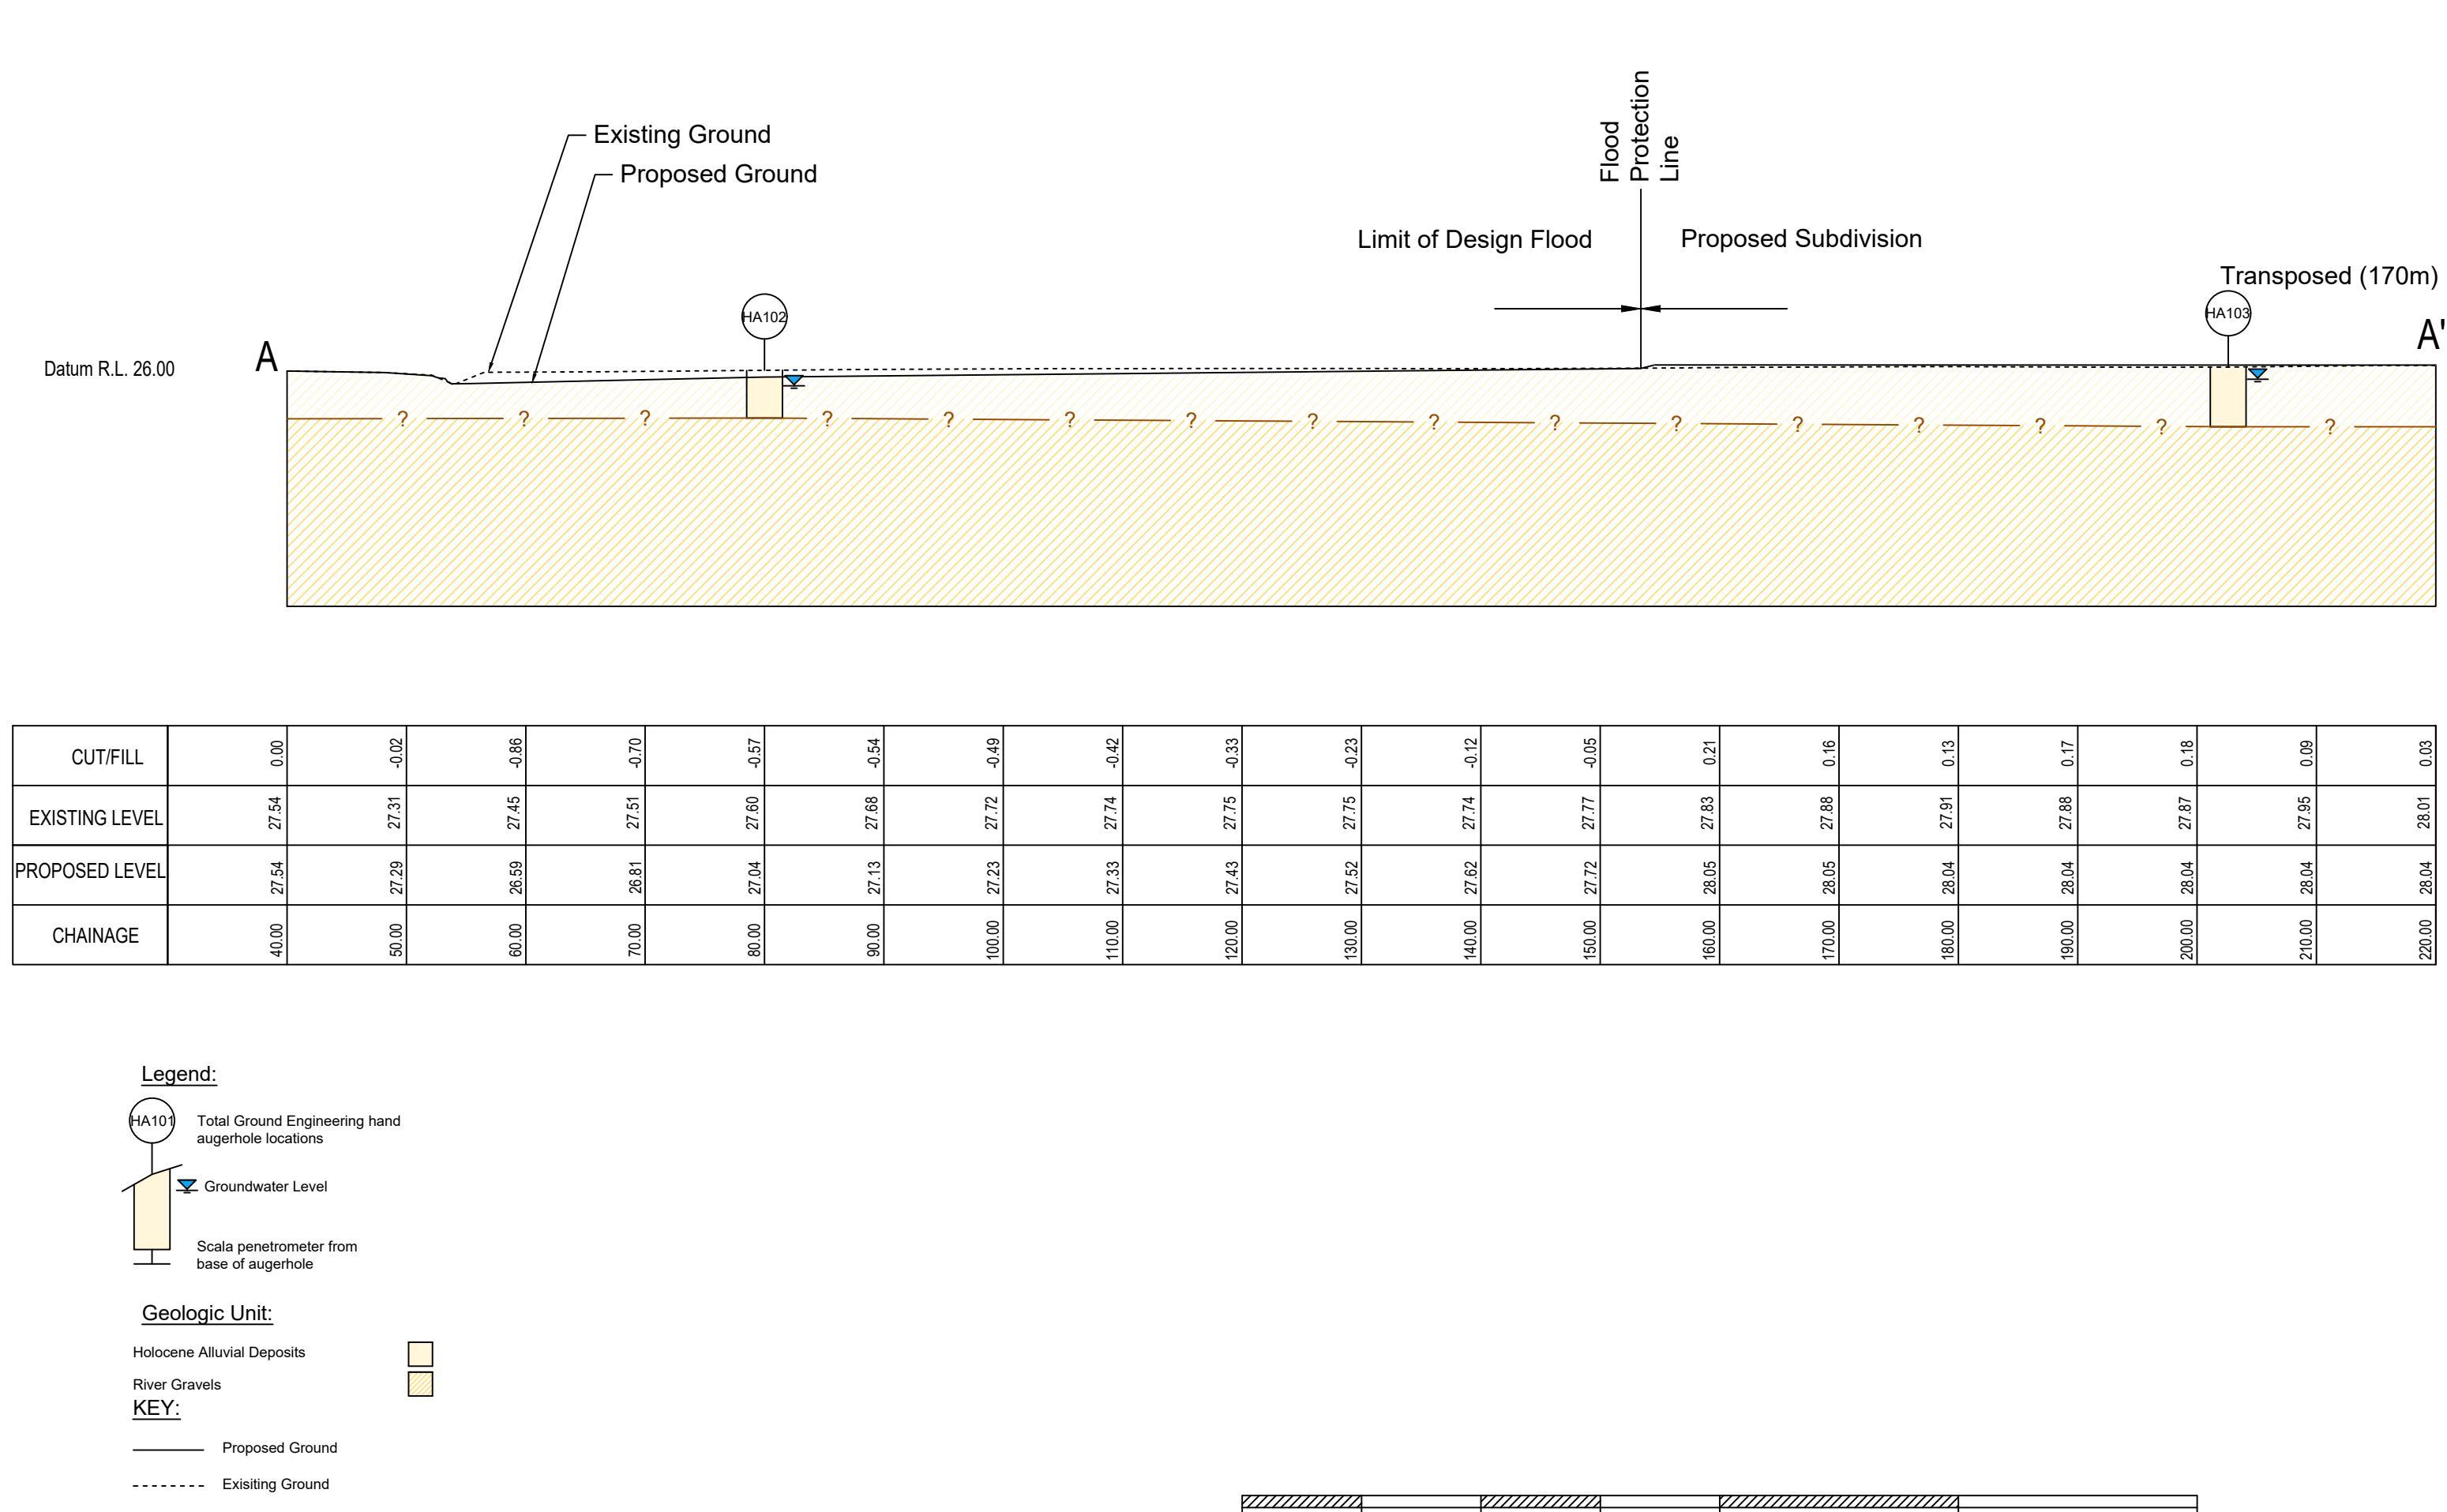
The subsurface conditions encountered during our field investigation generally comprised a layer of Holocene aged river deposits being stiff to very stiff silts with subordinate fractions of sands and clays interbedded with lenses of medium dense to dense sands, overlying dense to very dense river gravels at depth, in general accordance with the mapped geology and previous field investigations. The geological profile is shown in Figure 5 extracted from cross section A-A' attached in Appendix C.
