# Palmerston North City Council

## Notable Tree Survey March and April 2011

<b>Address</b>	74a Fitzroy Street	
<b>Tree name</b>	Copper Beech ( <i>Fagus sylvatica purpurea</i> )	
<b>Location of the tree on the site</b>	On the driveway	
<b>Owner's name</b>		
<b>Date of Inspection</b>	30 March 2011	<b>Inspected by</b> John Wakeling

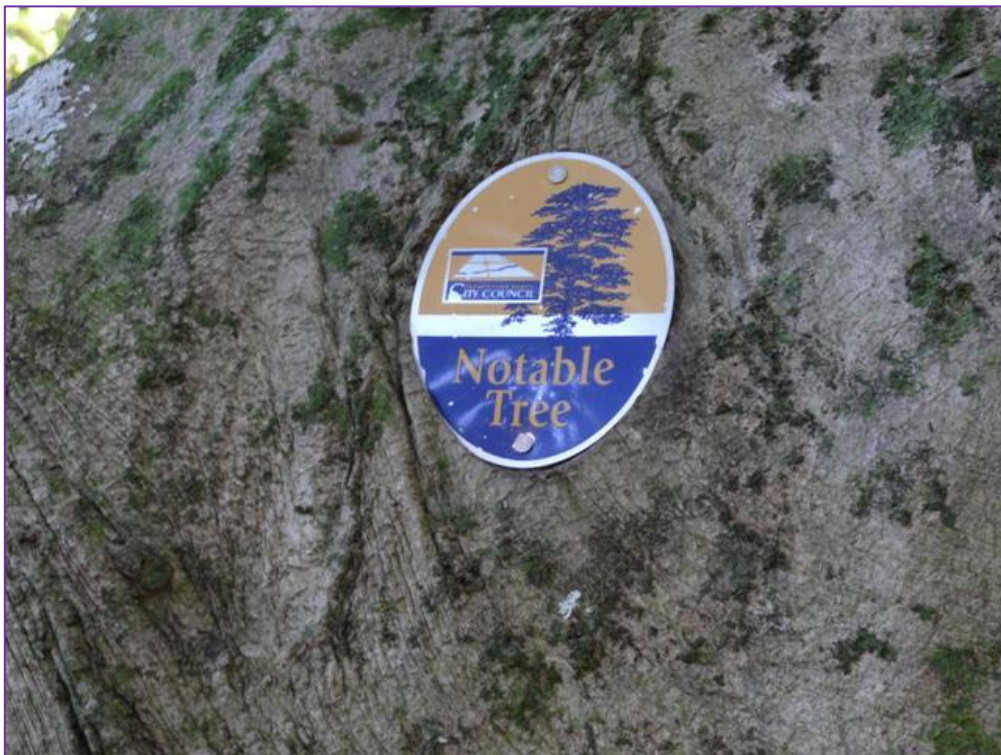
Figure 1 the low limb over the driveway will need some side branches removed before long

Category	Priority	Recommended Action	Timing (from April 2011)	Actioned	Completed
<b>Amenity</b>	<b>routine</b>	Deadwood. Shorten lower limbs to allow better driveway access.	In 2 to 3 years		
<b>Health</b>					
<b>Safety</b>					
<b>Overhanging b'dry</b>
