Palmerston North City Council

Notable Tree Survey March and April 2011

Address	632 Pioneer Highway	
Tree name	Black beech (<i>Nothofagus solandri</i>)	
Location of the tree on the site	Close to the entrance drive, near holiday cabins	
Owner's name		
Date of Inspection	31 March 2011	Inspected by John Wakeling

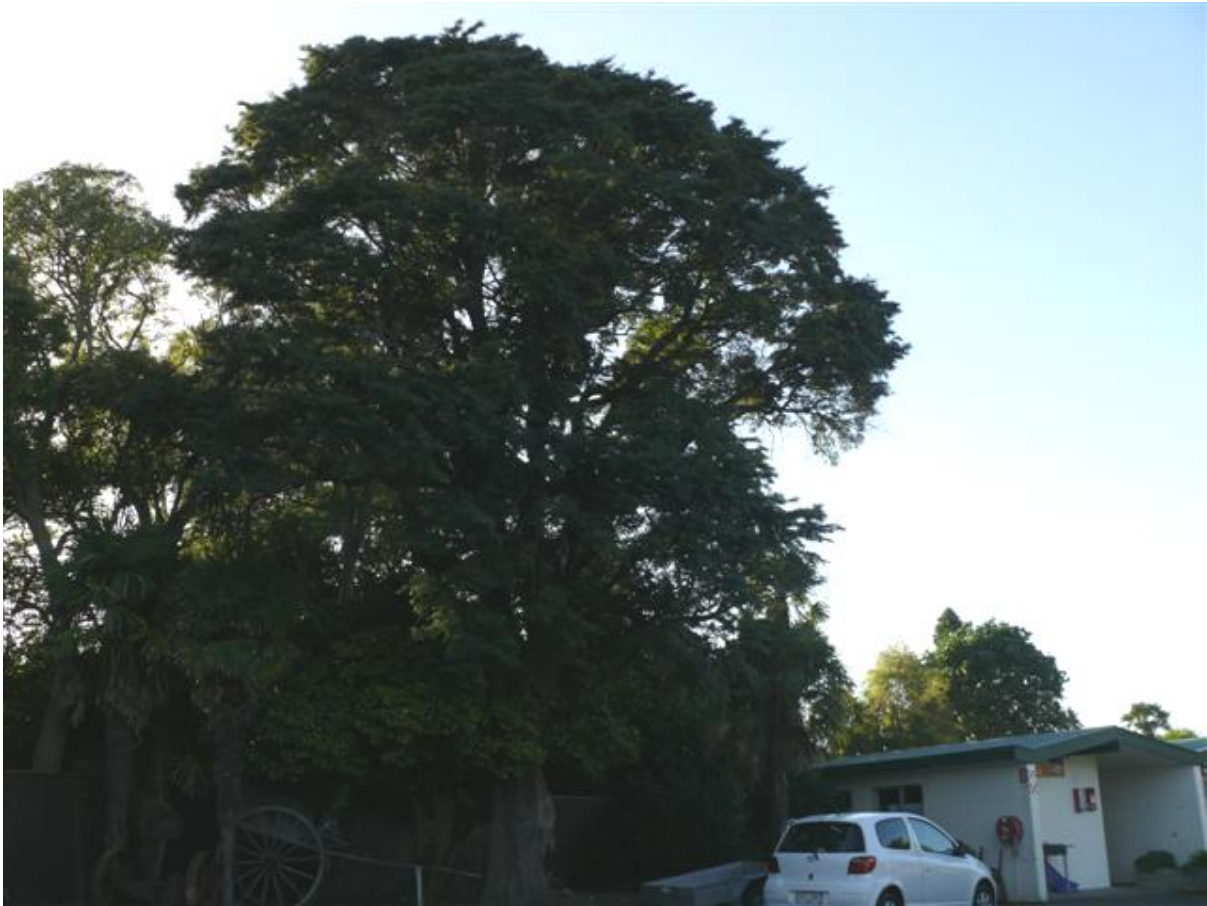
Figure 4. the dead lower limb should be removed

Category	Priority	Recommended Action	Timing (from April 2011)	Actioned	Completed
Amenity	urgent	Remove dead wood in the crown.	This year. Then 5 yearly		
Health	-	Apply a layer of mulch	On an annual basis		
Safety	See Amenity section above		ditto		
Overhanging b'dry
